Re: 2,000,000 Gallon Candler Mountain Reservoir  
Maintenance Inspection

Maintenance Inspection

2,000,000 Gallon Reservoir  
Candlers Mountain #1 (East Tank)

Lynchburg, Virginia

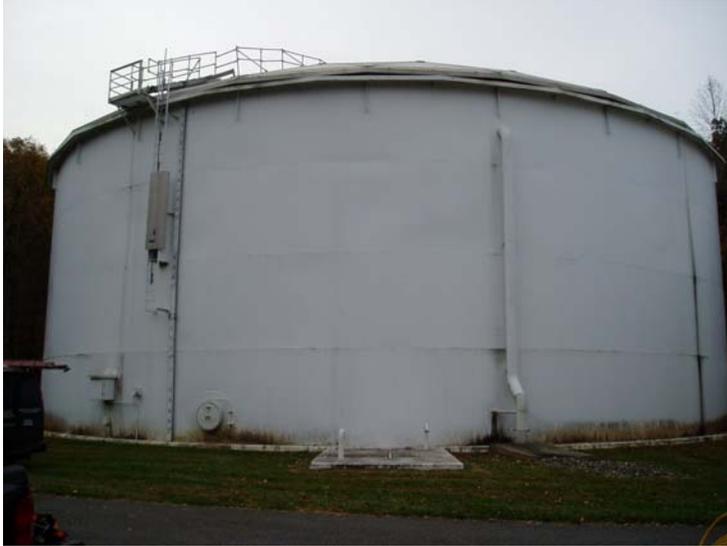
1) 2,000,000 gallon reservoir (Candlers Mountain Tank #1) located in Lynchburg, Virginia.

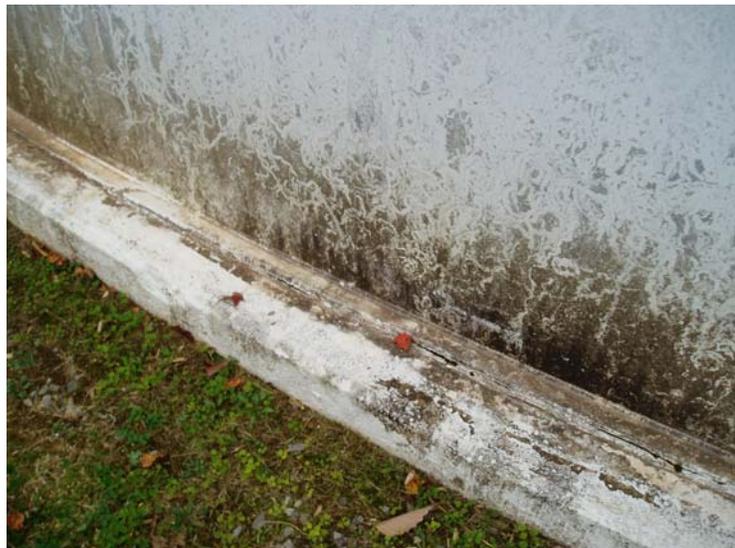
The caulk is in poor condition. Caulk is missing or damaged around most of the circumference between the bottom plate and the foundation.

2) Typical foundation section with loose caulking at the baseplate.

Replace the caulk by removing all caulk and replace with new caulking.

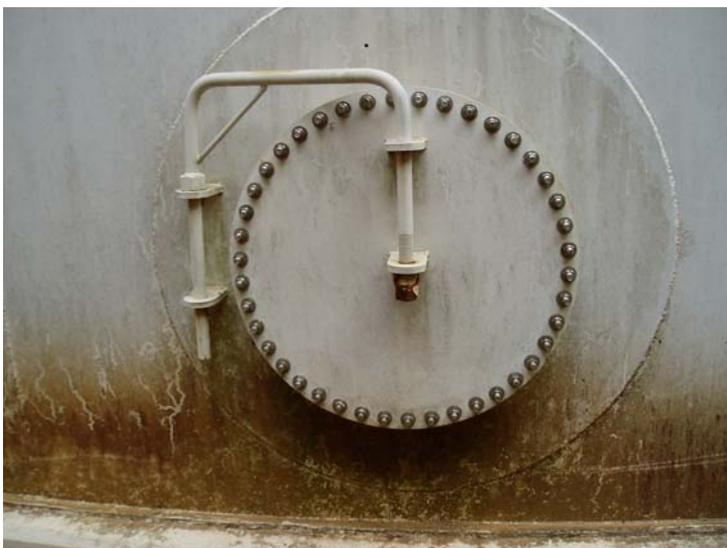
3) One of the bolted sidewall manways.

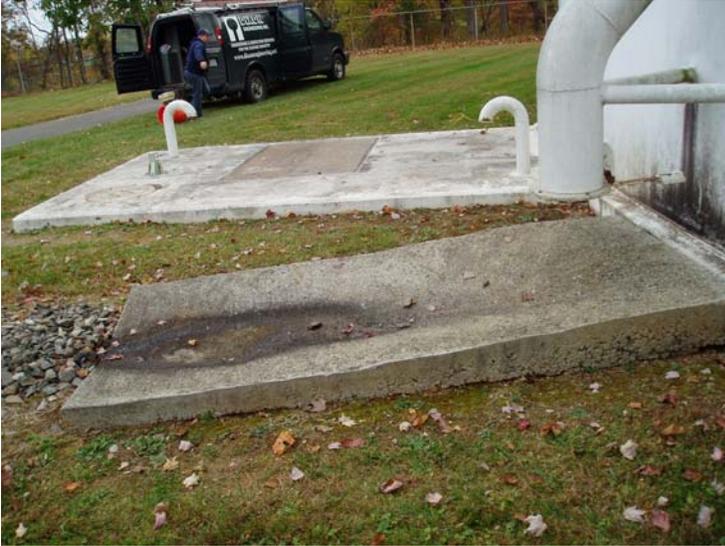
4) Overflow pipe with splash pad and flap gate.

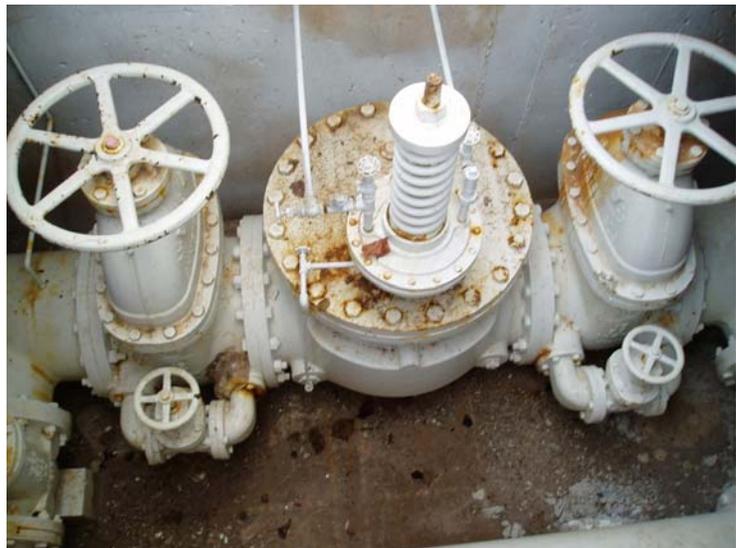
The piping is in good condition. Coating on the pipes is in good condition. The pipes and valves have some minor surface rust.

5) Pit piping with some rust bleedthrough.

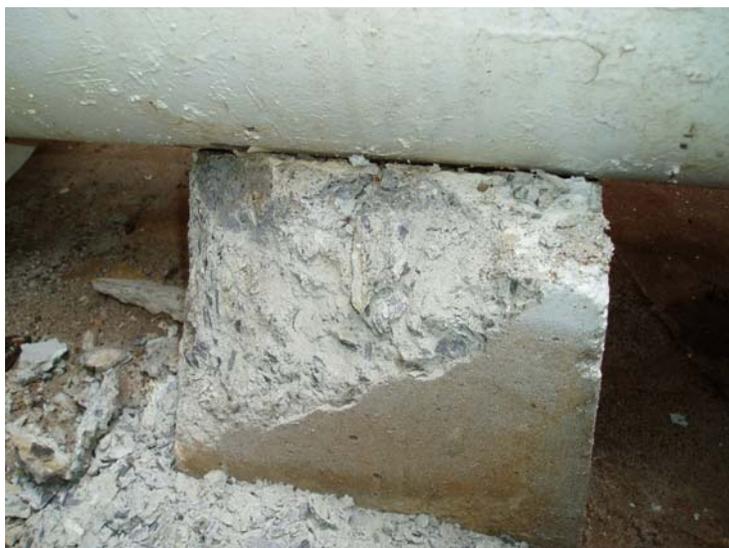
The piping in the pit is supported by concrete saddles. Two of the saddles have deteriorated.

6) One of two damaged pipe supports in the pit.

Rebuild the damaged pipe supports.

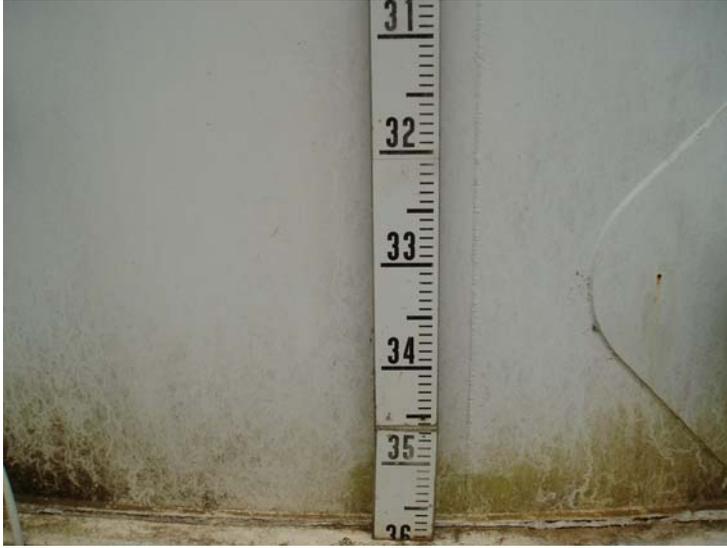
There is an inoperable level indicator on the sidewall that attaches to a float in the wet interior with a cable. The cable does not route through the conduit properly, making the device inoperable.

7) Level indicator was inoperable.

Remove the level indicator and seal openings in the roof. The cost would be incidental to exterior painting.

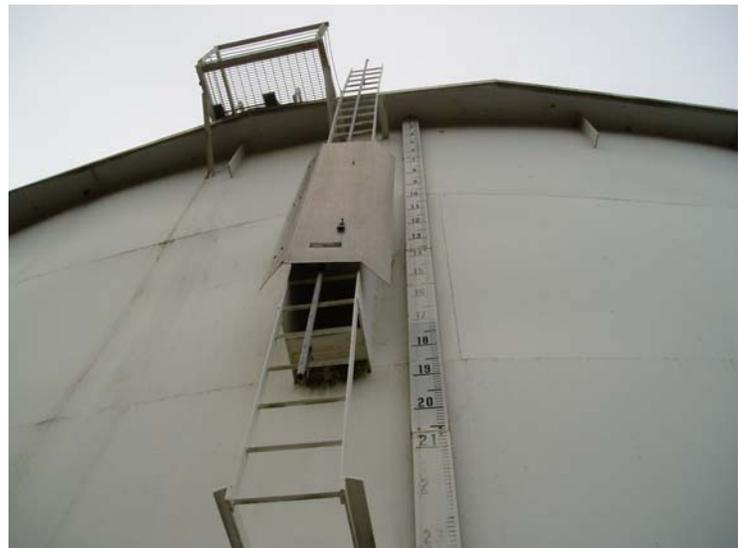
There is a vandal guard on the ladder with a missing bolt, the guard still protects from access.

8) Sidewall ladder with vandal guard.

Replace the bolt on the vandal guard. Cost would be incidental to exterior painting.

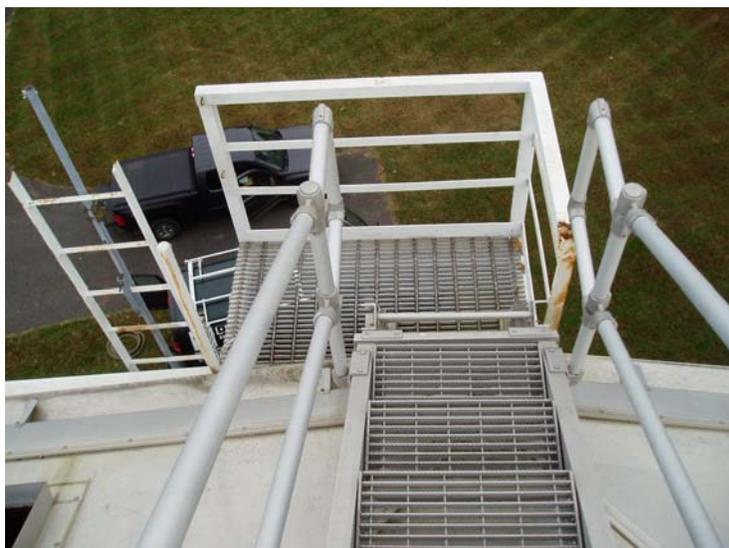
9) Platform at the upper sidewall.

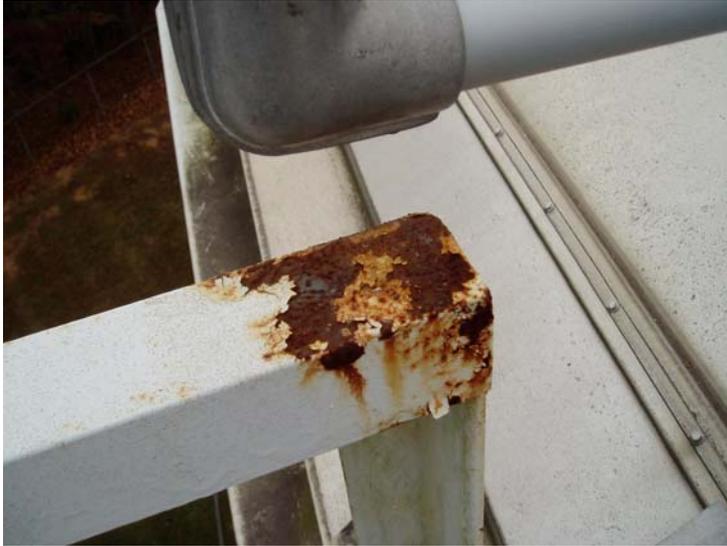
10) Coating failure on the platform railing.

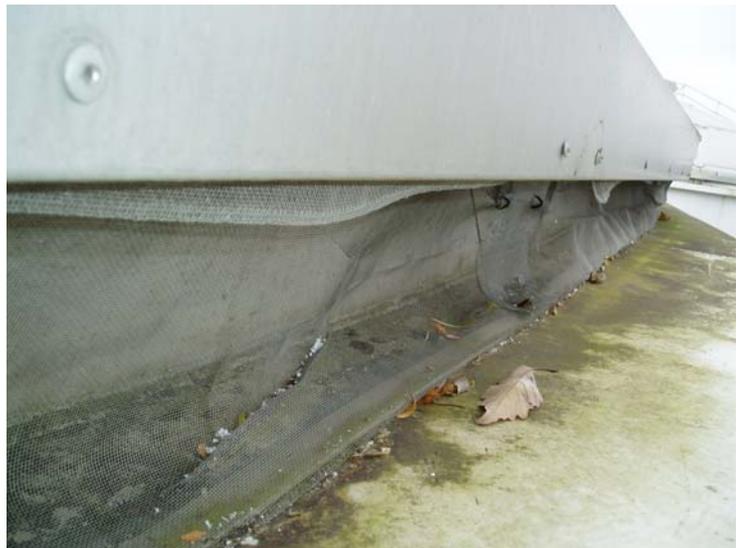
The sidewall to roof gap is screened. Complete inspection was not performed due to limited access, however evidence of containment entering into the tank was found.

11) Screen at the air gap between the roof and sidewall stiffener.

Install replaceable screened frames at the sidewall stiffener and roof connection. These are more sturdy and would be similar to those retrofitted on the 4.5 million College Hill reservoir.

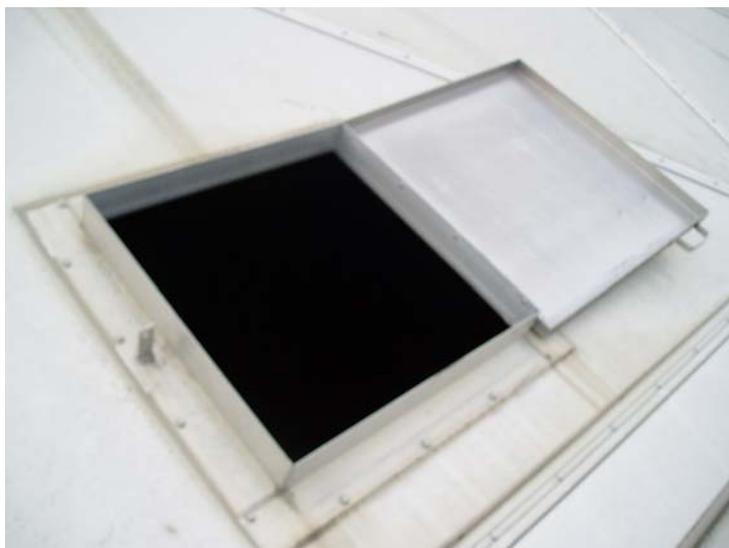
12) Roof hatch.

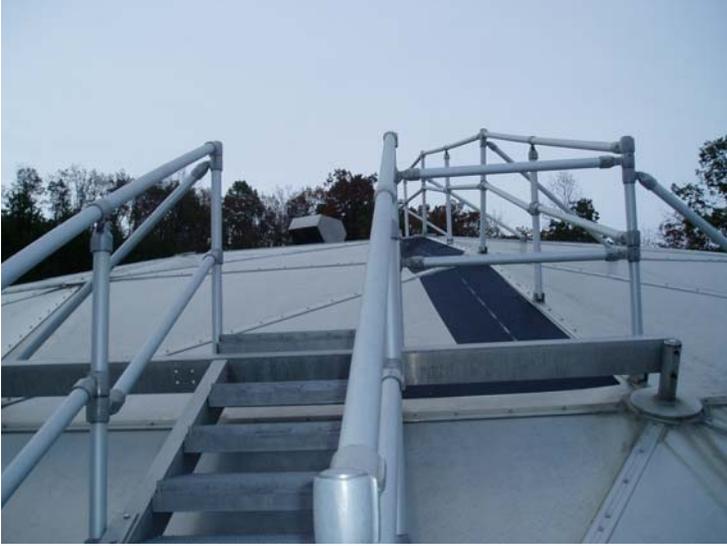
A handrail is located on the roof up to the center of the dome. Some sections are loose.

13) Roof stairs and railing.

Tighten the railing post bolts. The cost would be incidental to the recoating.

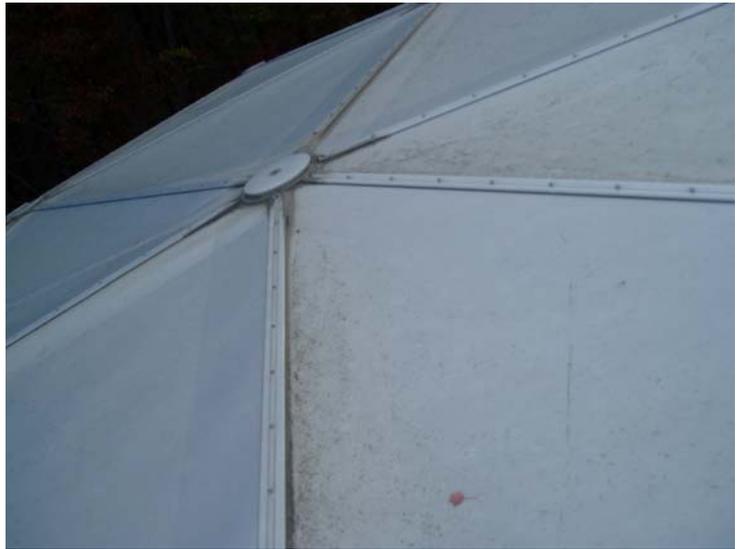
14) Typical hub and roof panel section.

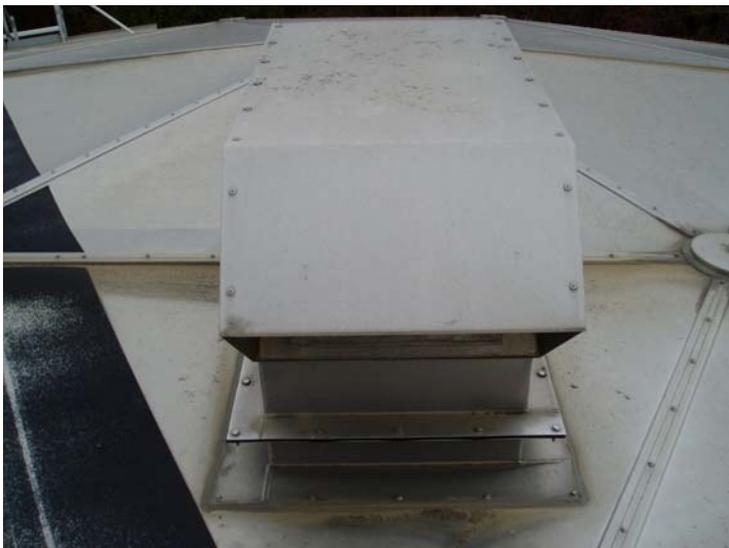
15) Frost free roof vent.

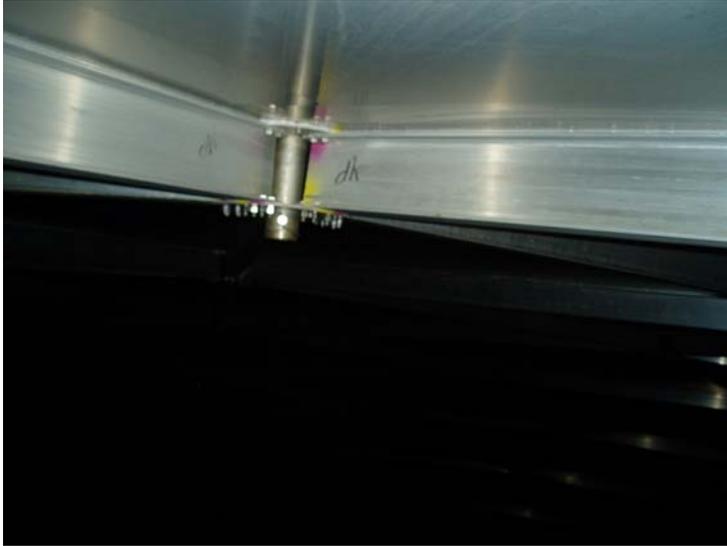
16) Interior roof.

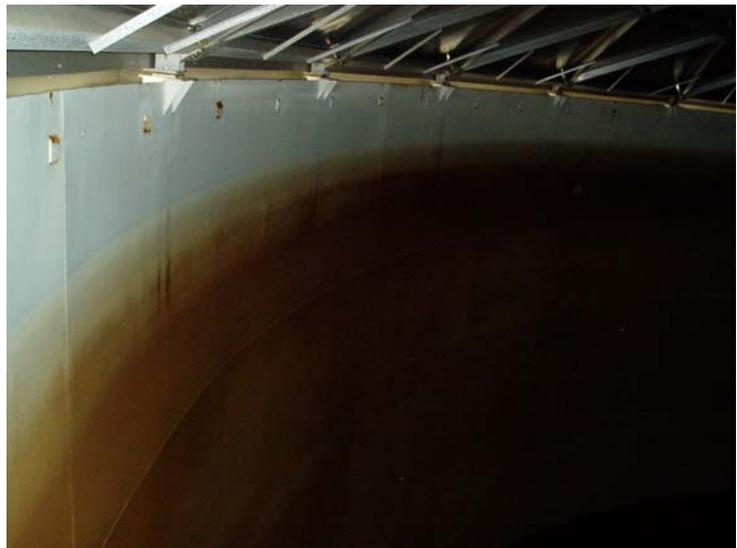
17) Roof connection at the side-wall.

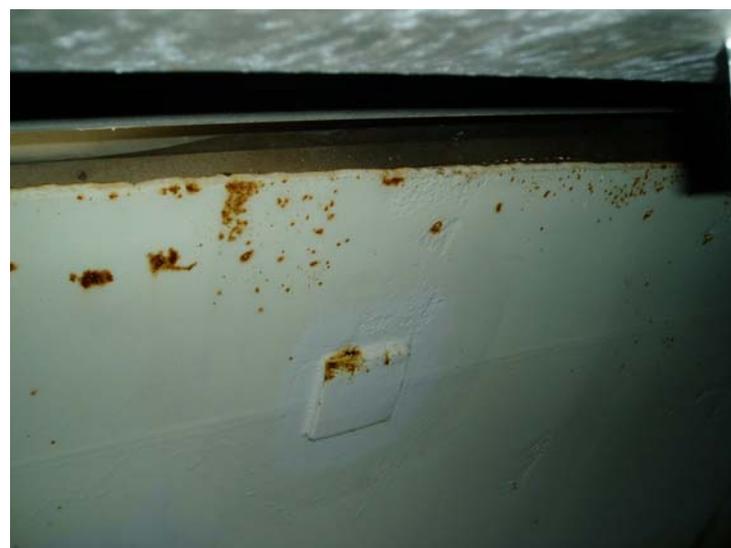
The sidewall coating is in good condition overall. There is not any significant damage at the high water line, which would be the area most affected by ice pressures and ice movement. Cause of deterioration is spot coating breaks with most of the failures at welded plates at the top of the sidewall.

18) Coating failures at the top of the sidewall.

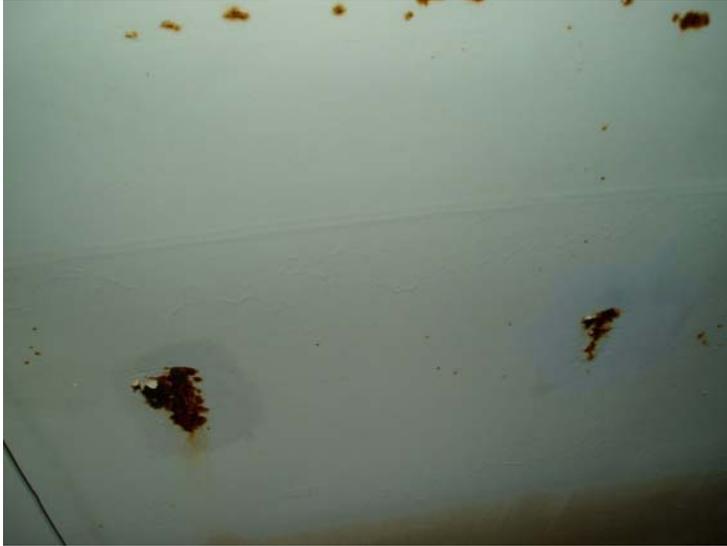
19) Coating failures on the upper sidewall.

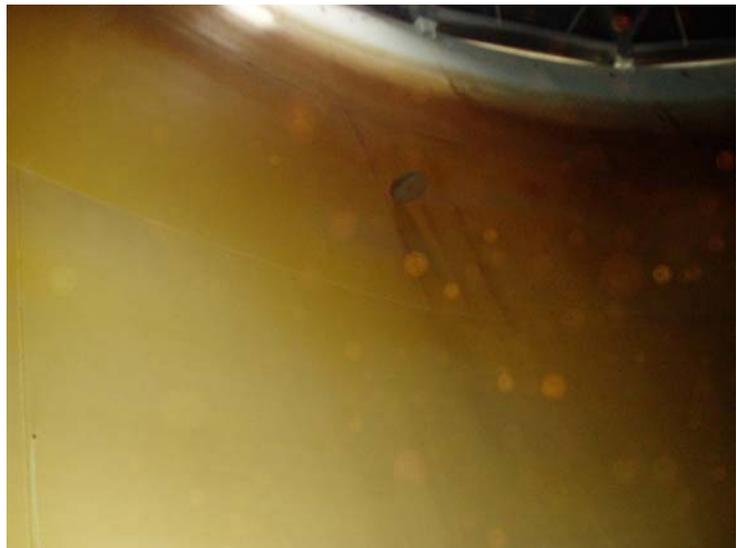
20) Sidewall overview and damaged level indicator float.

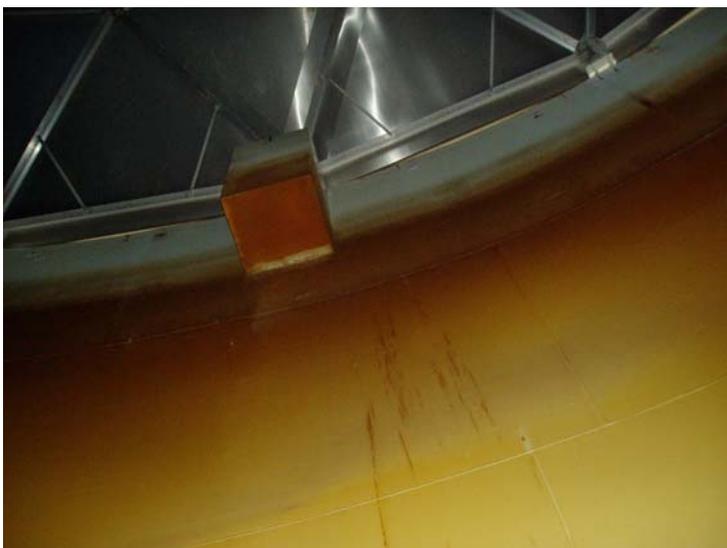
21) Overflow weir box.

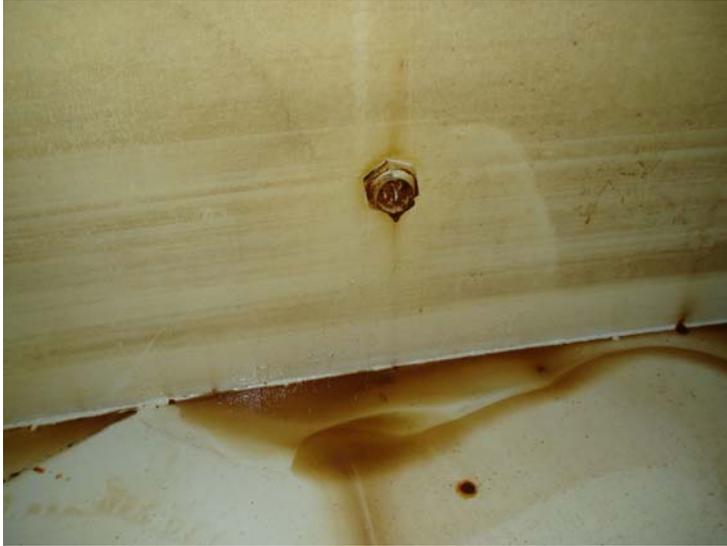
22) Pressure fitting on the side-wall.

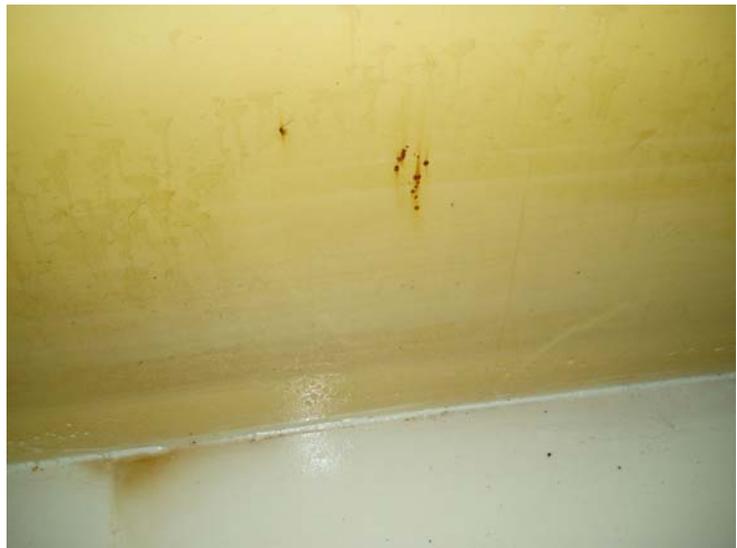
23) Coating failures on the side-wall.

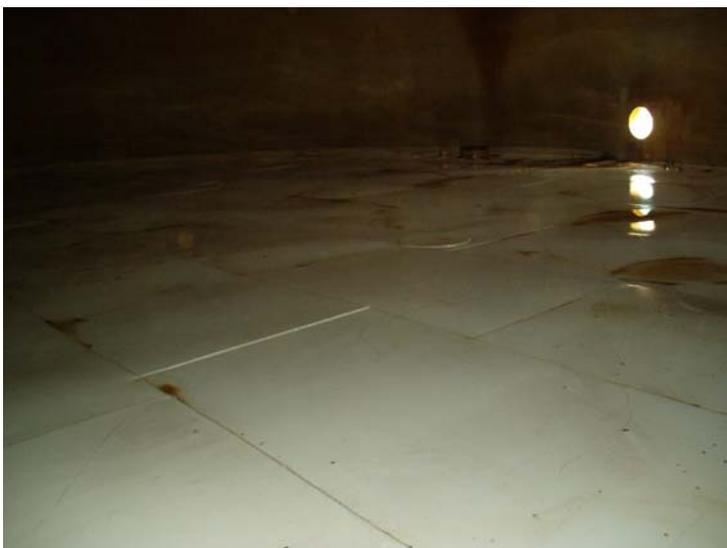
24) Floor overview.

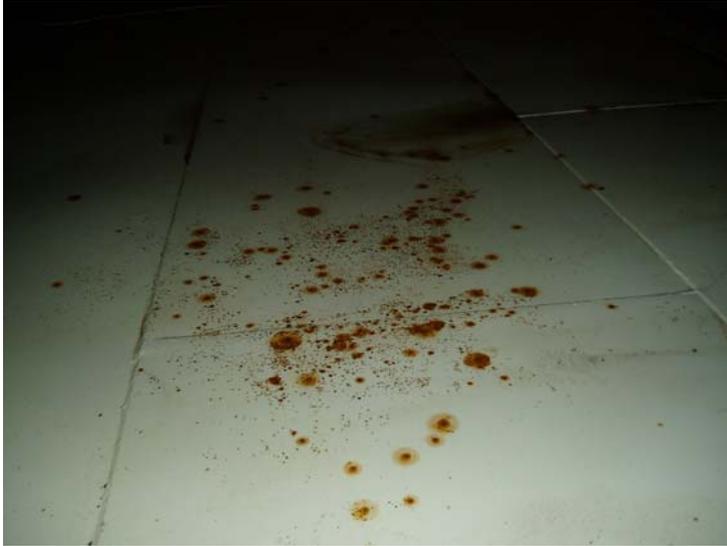
The coating on the tank bottom is in poor condition. Deterioration consists of spot coating breaks with well over 100 failures.

25) Coating failures on the floor.

The existing coating system has not deteriorated to the point where replacement is warranted assuming cathodic protection is installed. Installation of a cathodic protection system would adequately protect all areas below the high water line where the coating has deteriorated.

Install an impressed current cathodic protection system. The system is designed with a horizontal ring configuration. The anode is suspended into the lower one-third of the tank by floats. As water fills the tank, the anode takes the desired ring configuration. This design is considered ice-free. Formation of ice normally occurs at the high water level and some along the sidewalls. As long as the tank is operated in the upper one-half of its capacity, the probability of ice damage is very low. The anode used is a platinized niobium or titanium wire with a design life of ten years. The system also incorporates copper/copper sulfate reference anodes.

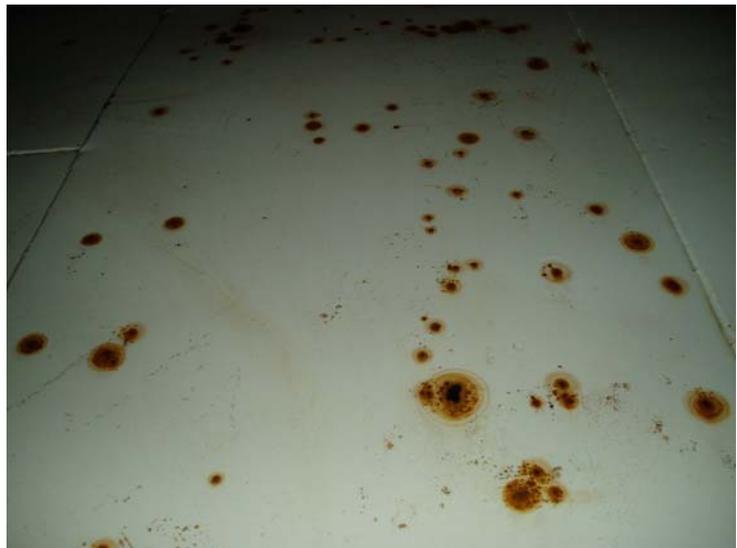
26) Spot coating failures on the floor.

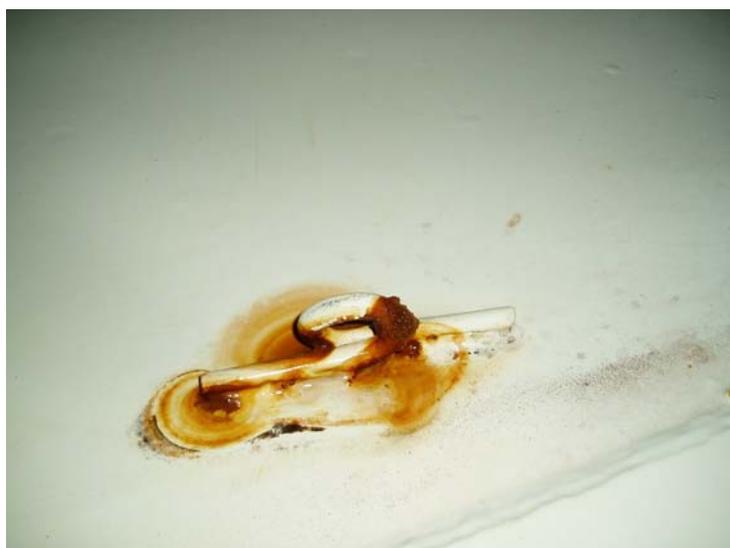
27) Cathodic protection attachment clip.

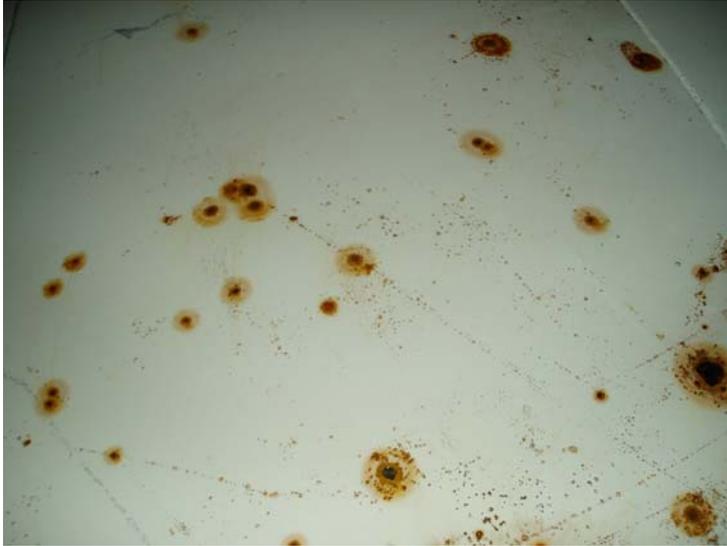
28) Coating failures on the floor.

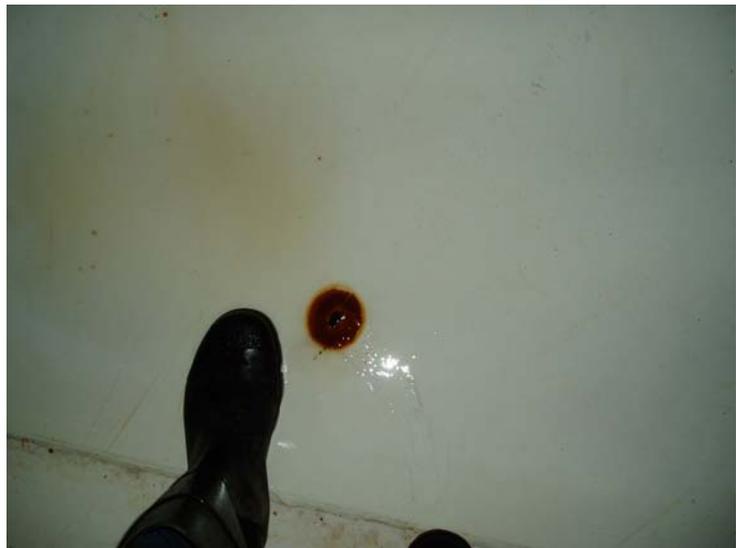
29) Spot coating failure on the floor.

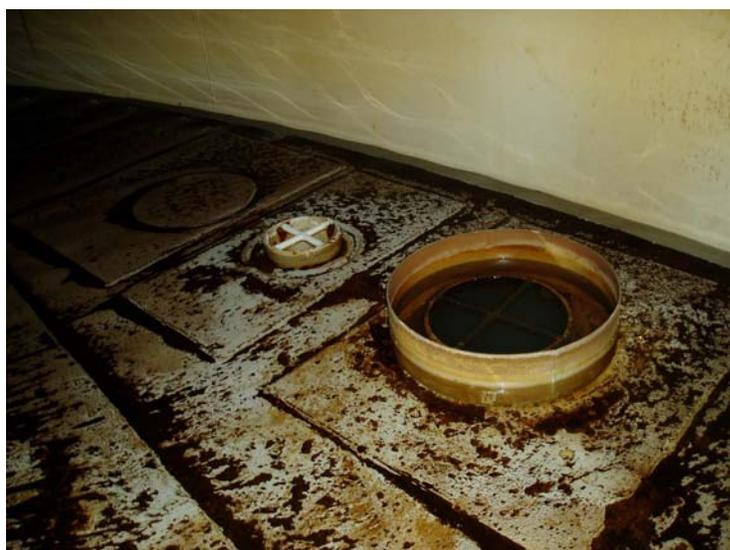
30) Fill line, draw line and drain line.
