Re: 2,000,000 Gallon Huntingwood Reservoir
Maintenance Inspection

Maintenance Inspection

2,000,000 Gallon Reservoir
Huntingwood

Lynchburg, Virginia

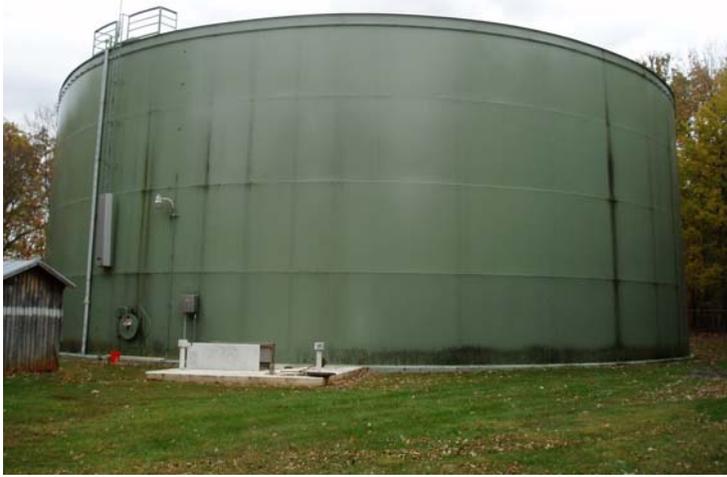
1) 2,000,000 gallon (Huntingwood) reservoir located in Lynchburg, VA.

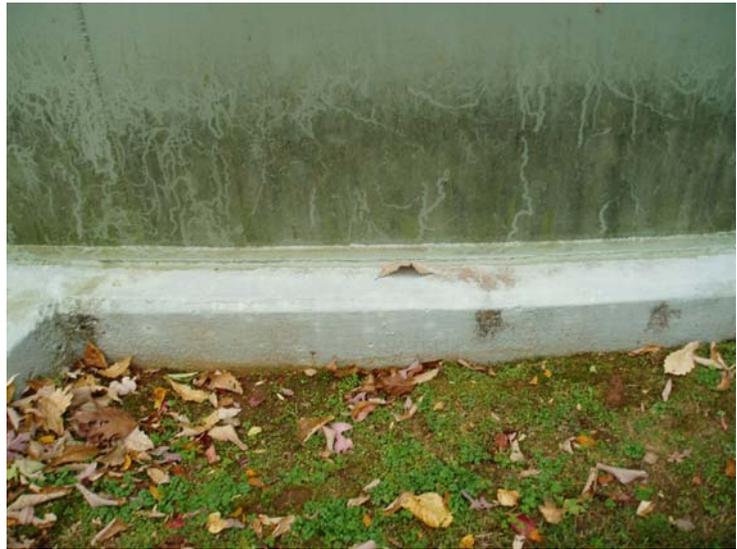
The exposed foundation is in good condition with no cracking or spalling noted.

2) Typical foundation section with no damage.

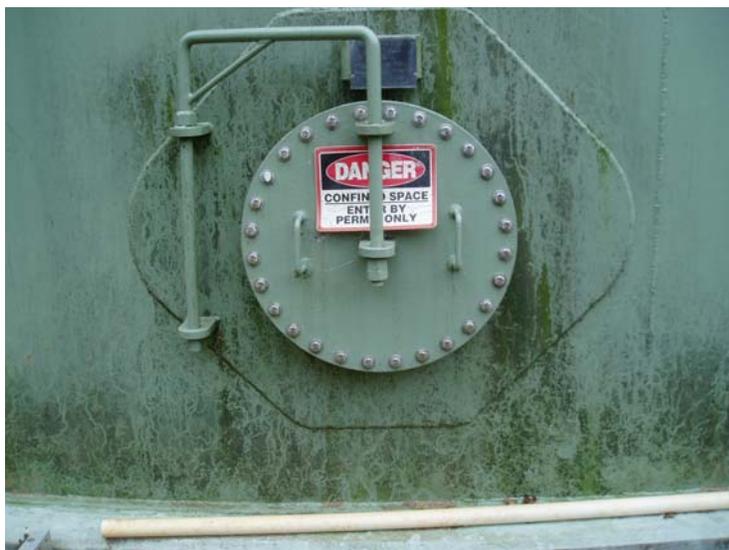
The tank has two 24-inch diameter access manways in the sidewall that are in good condition.

3) Sidewall manway with davit arm.

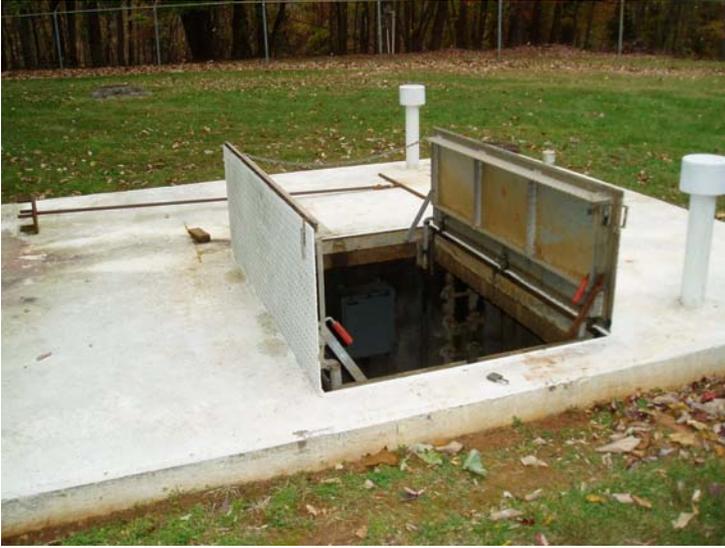
4) Pit vault with access doors.

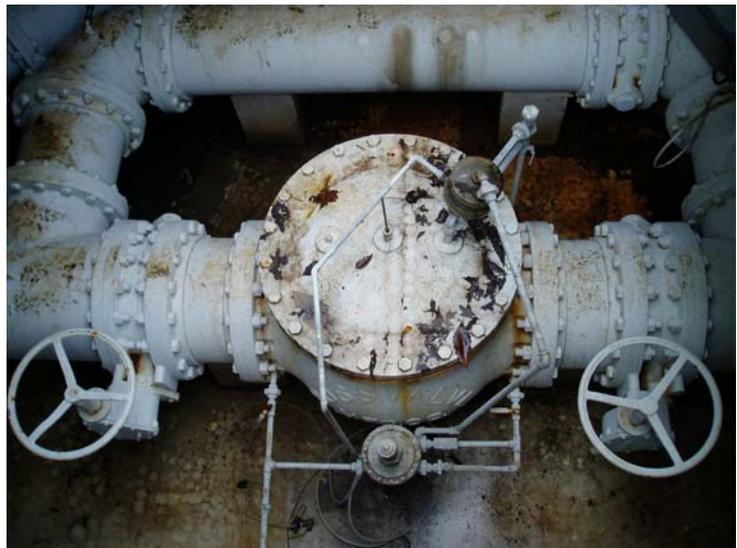
The piping is in good condition. Coating on the pipes is in good condition. The pipes and valves have minor surface rust.

5) Pit piping and valves with some rust bleedthrough.

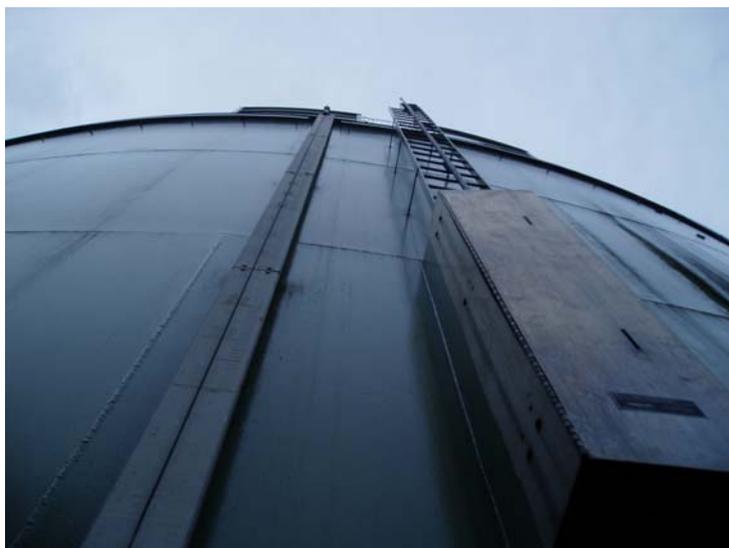
There is an inoperable level indicator on the sidewall that attaches to a float in the wet interior with a cable. The cable does not route through the conduit properly making the device inoperable.

6) Sidewall ladder with vandal guard. There is also a level indicator.

Remove the level indicator and seal the openings in the roof. The cost would be incidental to wet interior roof painting.

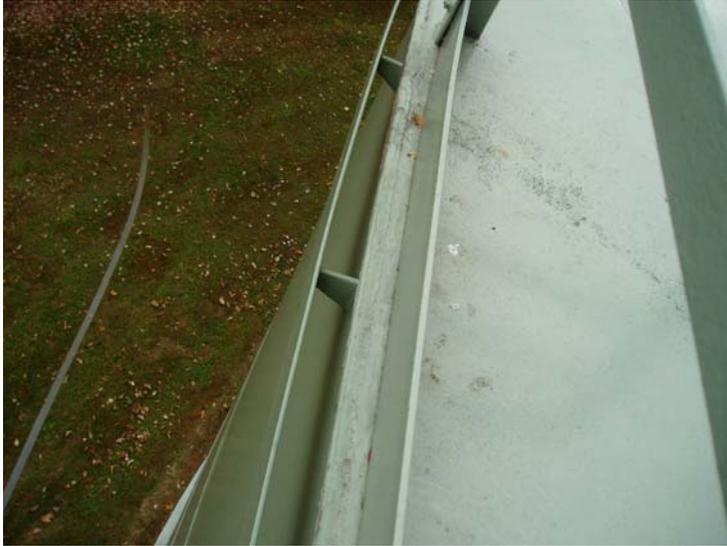
7) Painter's railing at the upper sidewall.

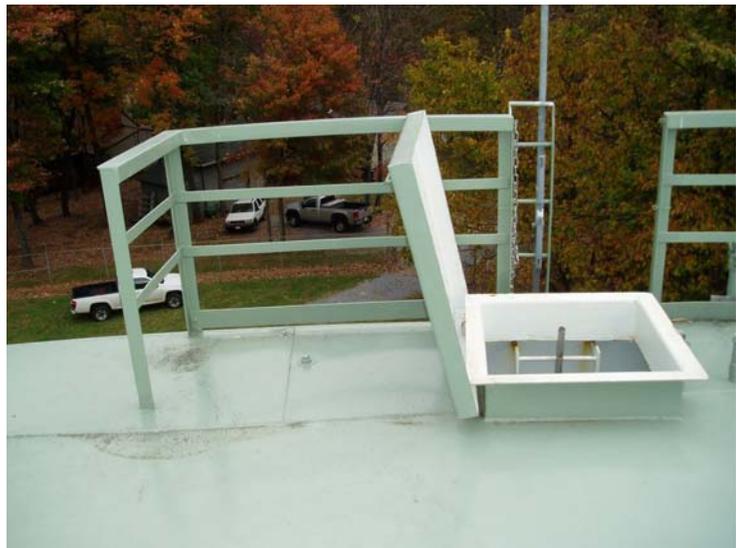
The tank has a 30-inch square, flip-top roof access hatch to the wet interior. The hatch is in good condition.

8) Roof hatch and railing.

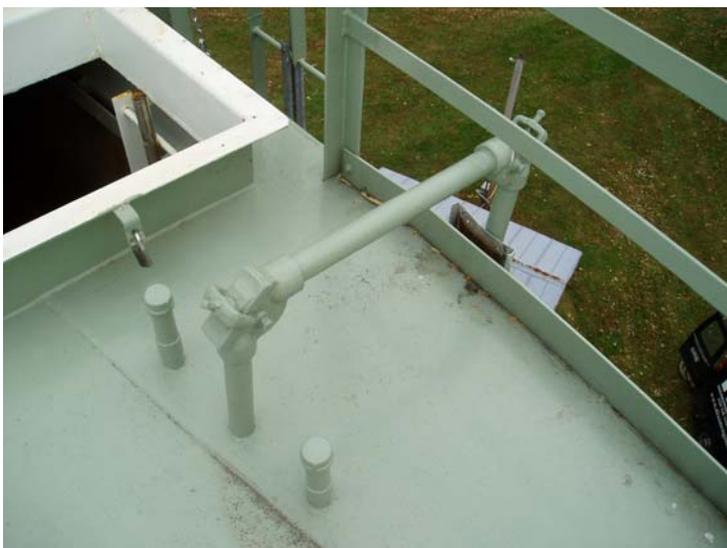
9) Level indicator conduit.

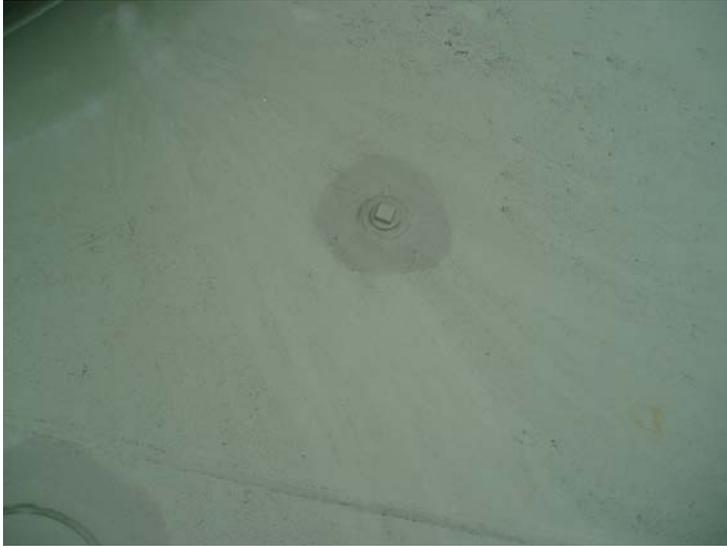
The exterior coating is in good condition with no failures noted. The touch-ups performed on the roof couplings is a slightly different color from the rest of the tank.

10) Roof coupling with touch up paint visible.

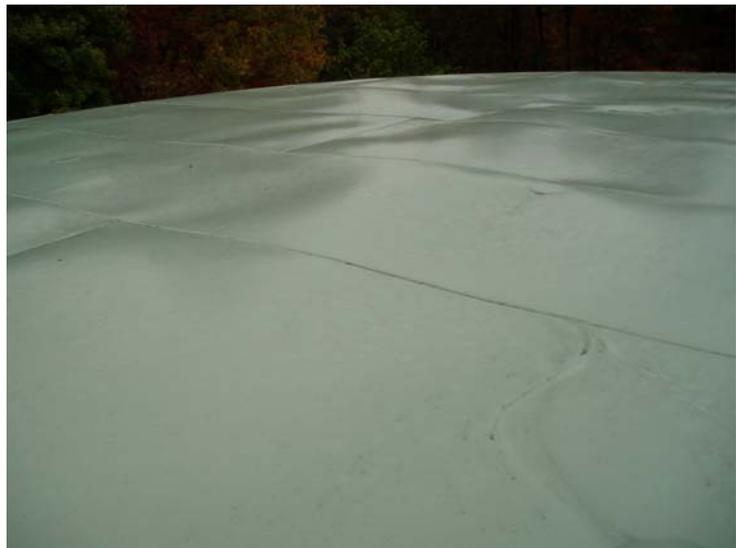
11) Roof coating is in good overall condition.

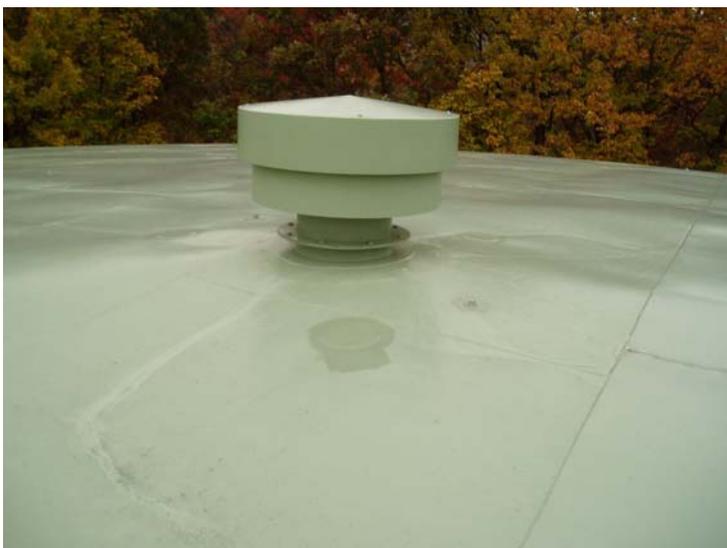
The roof has three 24-inch vents with a pressure-vacuum design. The vents are in good condition. The screens are fully intact.

12) Frost free roof vent is in good condition.

Annually inspect the vents to make sure the screen is open and not damaged.

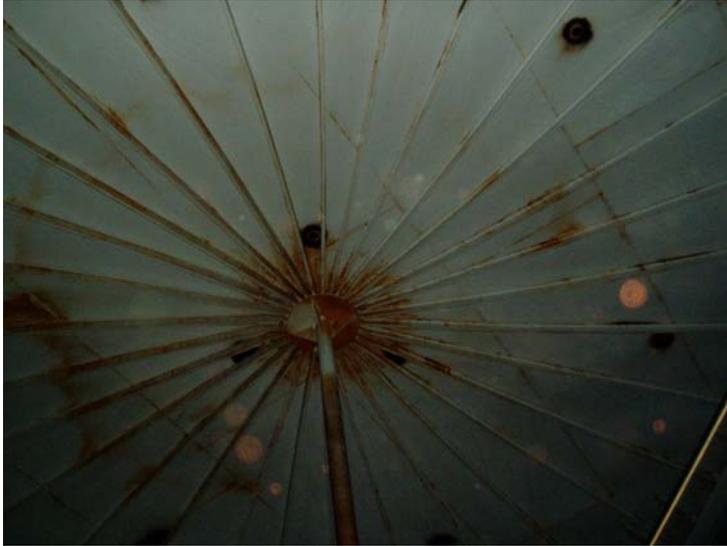
The roof coating is in poor condition, with the primary areas of deterioration along the lap seams, the beam edges, and in the crevices. Some steel loss has started on the roof beams. Roof beam edge corrosion is typical but should be corrected before significant loss of steel occurs.

13) Wet interior roof with rust bleedthrough in several areas most heavily around the center column.

Remove the roof coating system by abrasive blast cleaning the metal to a near white metal grade (SSPC-SP 10) and apply a new three-coat epoxy coating system with a zinc primer.

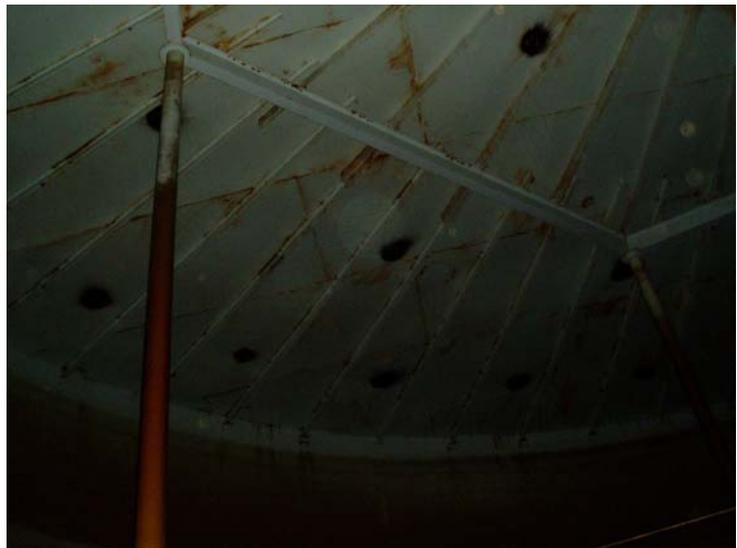
14) Roof section with rusting at the lap seams and stiffeners.

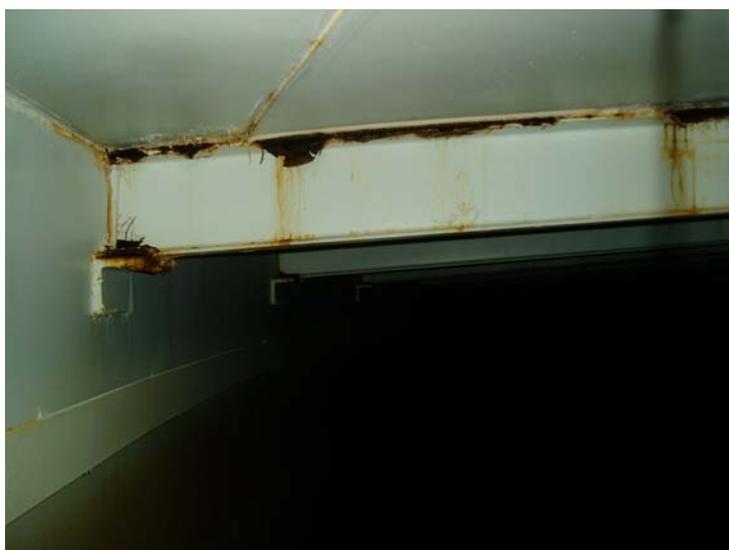
Number in inner ring: **30**
Number in outer ring: **54**
Number of circular beams: **1**
Style: **Radial**
Shape: **Channel**
Dimensions: **8 x 2 inches**
Connections: **Welded**
Coating condition: **Poor**
Metal condition: **Fair**
Roof beam comments: **Starting to lose steel at outer connections**

15) Roof stiffener with rust undercutting.

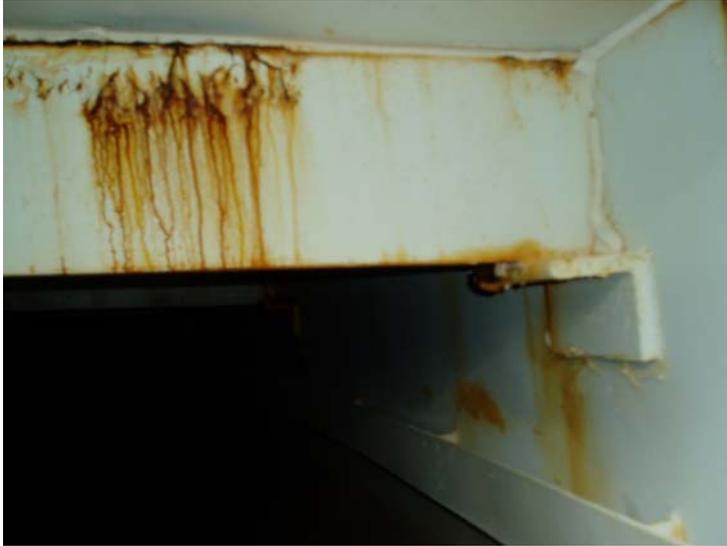
16) Coating failures on the roof stiffeners.

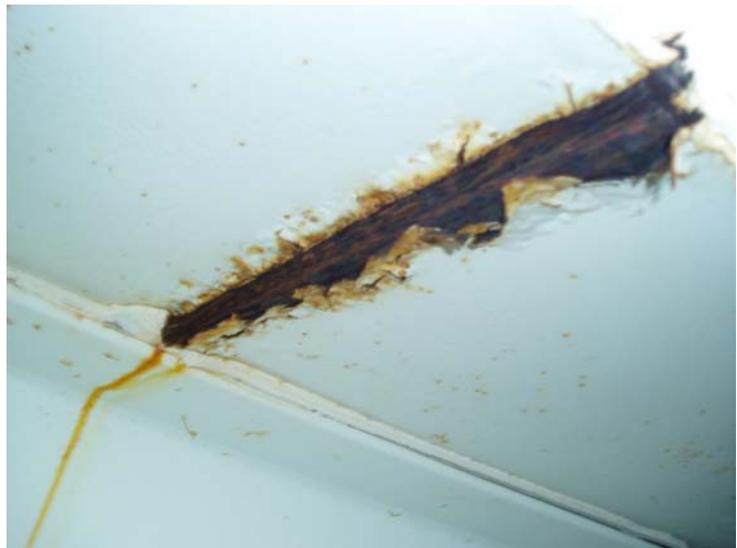
17) Coating failures with rust undercutting.

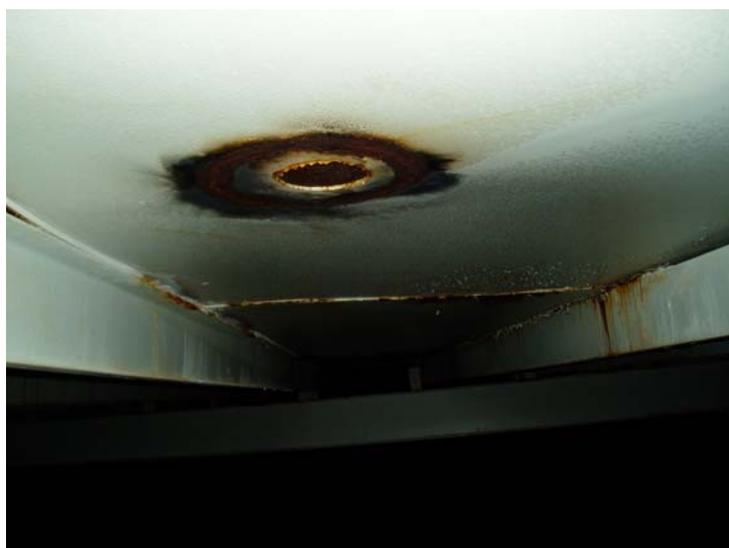
Roof comments: **Rust bleedthrough; weld burns throughout**

18) Weld burns on the roof at coupling.

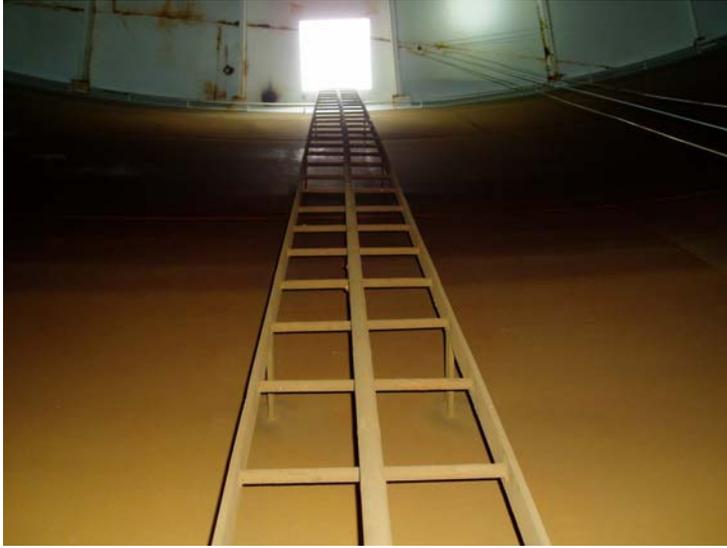
The wet interior contains a ladder that is in good condition and has a rail-type fall prevention device.

19) Wet interior ladder is intact.

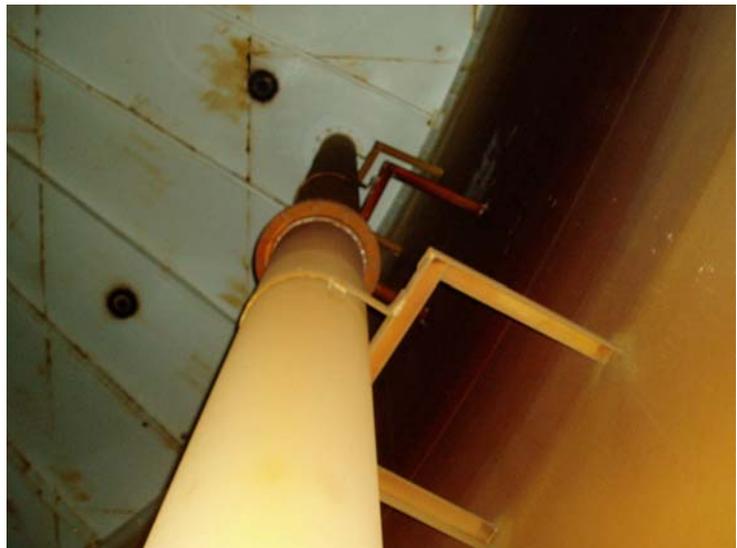
20) Overflow pipe and supports.

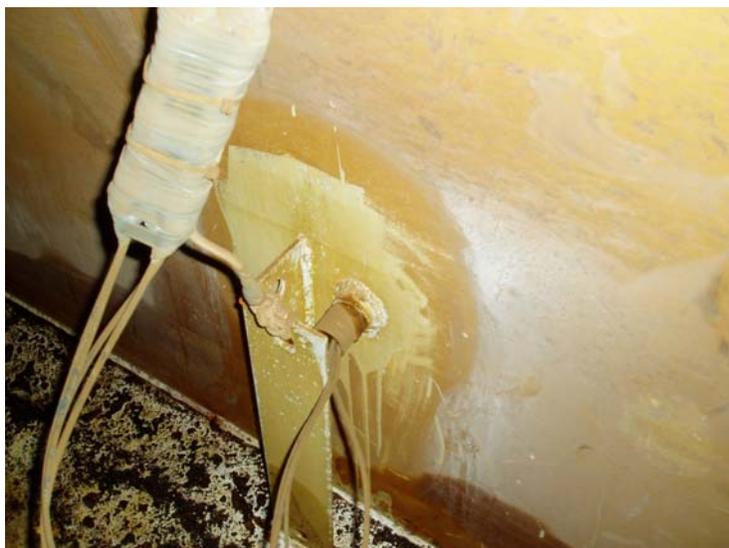
21) Cathodic protection pressure fitting.

Continue operation of the submerged cathodic protection. Have a qualified contractor maintain the system.

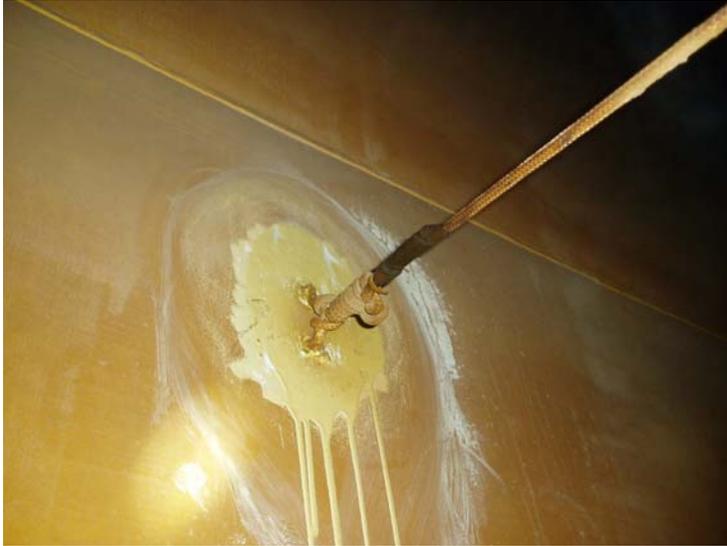
The tank has a floating ring, ice-free cathodic protection system that is in good condition. Tank's surfaces below the high water line are protected by the submerged cathodic protection system that is suspended from the sidewall.

22) Typical sidewall cathodic clip and rope connection.

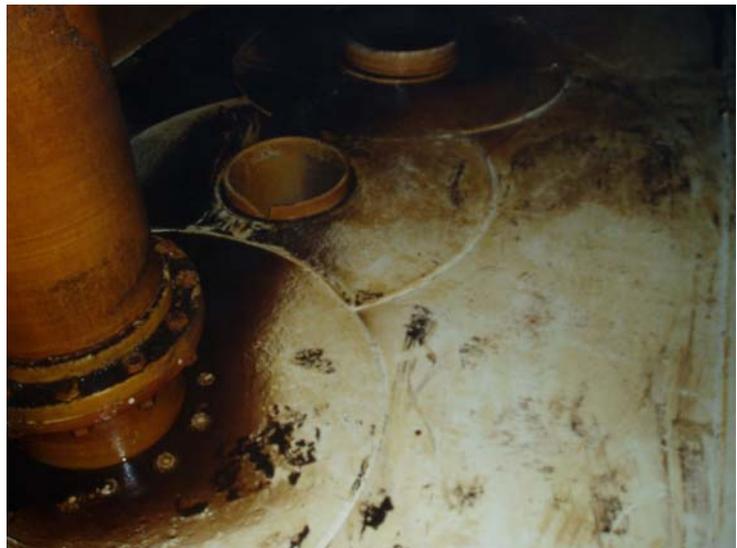
23) Overflow, fill and draw line in the floor.

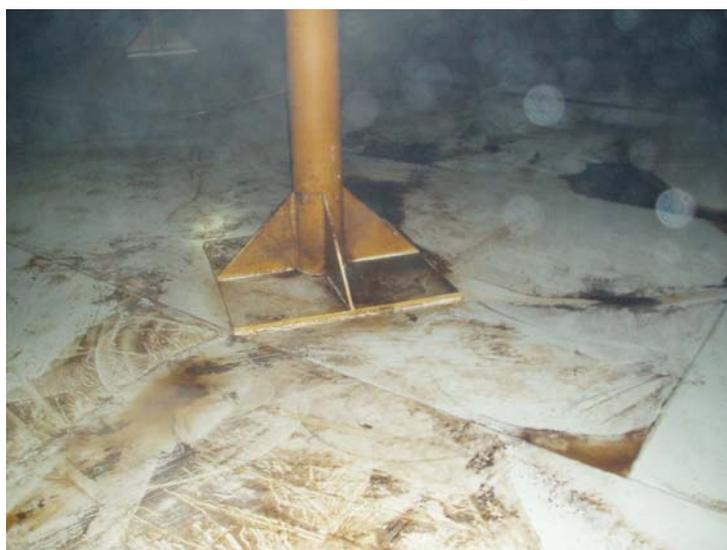
24) Column base.

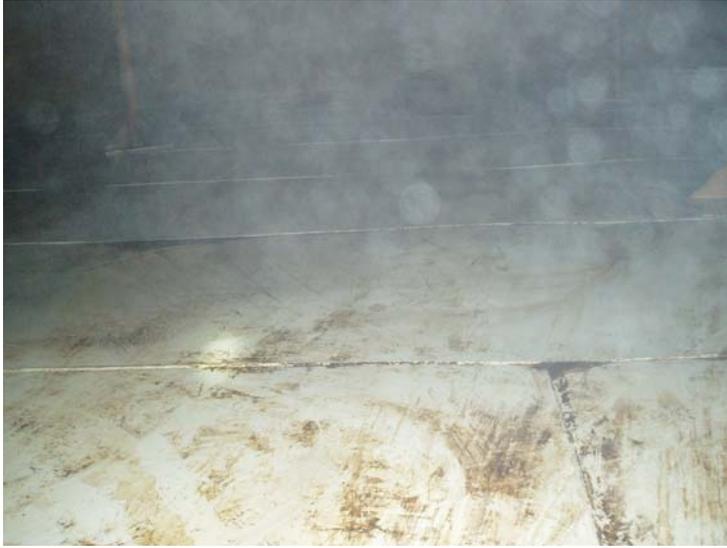
The sidewall and floor coating is in good condition with no coating breaks found.

25) Wet interior floor. Coating is in good overall condition.
