**Addendum for Invitation for Bids
College Hill 10.5 MG Tank Rehabilitation**

13-829

Re: 10,500,000 Gallon College Hill Reservoir
Maintenance (Dive) Inspection

Maintenance (Dive) Inspection

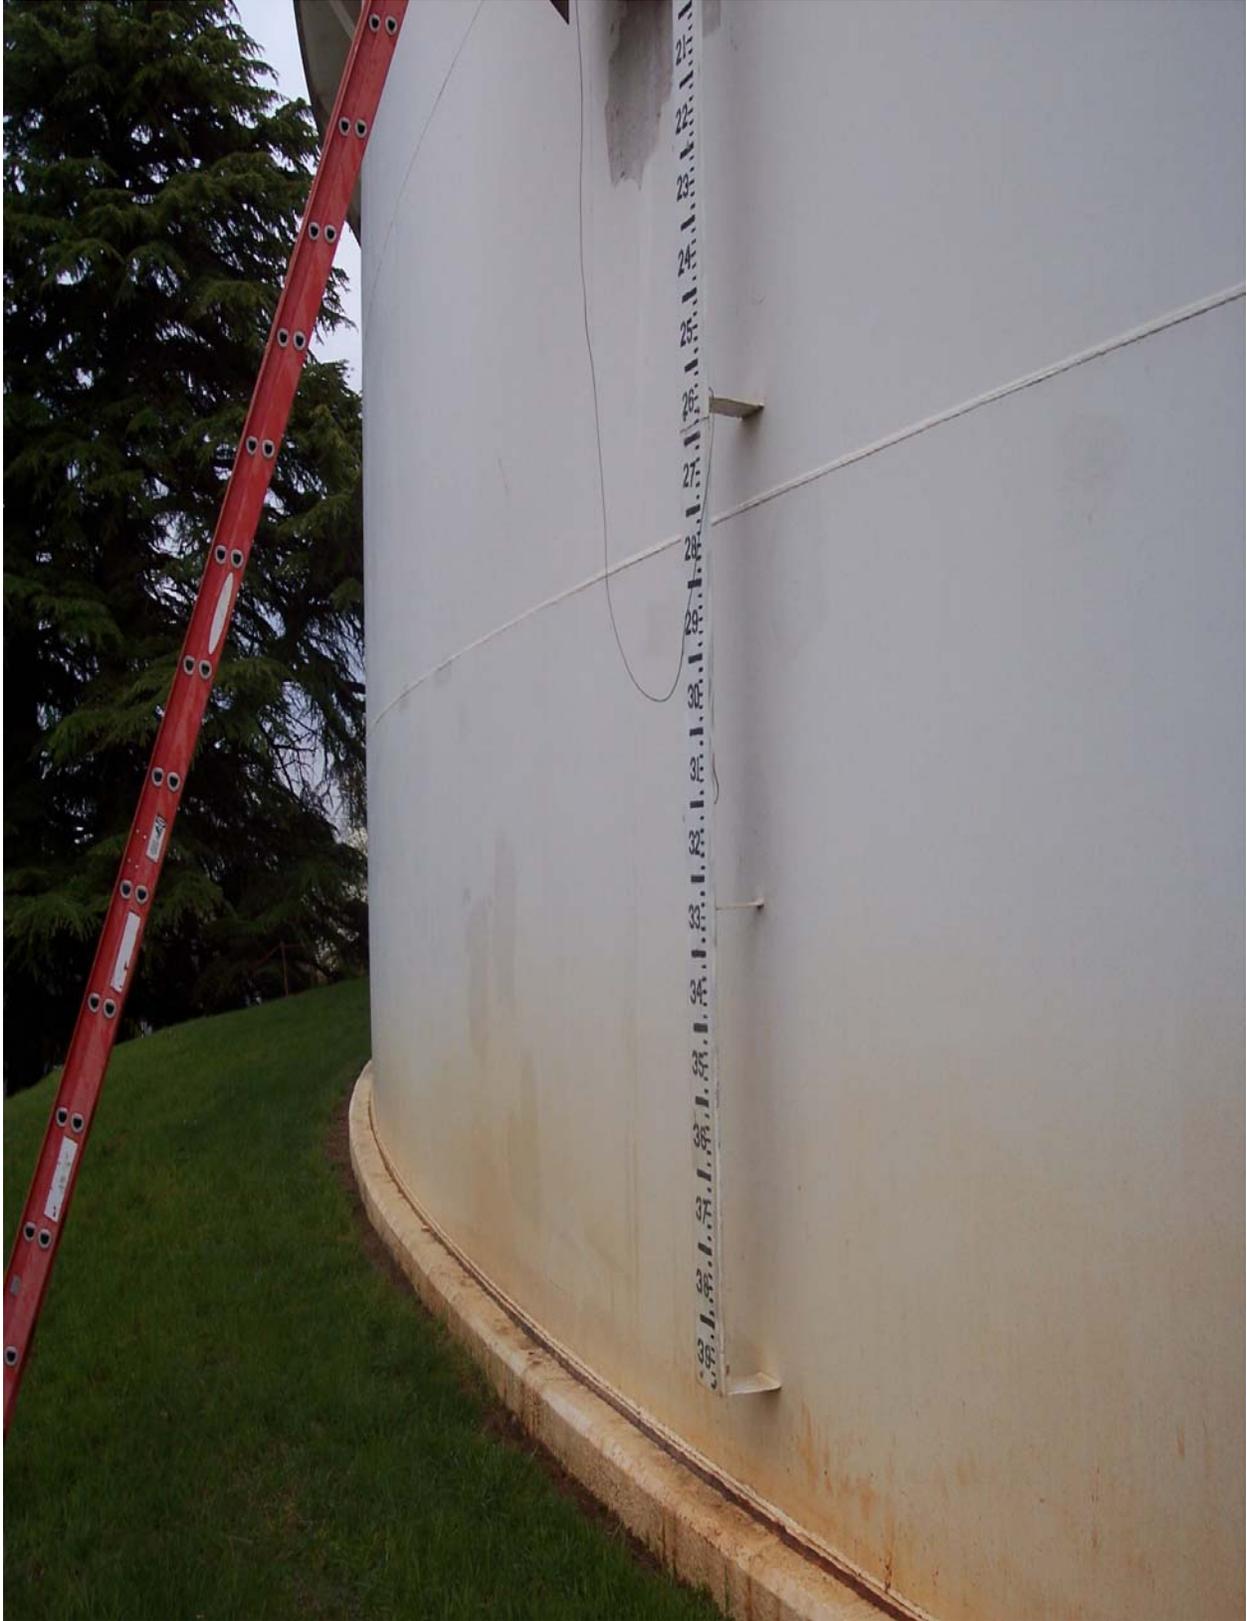
(1) College Hill 10,500,000 Gallon Reservoir.

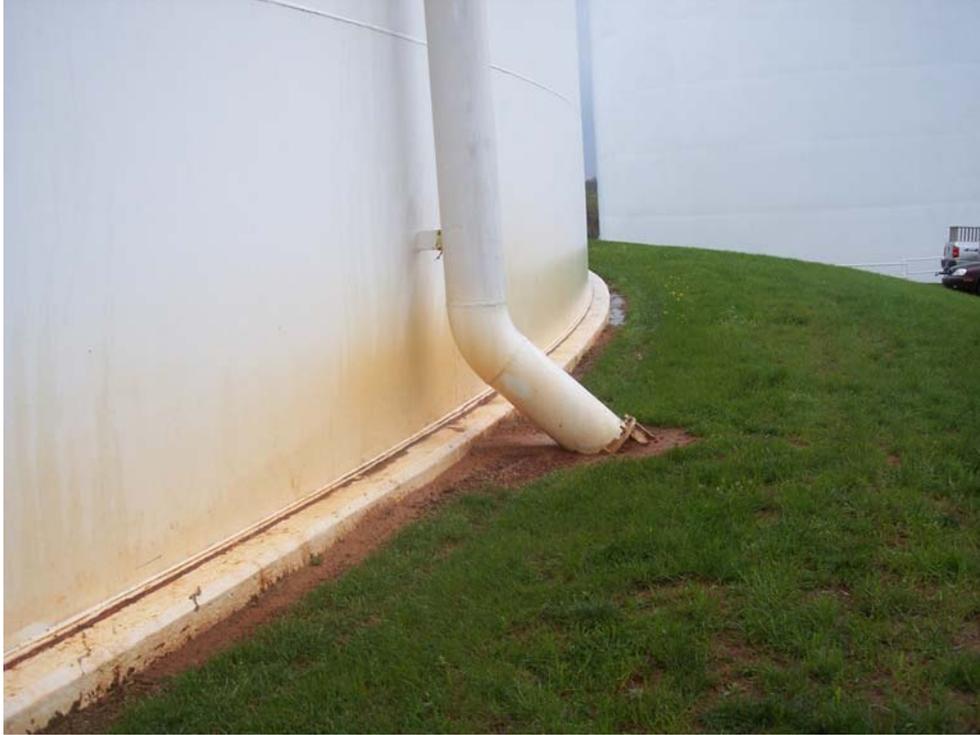
(2) As reported, the fill lines are overflow from adjacent tanks.

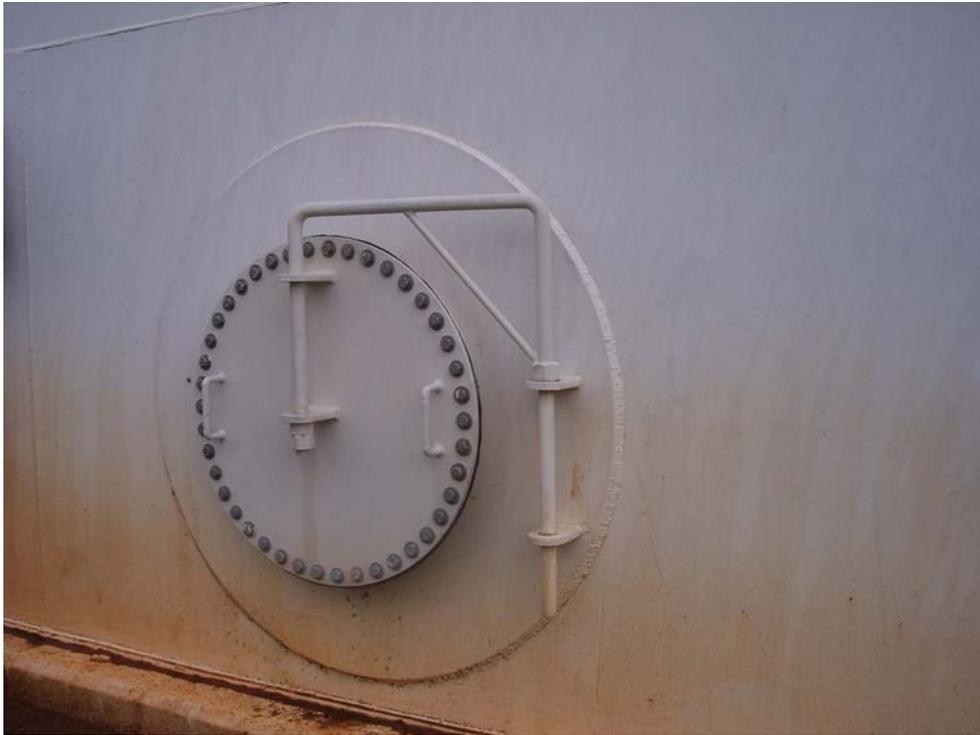
(3) Manways with davit arms.

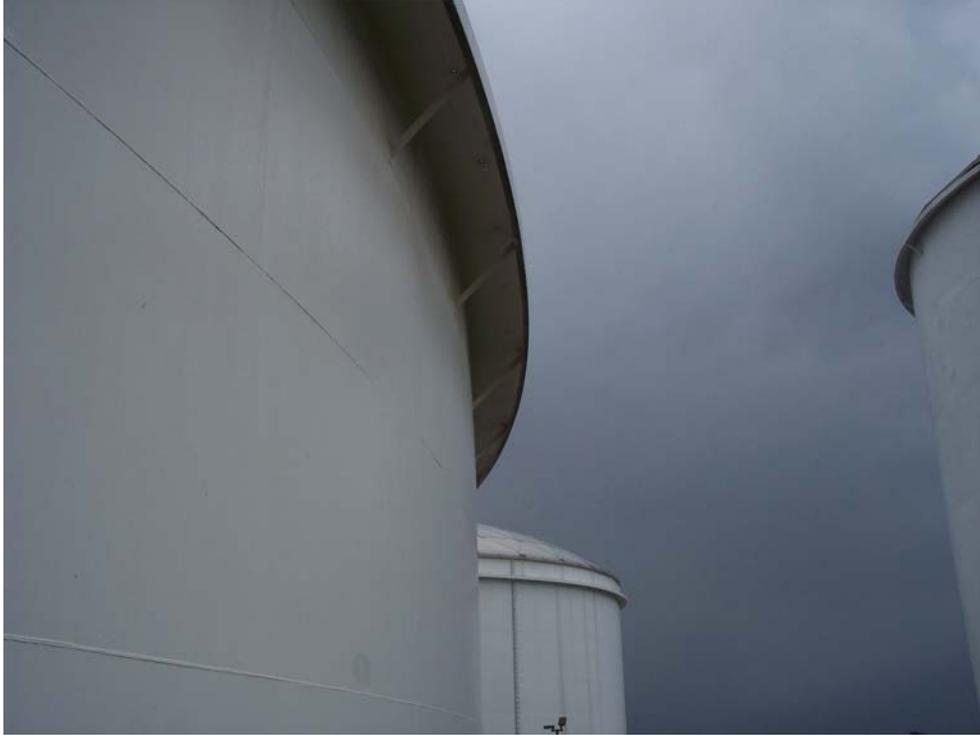
(4) Some discoloration on sidewalls.

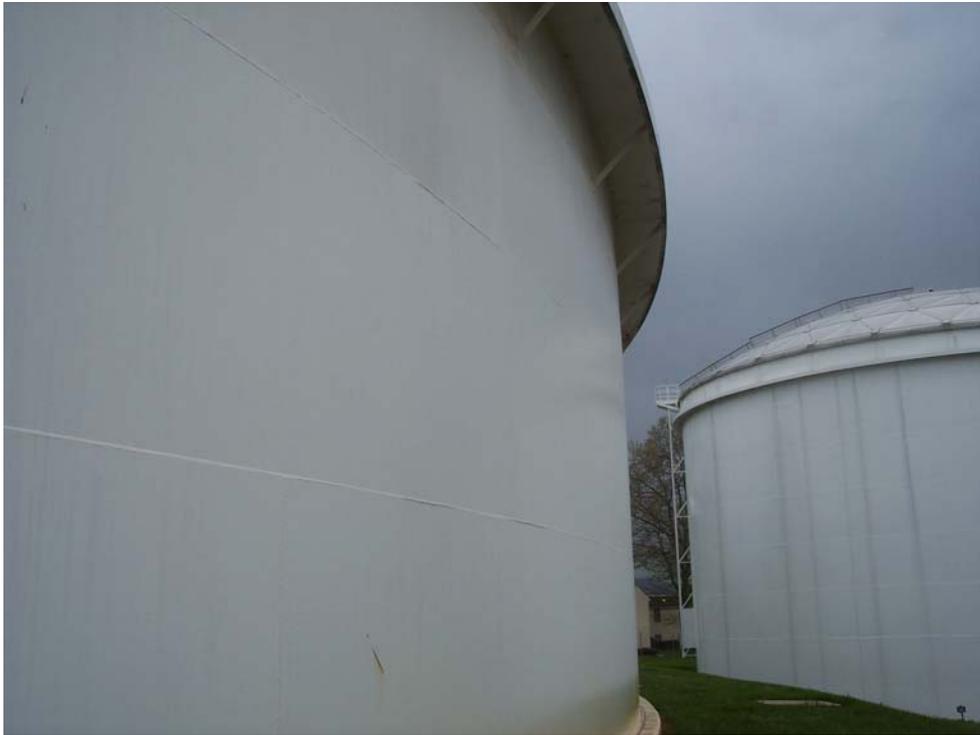
(5) Sidewall panel with some buckle at the weld seam.

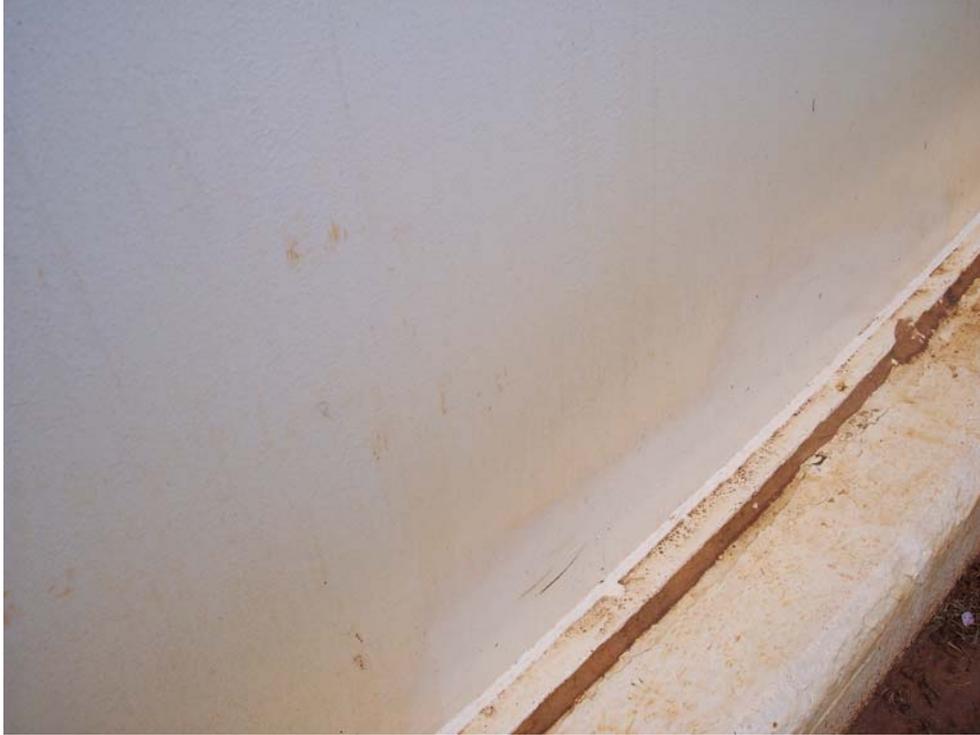
The sidewall coating is in good-to-fair condition. Primary method of deterioration is abrasion. A few coating breaks were found. The sidewall coating has been repainted where prior damage existed. The sidewall coating is 12 – 24 mils thick.

(6) Red clay on lower sidewall - some abrasions.

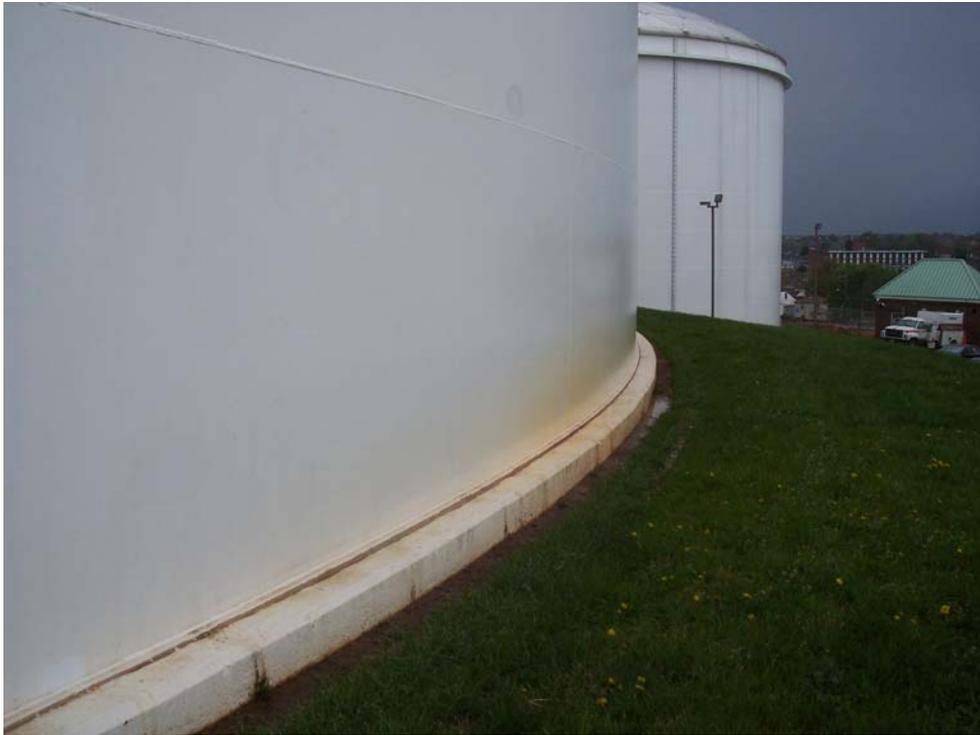
The exterior coating is a multiple coat epoxy urethane system that is faded and there is some loss of gloss. Surfaces have faded due to exposure to ultraviolet rays, which is a normal occurrence for an exterior coating system. The coating is adequately protecting the metal, and aesthetics are fair. There are several areas where the existing coating appeared to be improperly catalyzed.

(7) Exterior tank wall has fair aesthetic appearance.

Take no immediate action on the exterior. Budget for overcoating in 2012, or when aesthetics dictate. Current adhesion showed the existing coating would support an additional recoat.

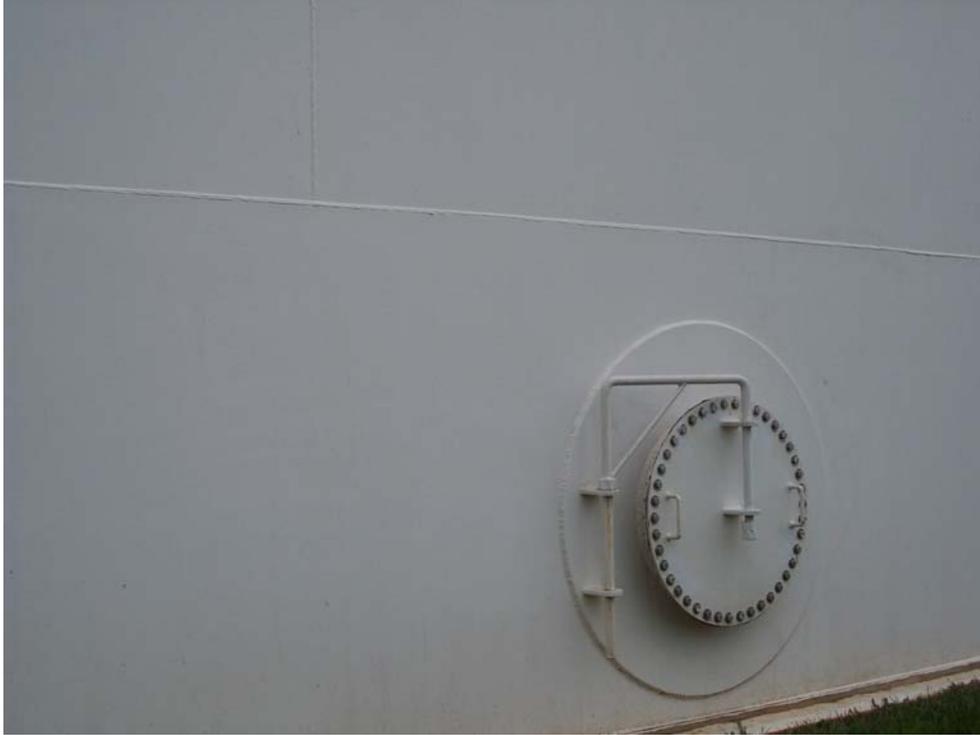
(8) Manways are not leak-free.

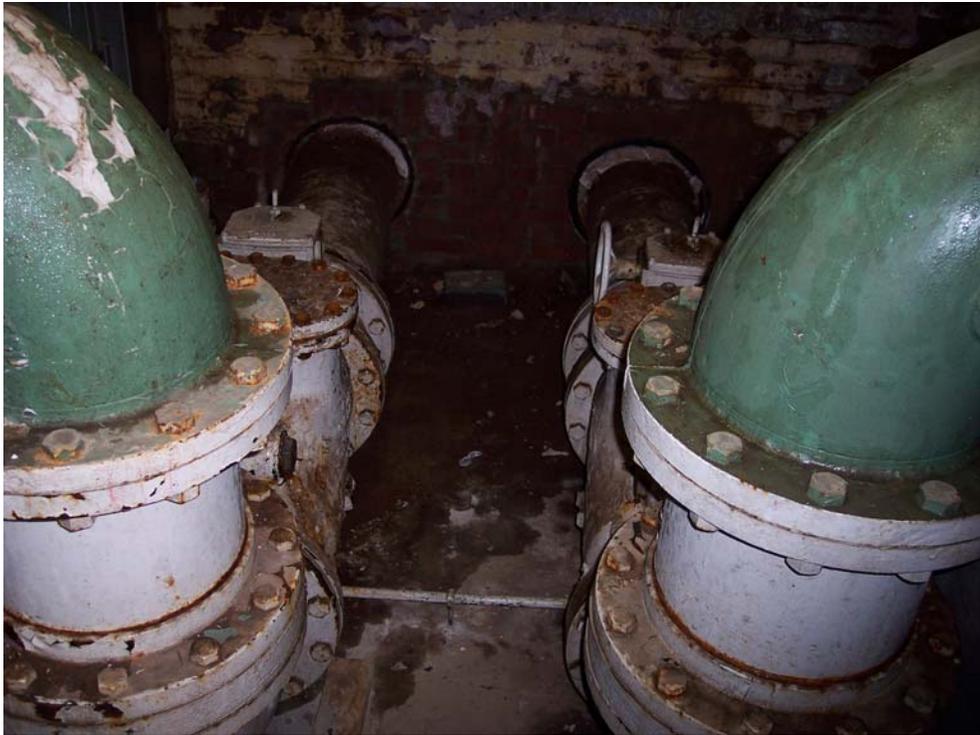
(9) Pump house adjacent to tank with high service pumps.

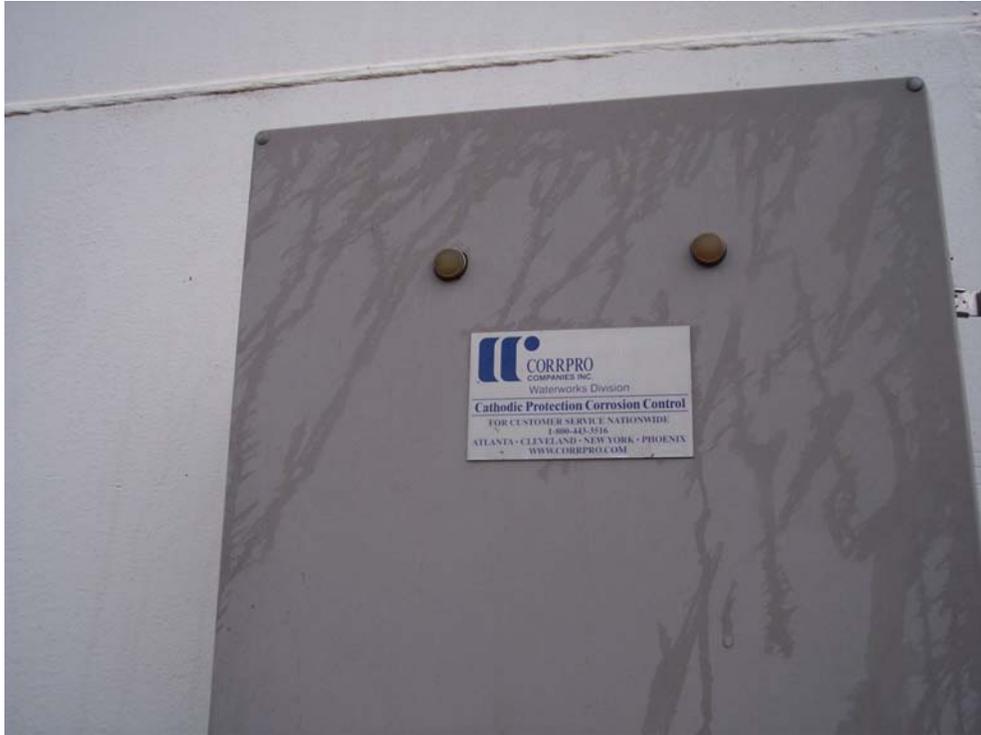
The tank has a functioning cathodic protection system. It is a ring, ice-free system that is in good condition. Tank surfaces below the high water line are protected by the system. The supporting ropes and anode wires are in good condition, with no anode breaks noted. The pressure fitting exiting the sidewall showed no signs of leaking.

(10) Tank's interior contains a floating cathodic system by Corrpro.

Continue operation of the submerged cathodic protection system. Have a qualified contractor maintain the system.

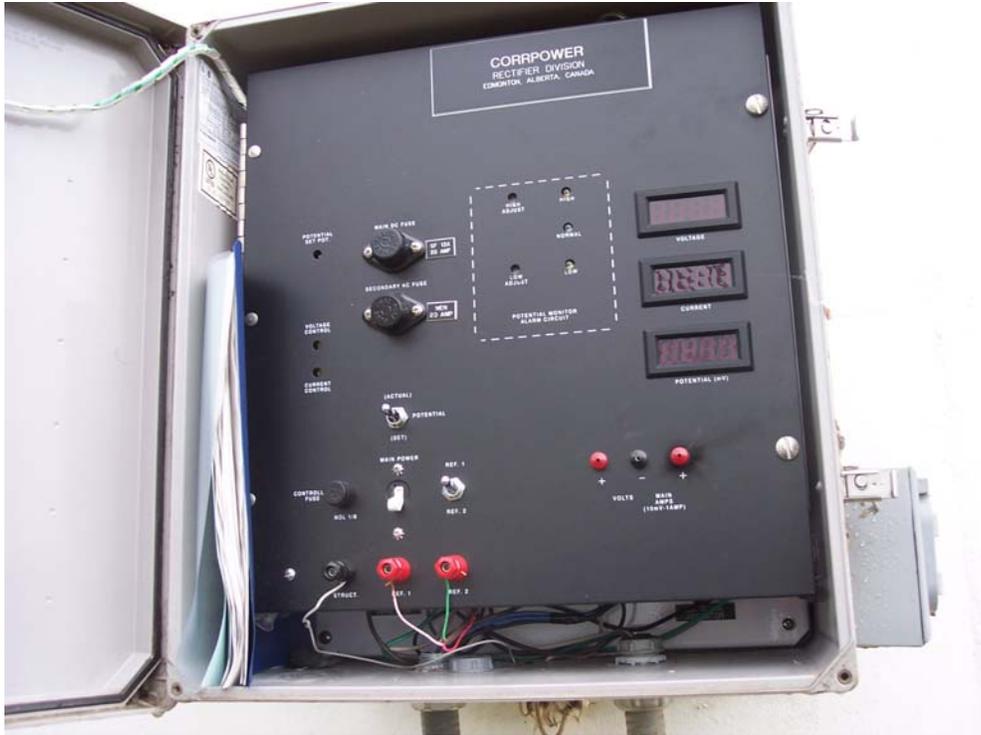
(11) Rectifier was reported as operational.

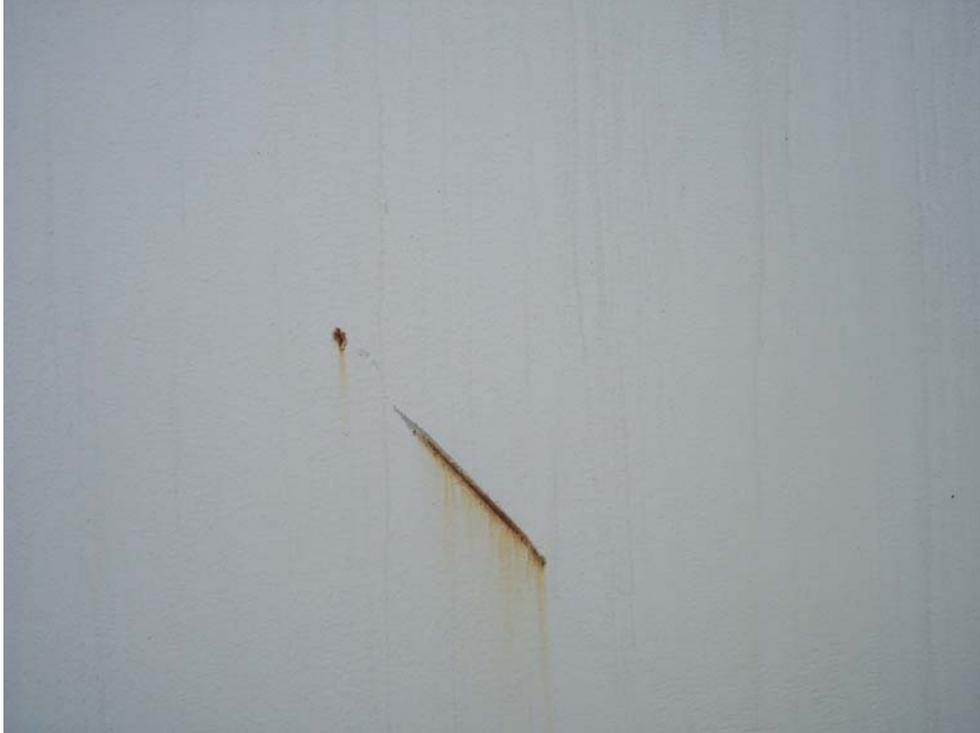
(12) Exterior abrasion.

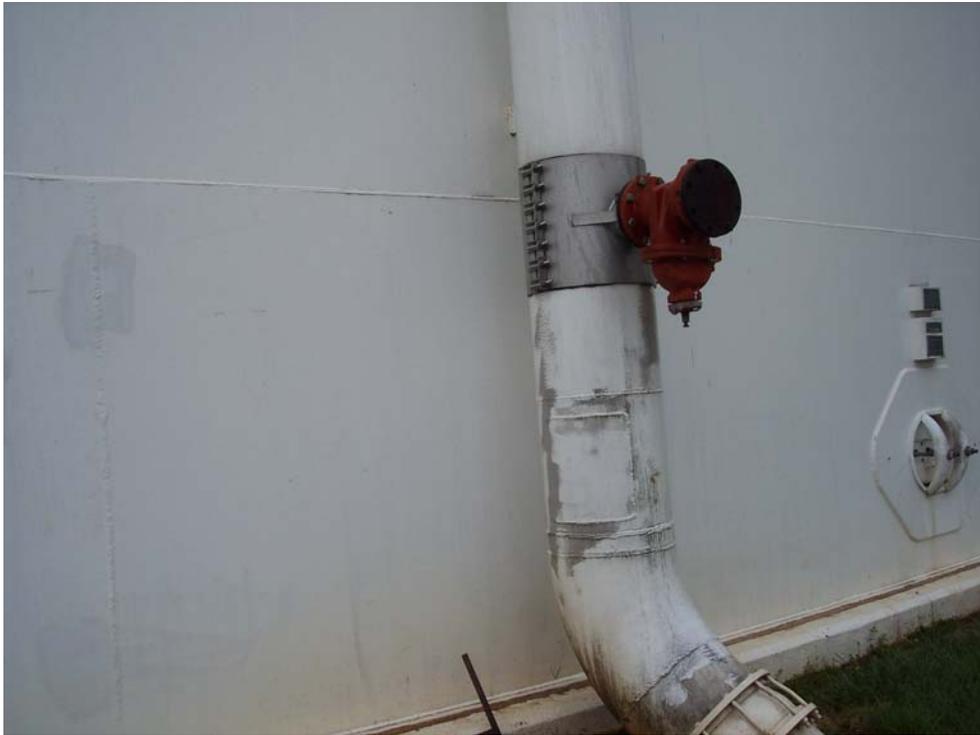
(13) SST saddle installed on piping—discoloration of spot repairs.

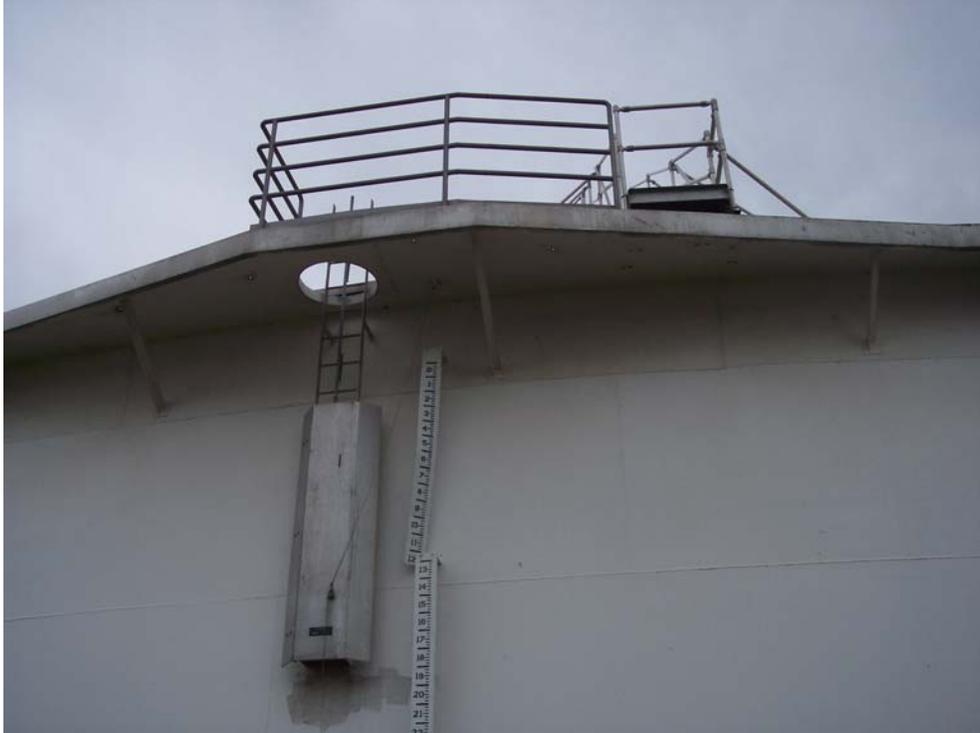
(14) Tank sidewall contains a non-functional level indicator. Discoloration of spot repairs.

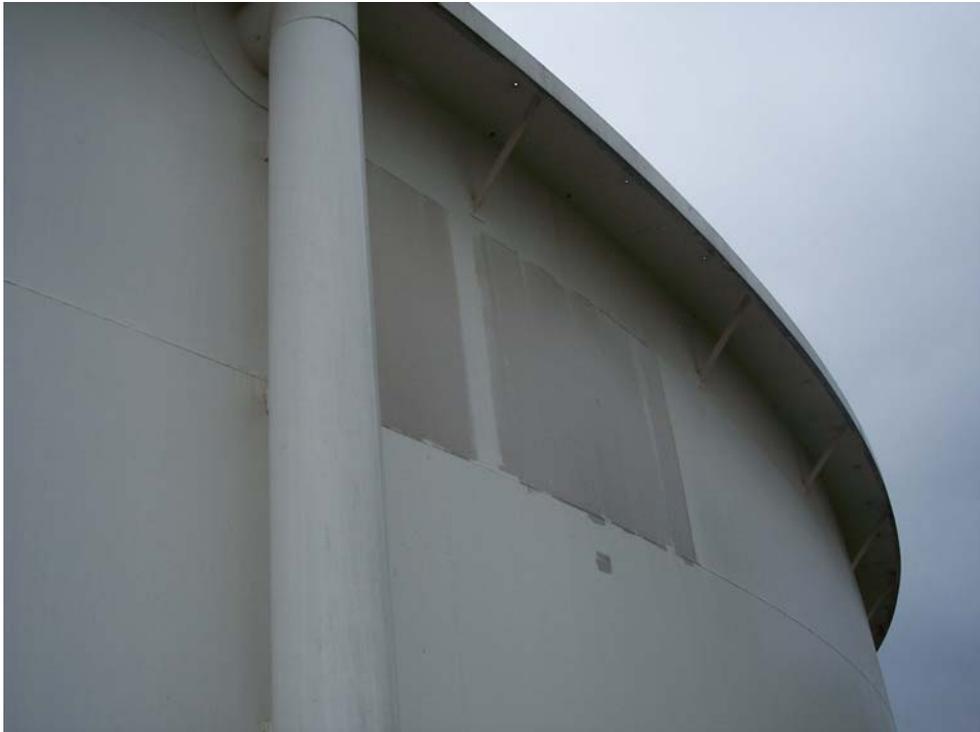
(15) Discoloration of upper sidewall panels may be an indication of improperly catalyzed material.

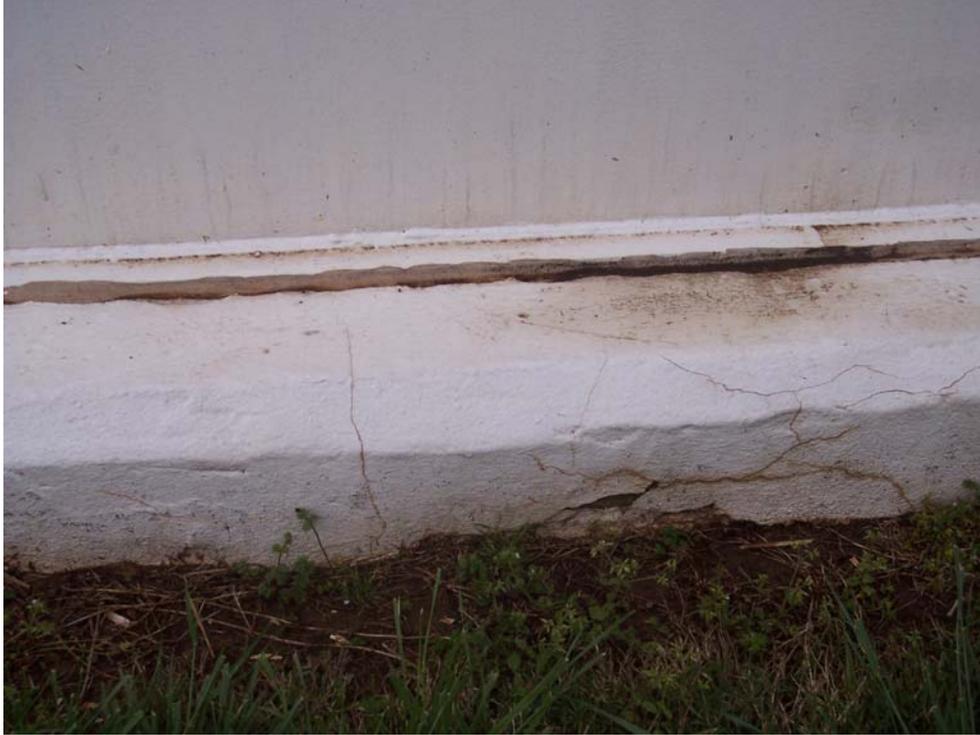
The exposed foundation is in good condition and showed minor amounts of deterioration (cracking).

Exposed foundation condition: **Good**
Chipped or cracked: **Yes**
Severity: **Minor**
Exposed rebar: **No**
Type of grout: **Cement**
Condition: **Good**
Grout missing: **No**
Comments: **Hairline cracks**

(16) Hairline cracks and some spalled concrete on side of foundation.

High pressure wash the concrete and patch the small areas of deterioration. Coat the exposed concrete with an epoxy polyurethane coating to prevent further deterioration.

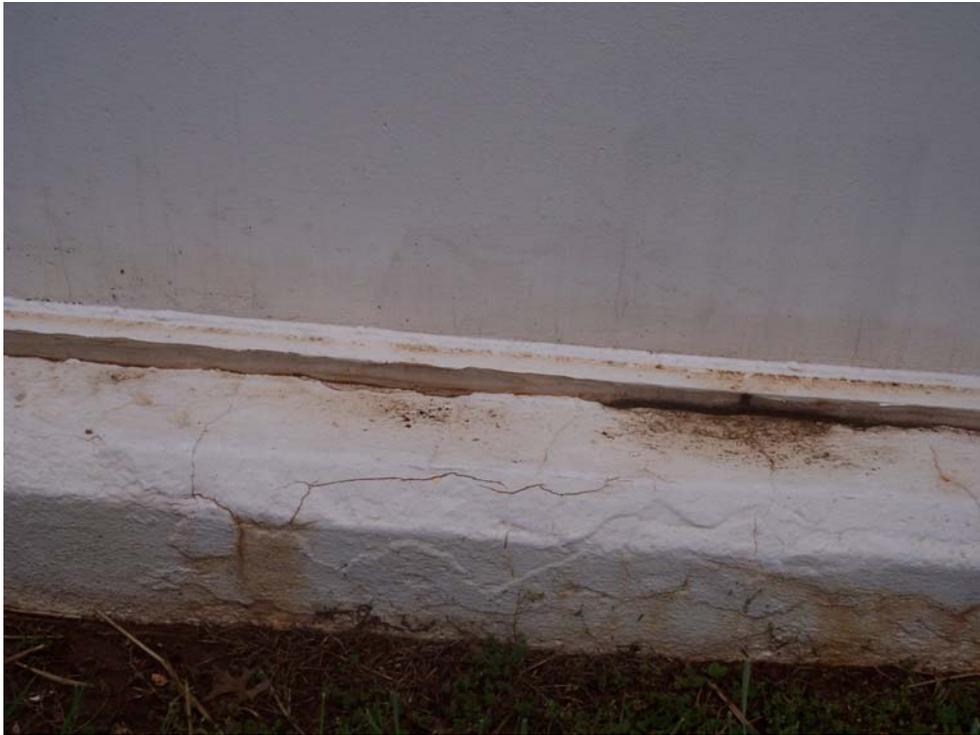
The caulk is in fair condition, with 20 ft. deteriorated between the base pad and foundation.

(17) Deteriorated grout.

Remove all loose or deteriorated caulk and repair with a urethane caulk.

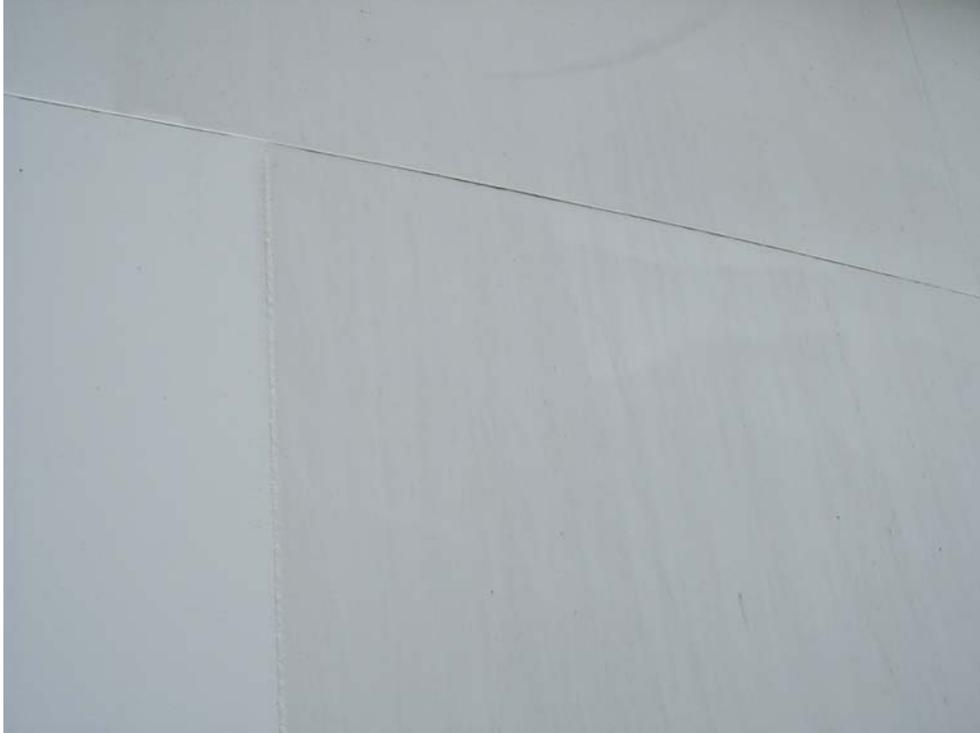
(18) Discoloration on east sidewall.

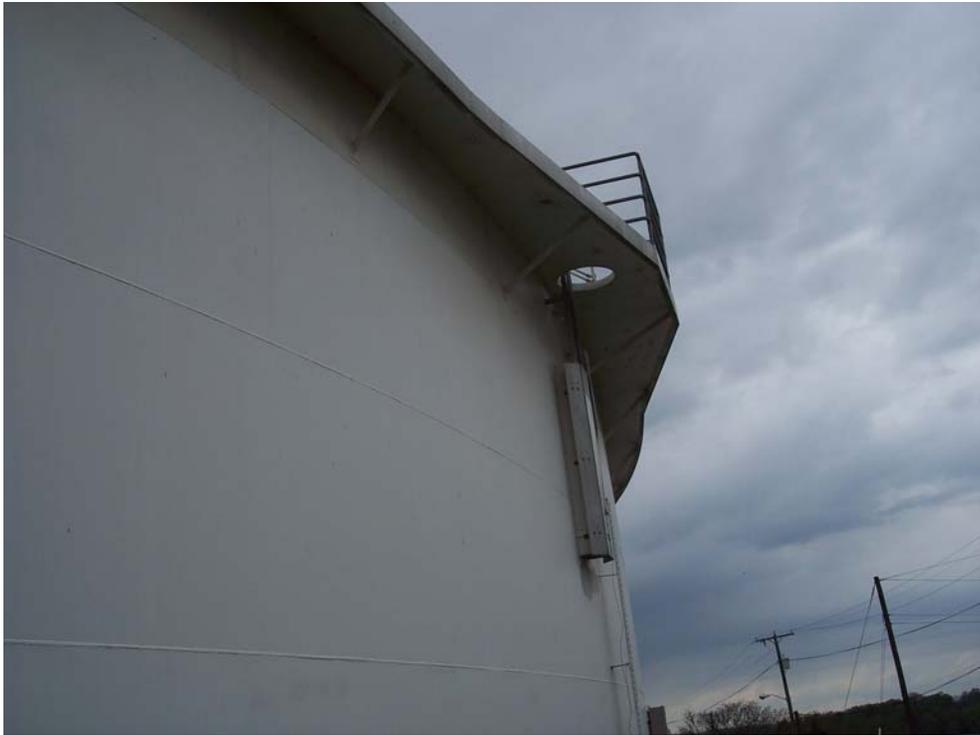
(19) Vandal guard on sidewall ladder is padlocked.

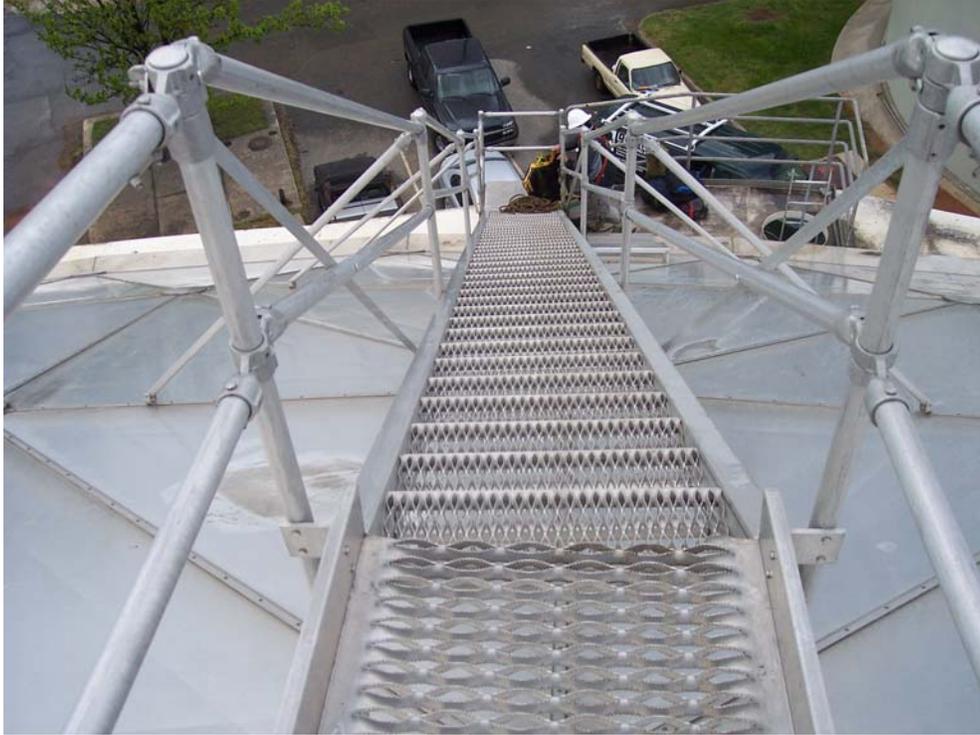
(20) Geodesic dome contains stairs and hand rail that are intact.

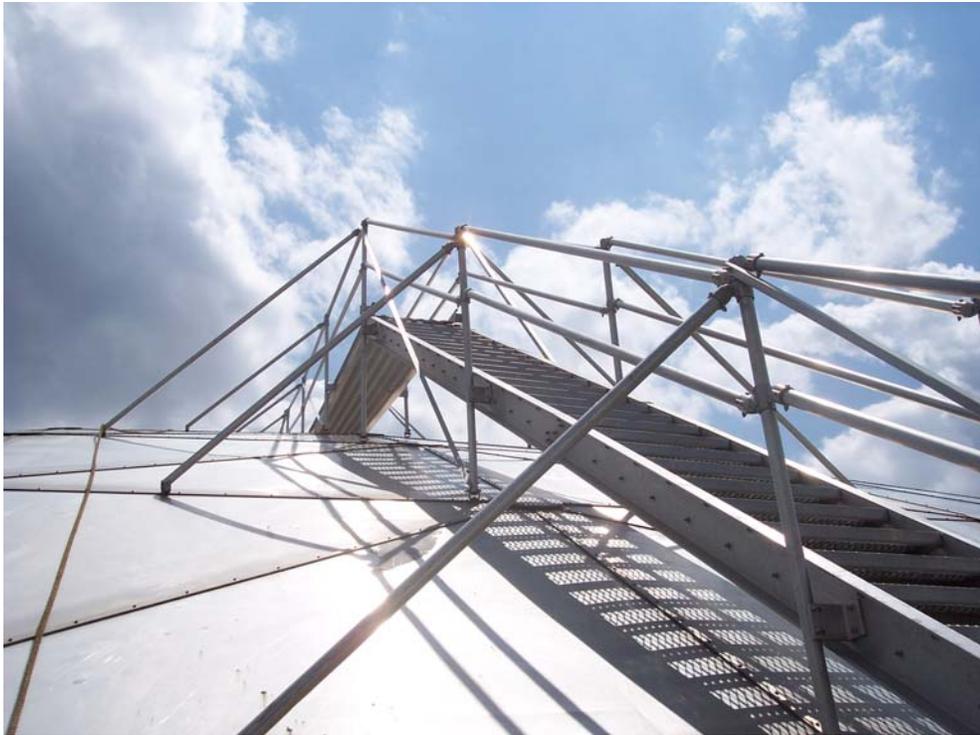
(21) Hand rail supports extend to the dome framing and are intact.

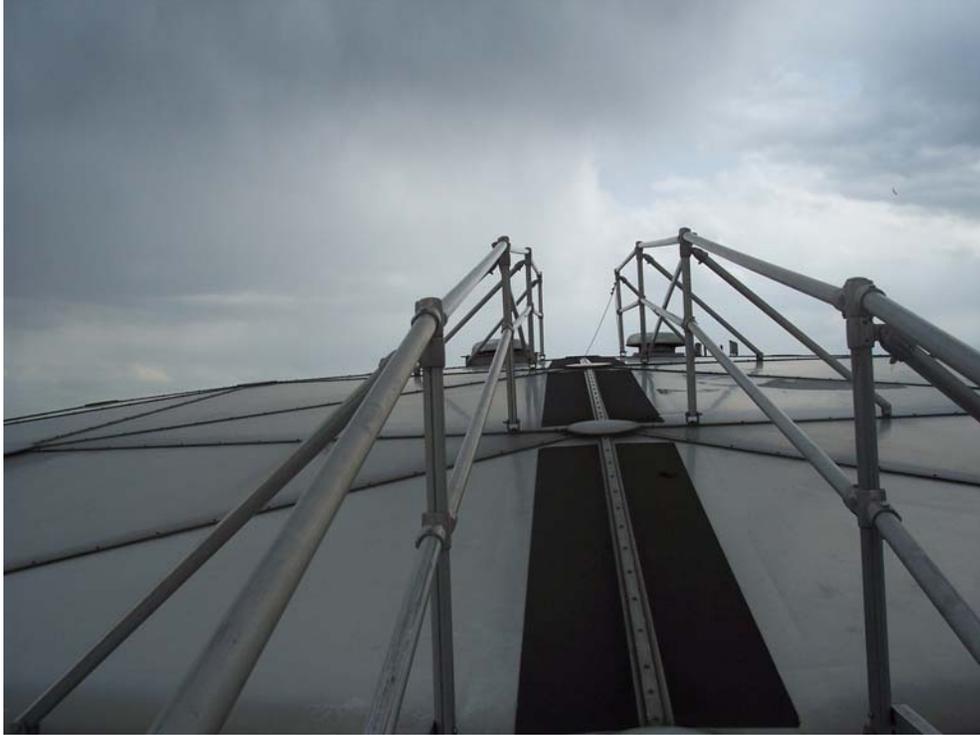
(22) At the step ending are strips of anti-slip material adhered to the dome panels.

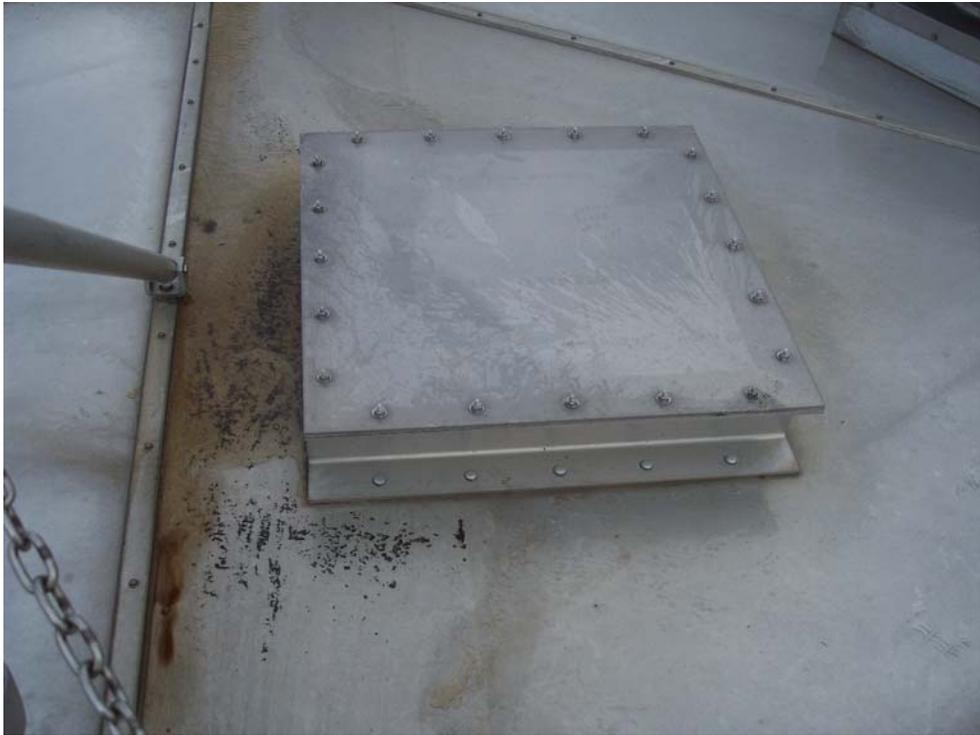
(23) Bolted painter's ventilation hatch.

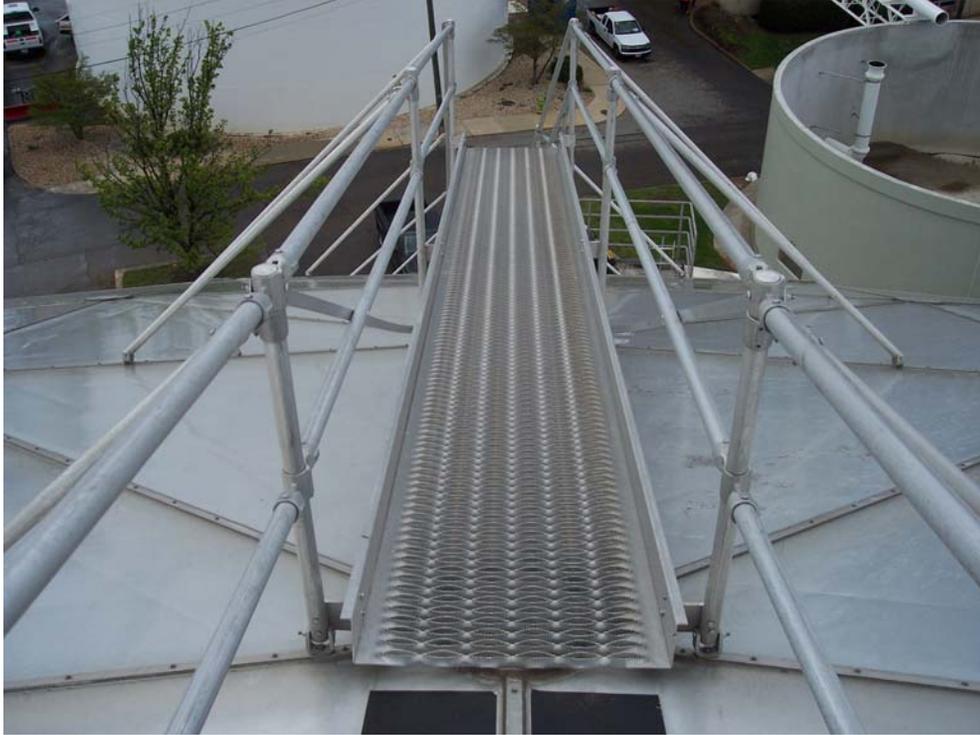
(24) Roof transition to sidewall stairs.

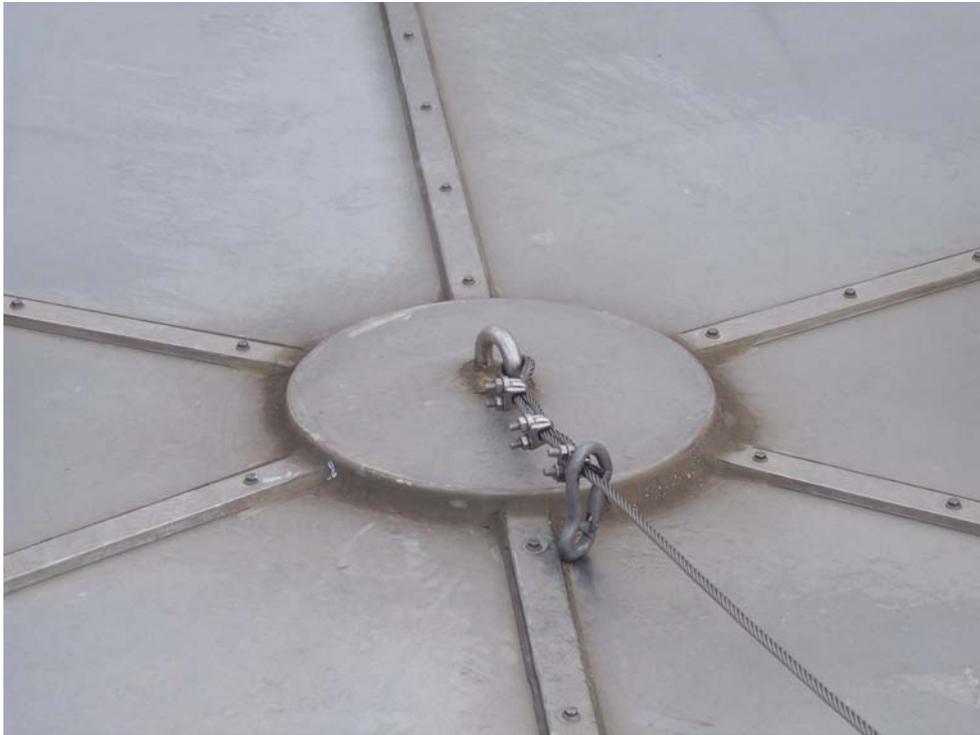
(25) Center roof tie-off point.

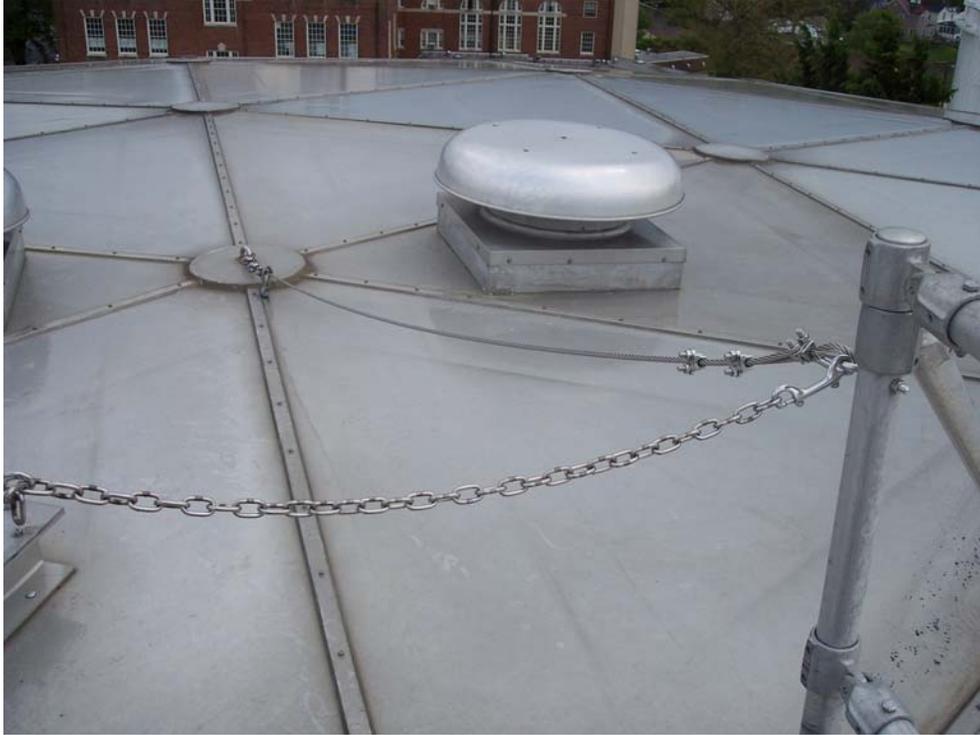
(26) Screened roof vent.

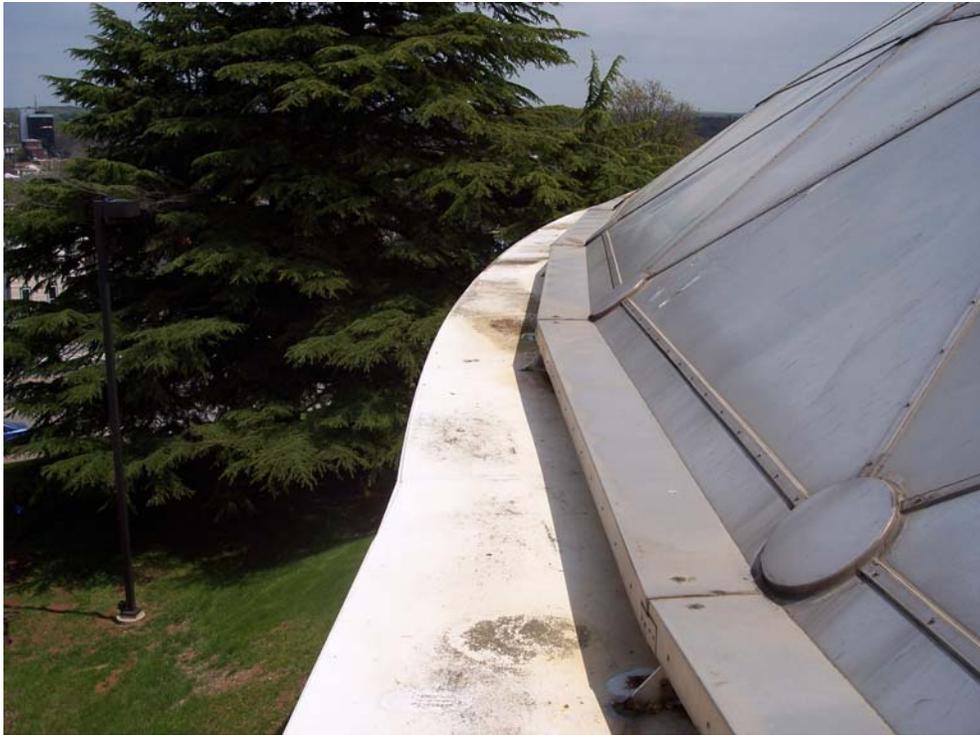
(27) Wind girder - indication of ponding water.

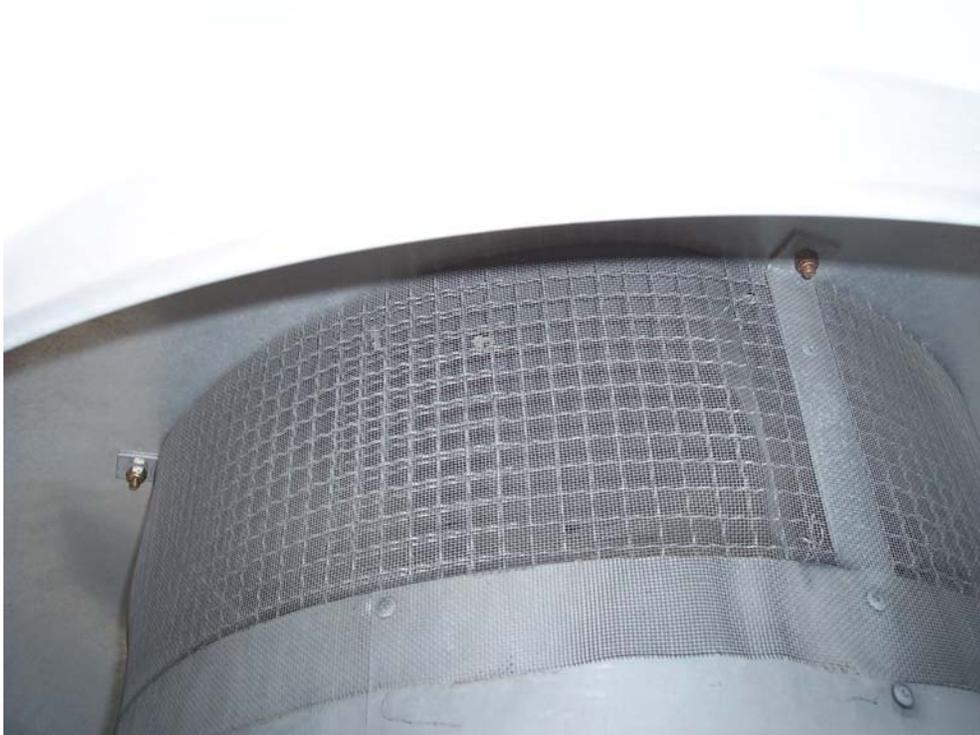
(28) Dual screened roof vent.

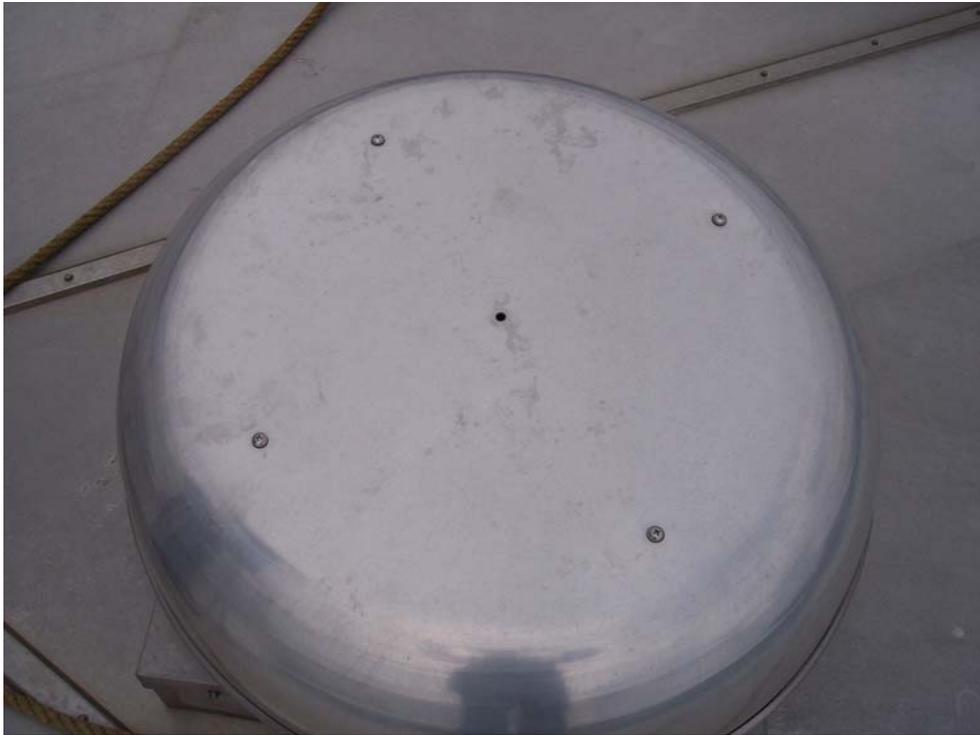
(29) Hole in center of roof vent - caulked by inspector at time of inspection.
