**Addendum for Invitation for Bids
College Hill 10.5 MG Tank Rehabilitation**

13-829

Re: 10,500,000 Gallon College Hill Reservoir
Maintenance (Dive) Inspection

Maintenance (Dive) Inspection

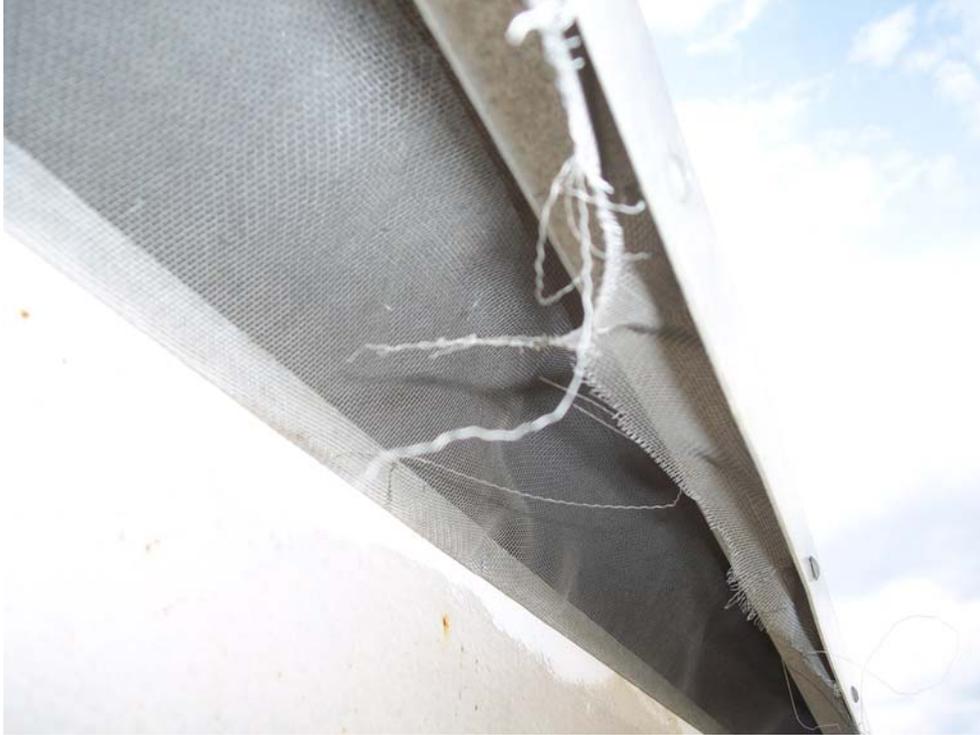
(30) Wind girder screen is intact.

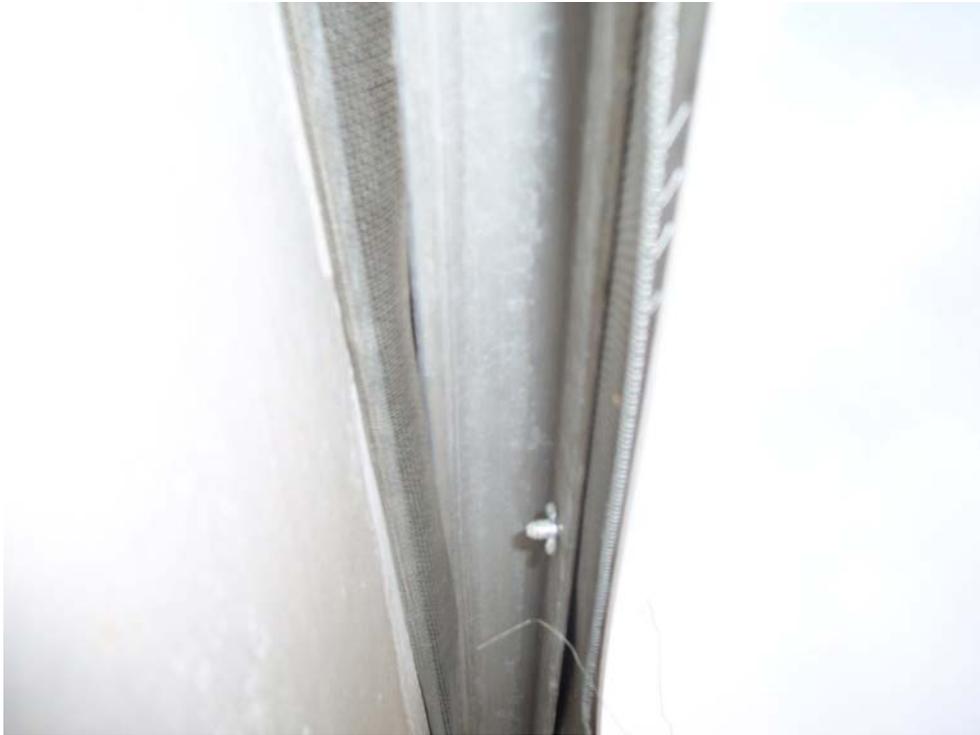
(31) Screen is secured to tank's sidewall and dome.

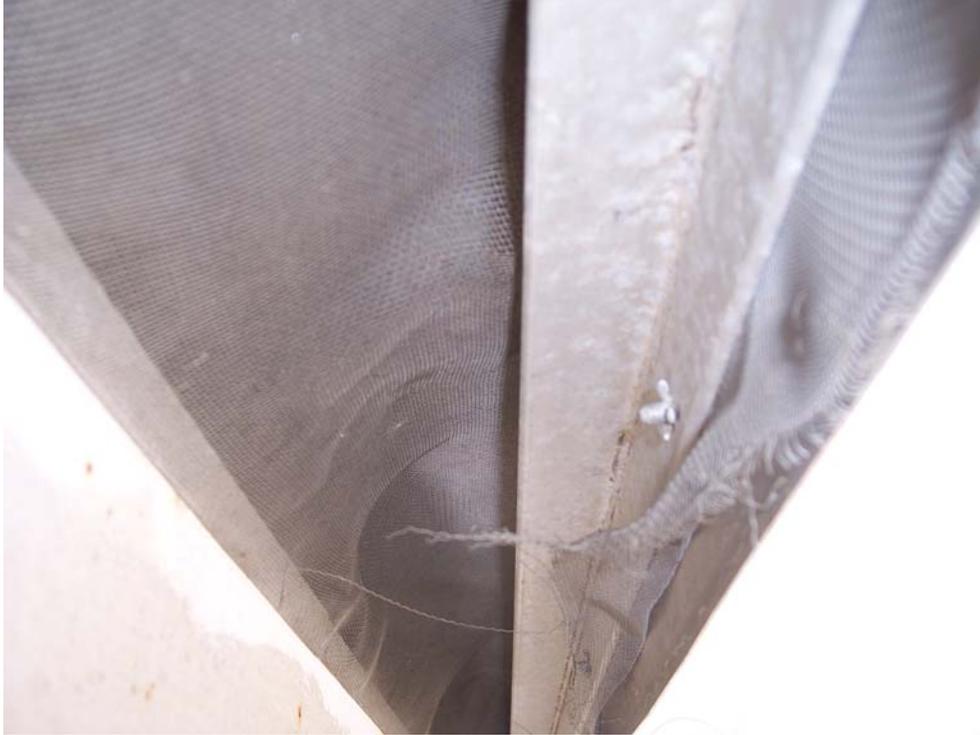
(32) Connection to dome.

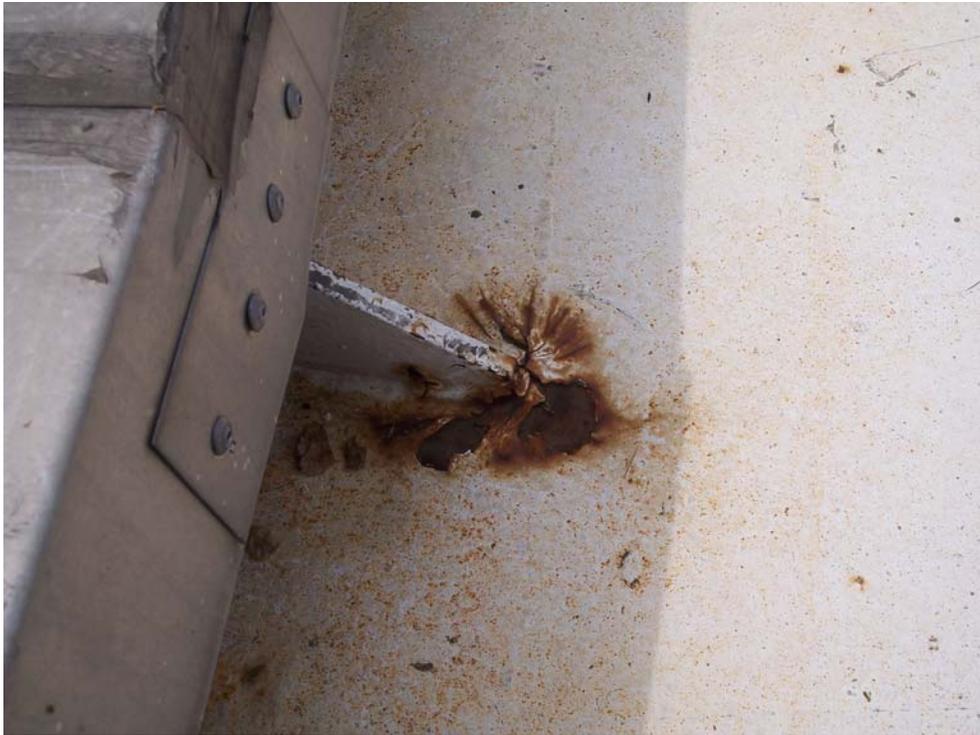
(33) Wind girder angle support indicates some stress breaking coating.

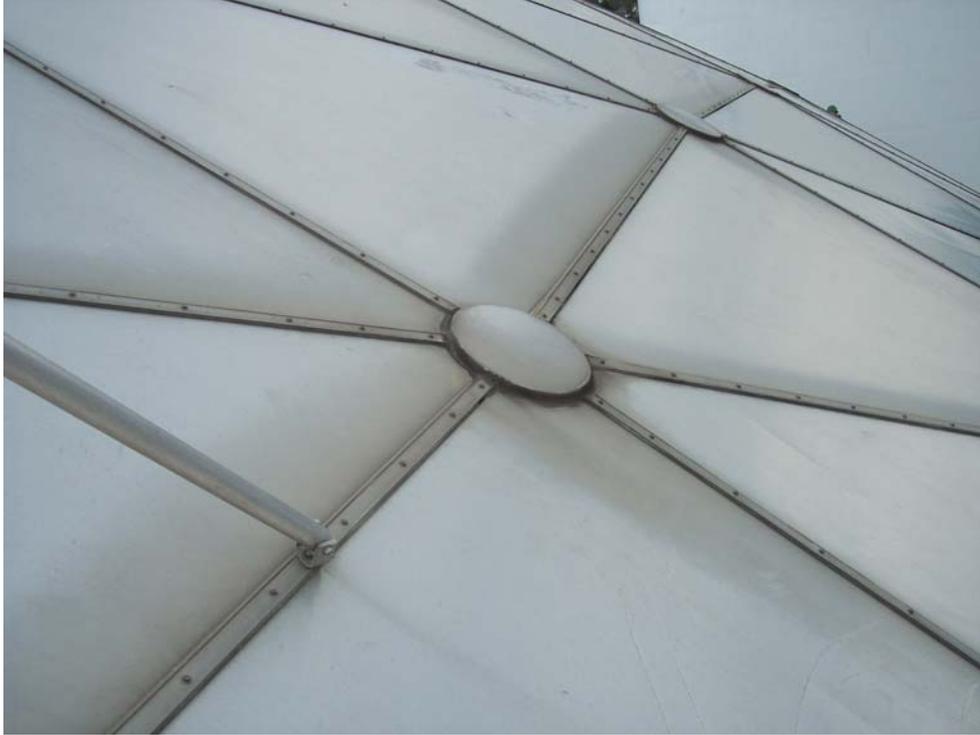
(34) No indication of leaking dome caps.

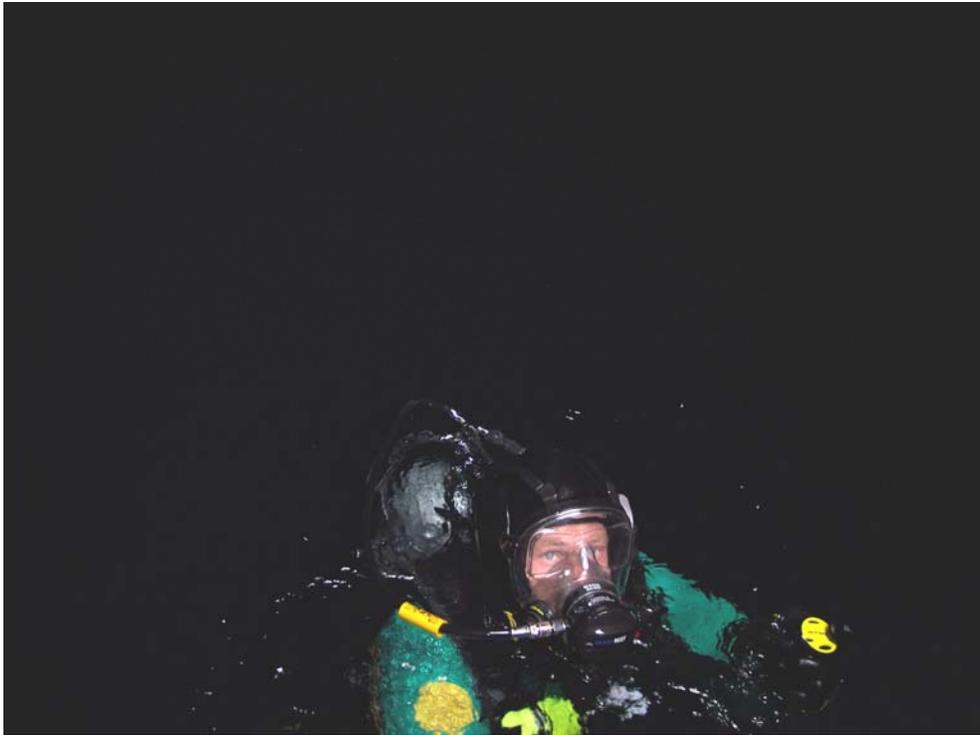
(35) Interior was inspected utilizing a diver.

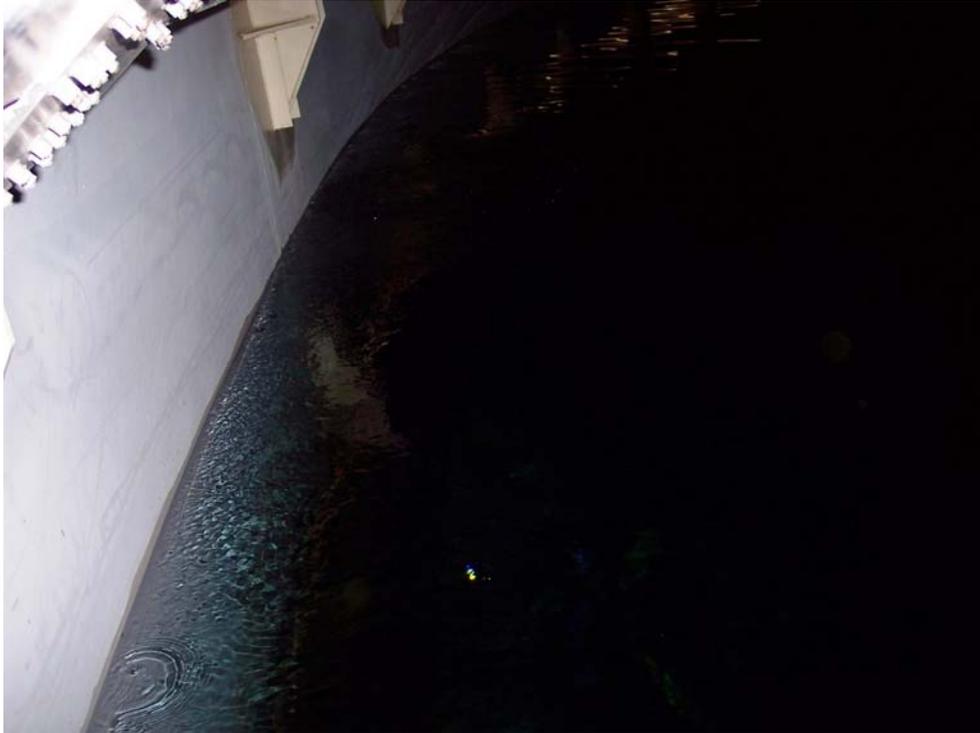
(36) Wet interior sidewall above water level - coating intact.

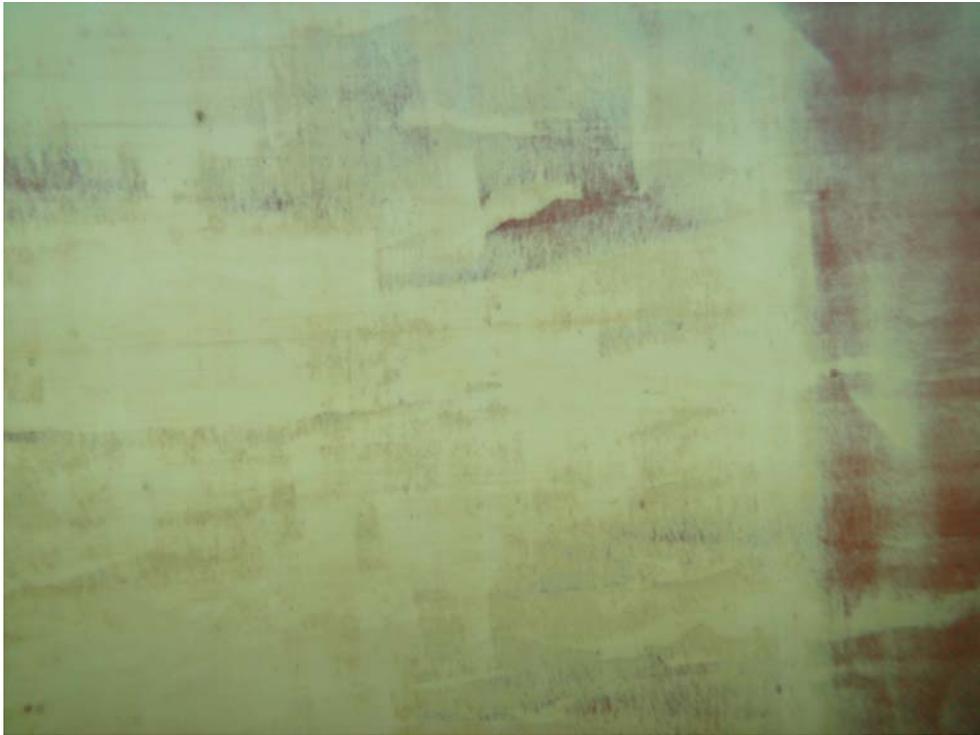
The wet interior coating is an epoxy system applied by G & M Painting in 1999. The sidewall coating is in fair condition, 98% intact, with no significant damage at the high water line, which would be the area most affected by ice pressures and ice movement. Causes of deterioration are blisters, primer bleed-through, and delamination. The coating is still protecting the metal, with the exception of several spot coating breaks.

(37) Discoloration and primer bleed-through below water level.

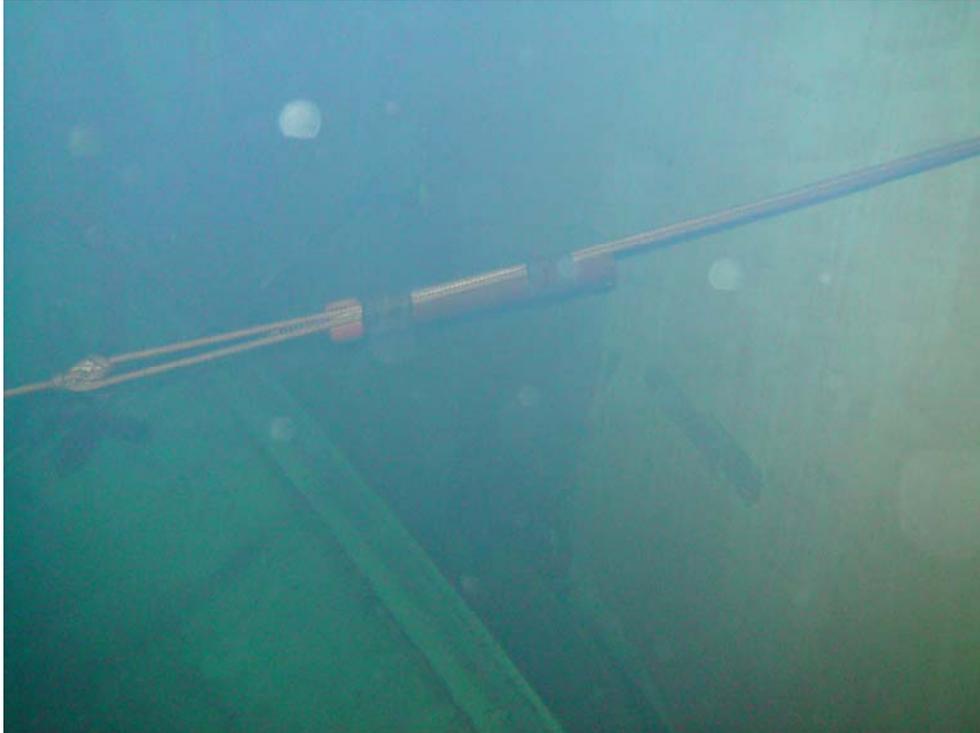
(38) Tank has an intact floating-type anode.

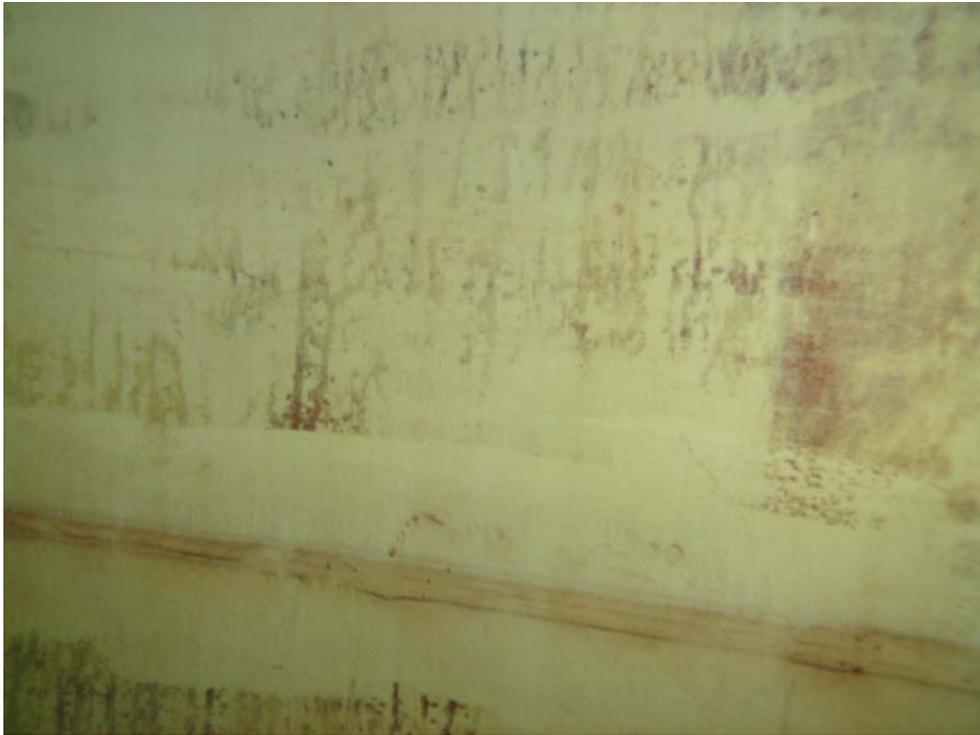
(39) Discoloration of topcoat, primer bleed-through, and stripe coat on wet interior.

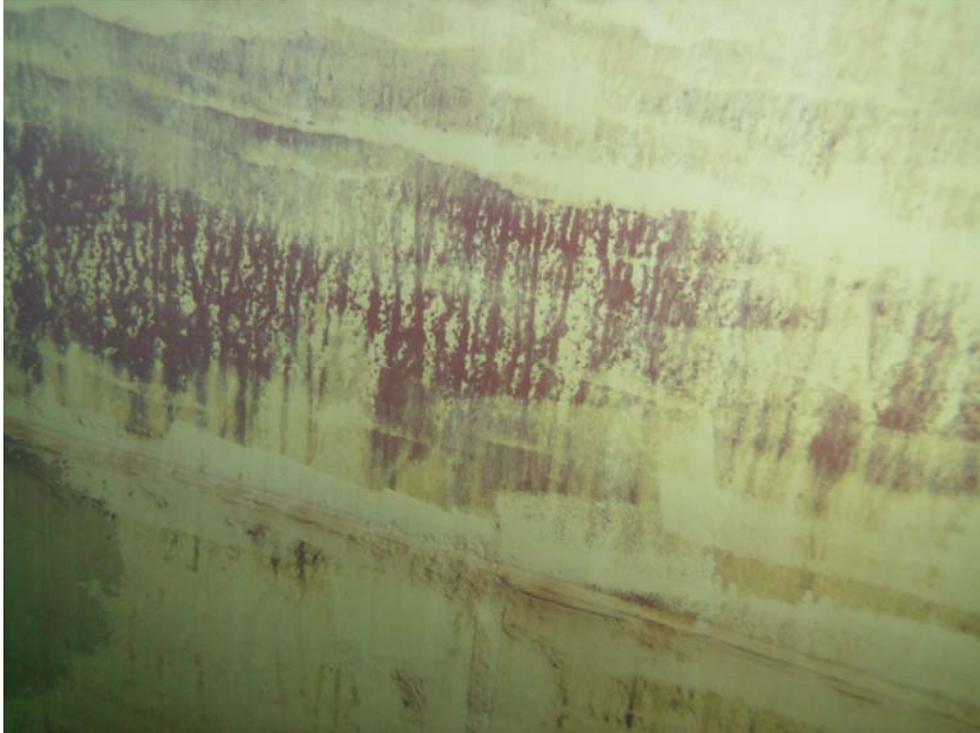
(40) Primer bleed-through.

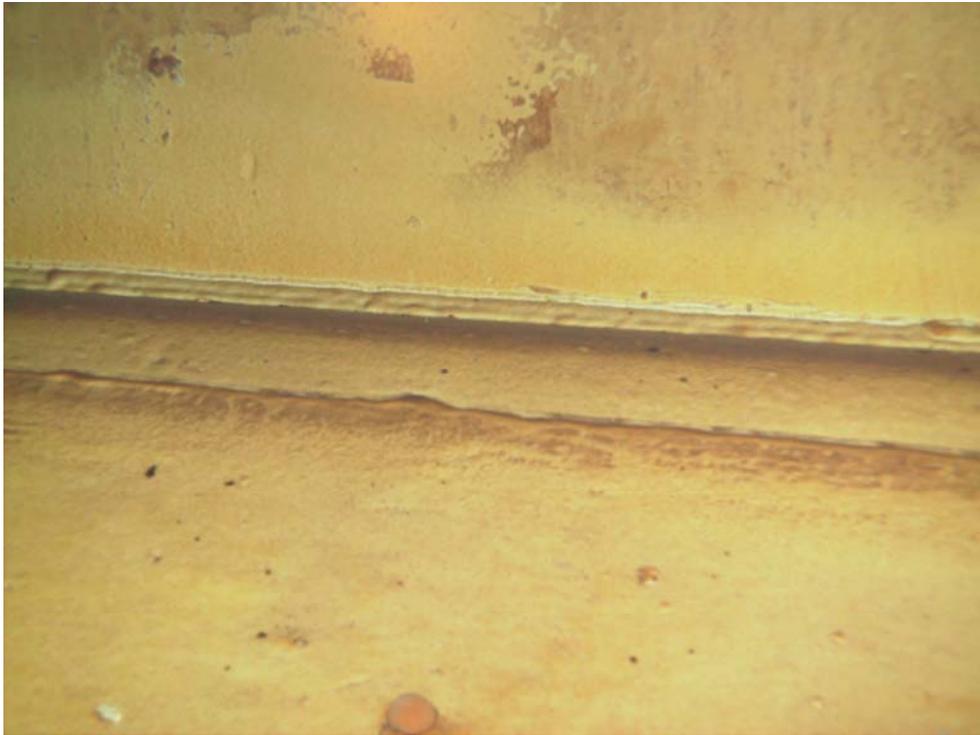
(41) Sidewall stiffener.

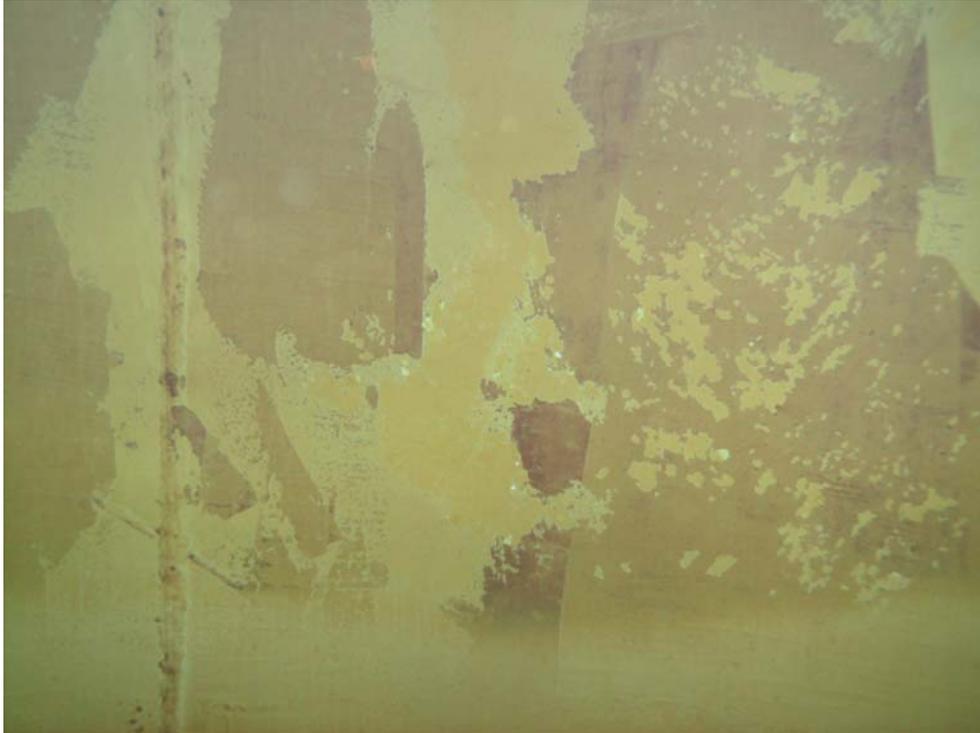
(42) Coating repairs were evident.

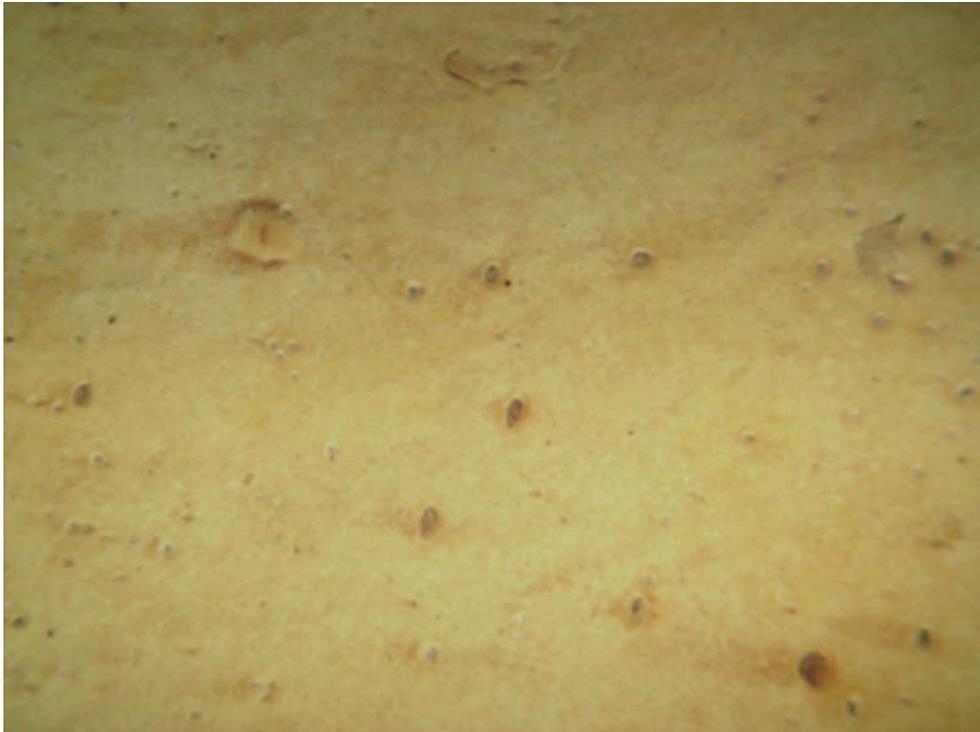
(43) Blisters.

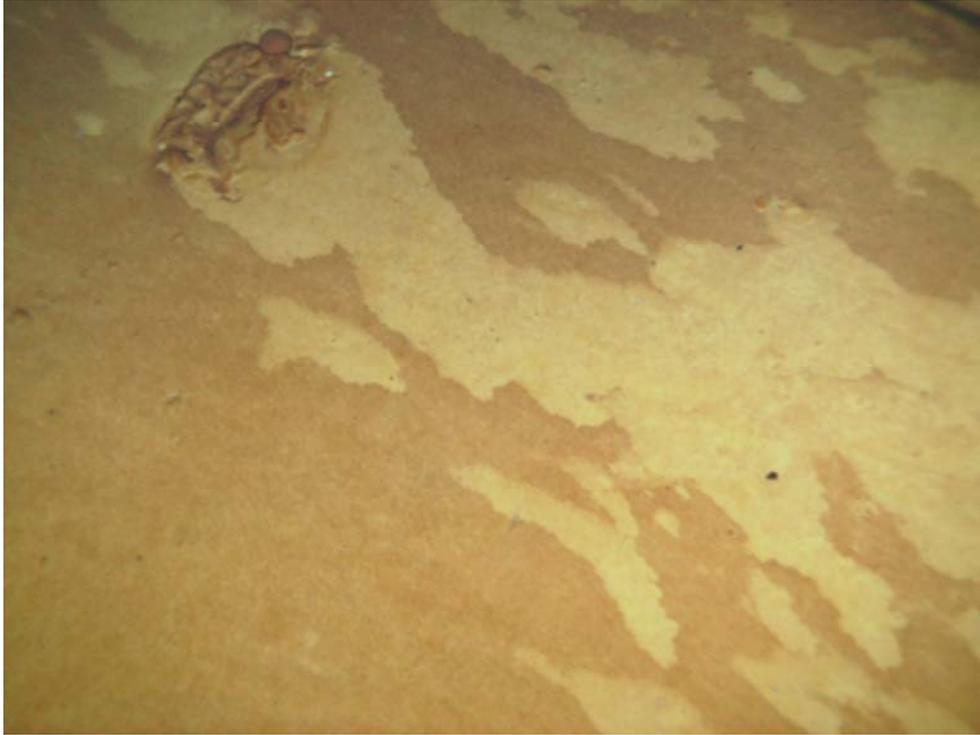
(44) Sediment.

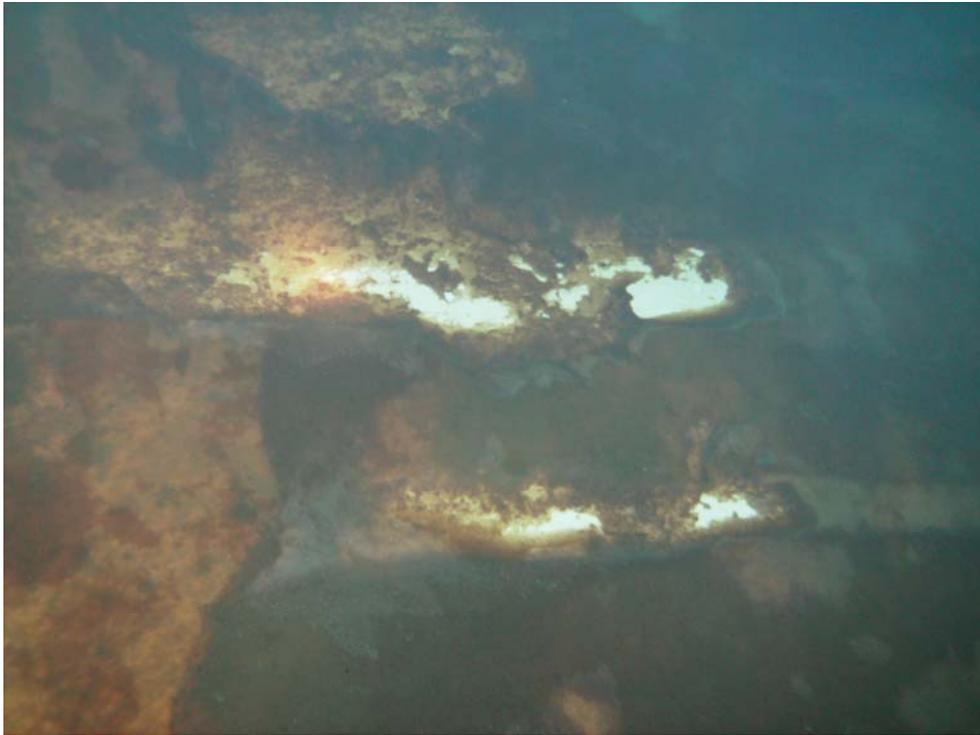
(45) Sediment.

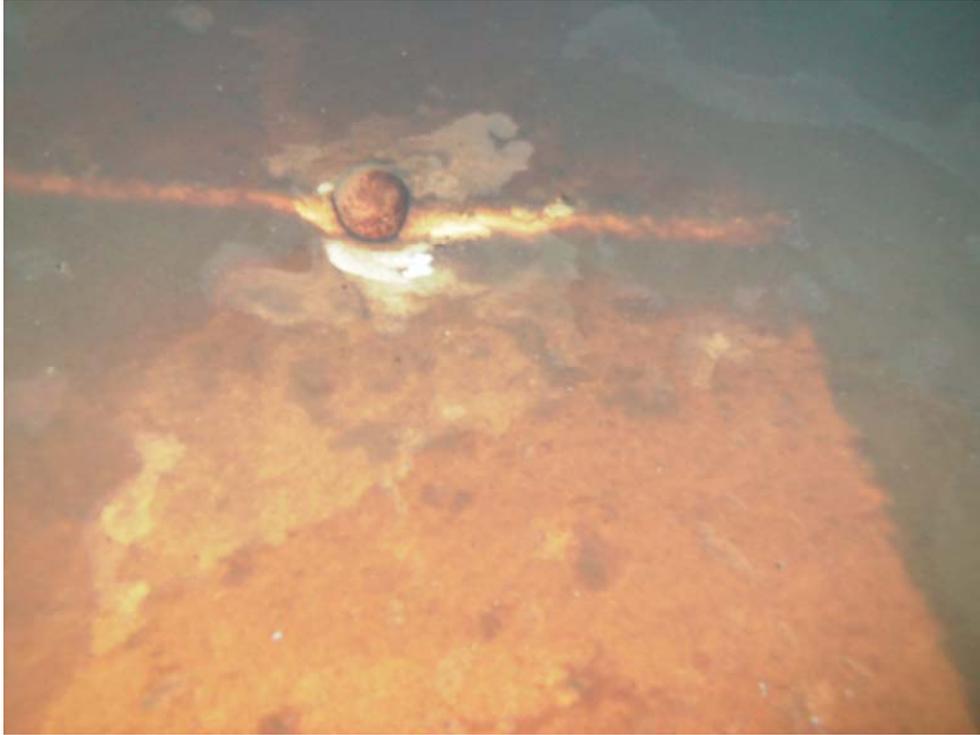
(46) Corrosion byproduct indicating cathodic system is operational.

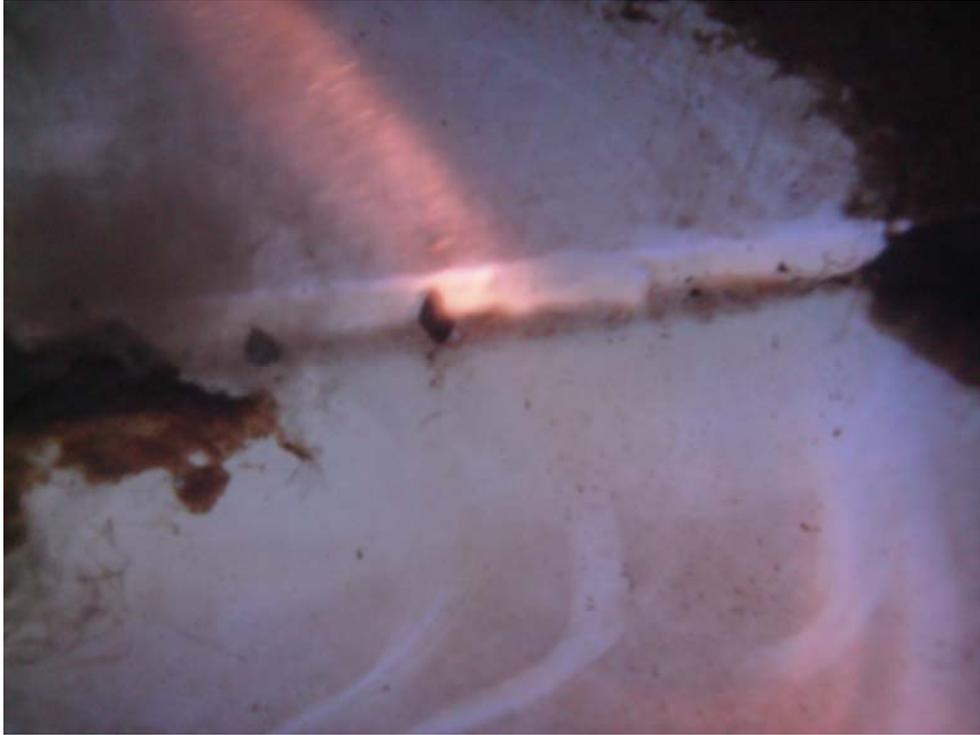
(48) Spot failures on weld seam.

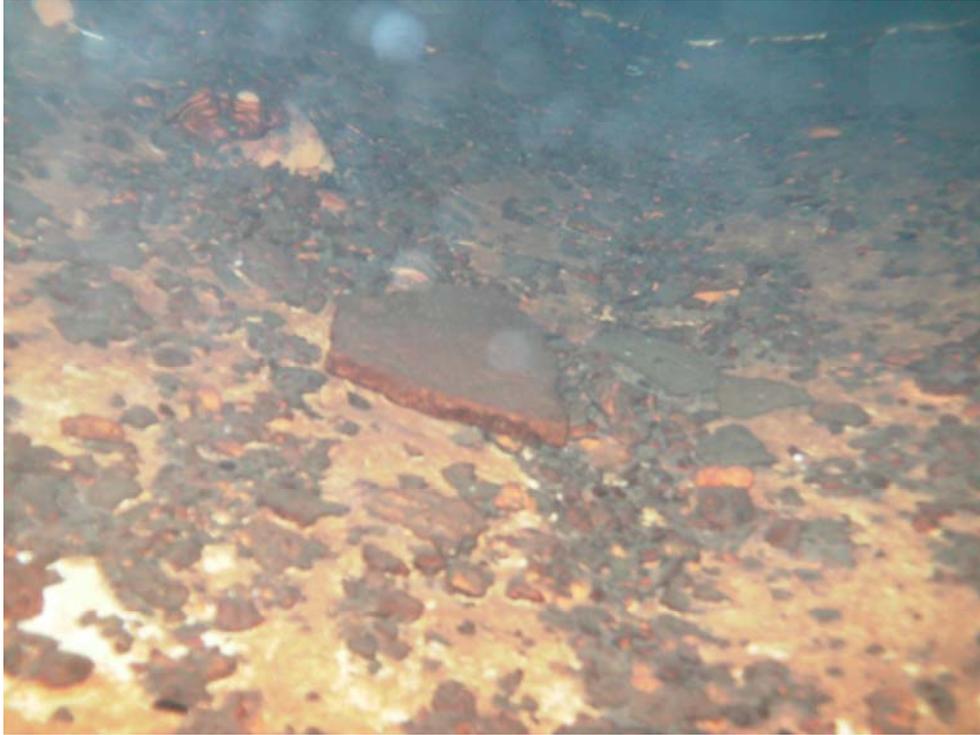
(52) Sediment.

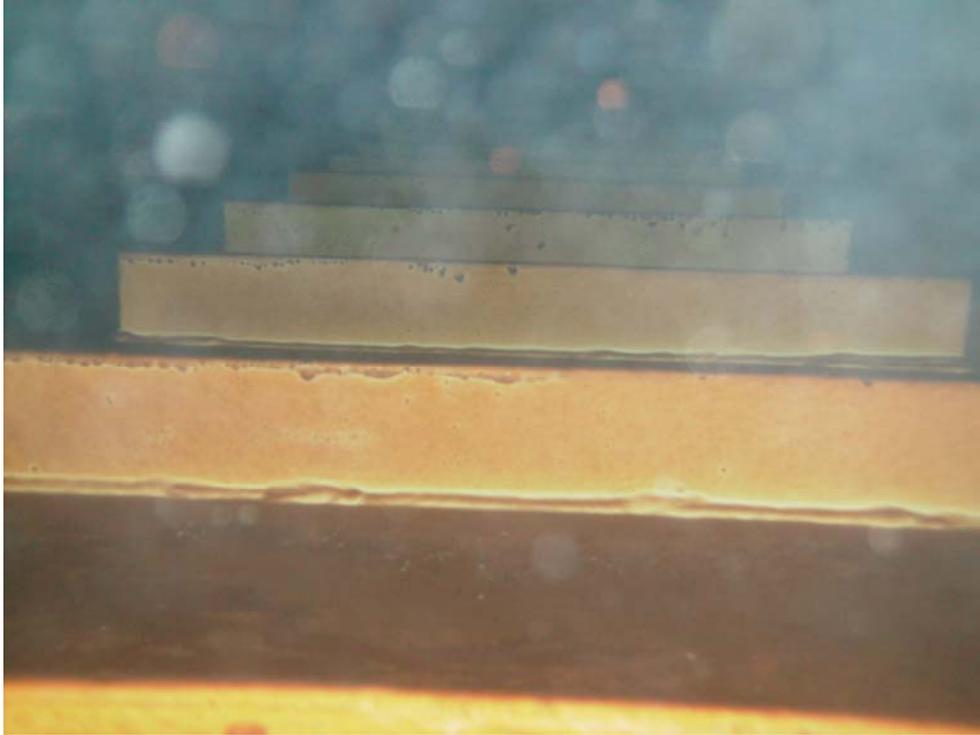
(53) Silt sediment.

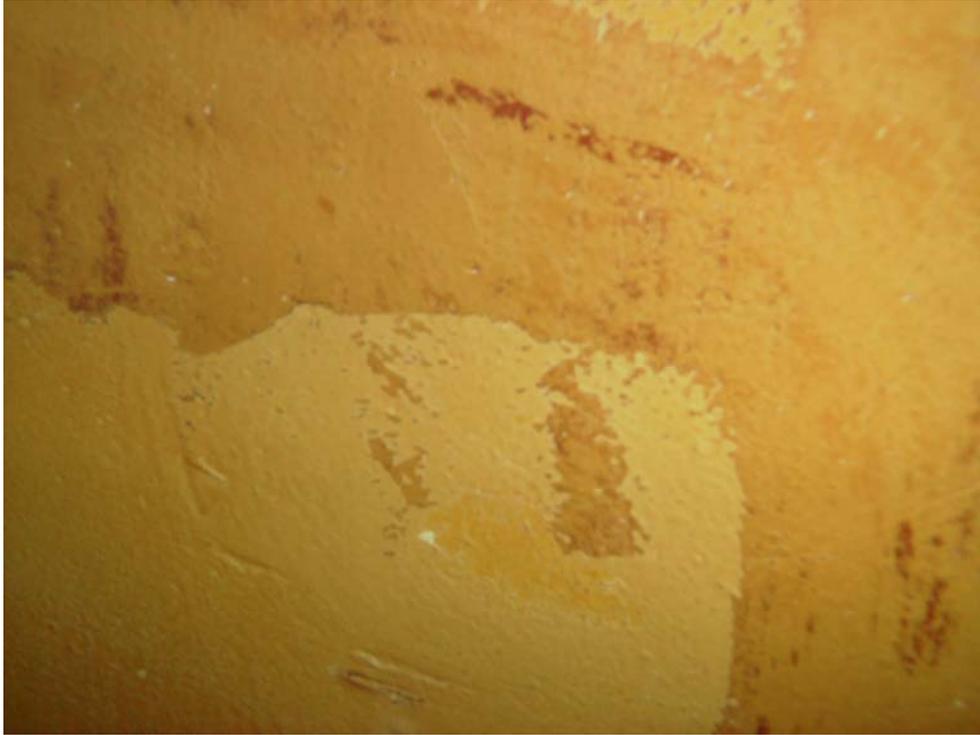
(54) Discoloration of topcoat.

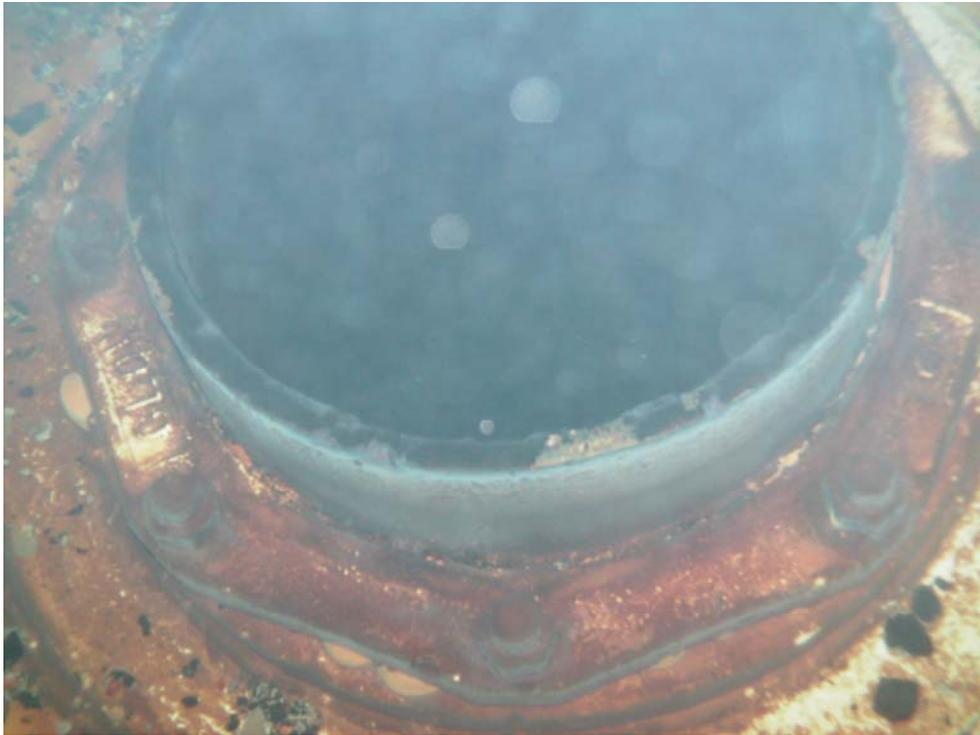
(55) Effluent piping.

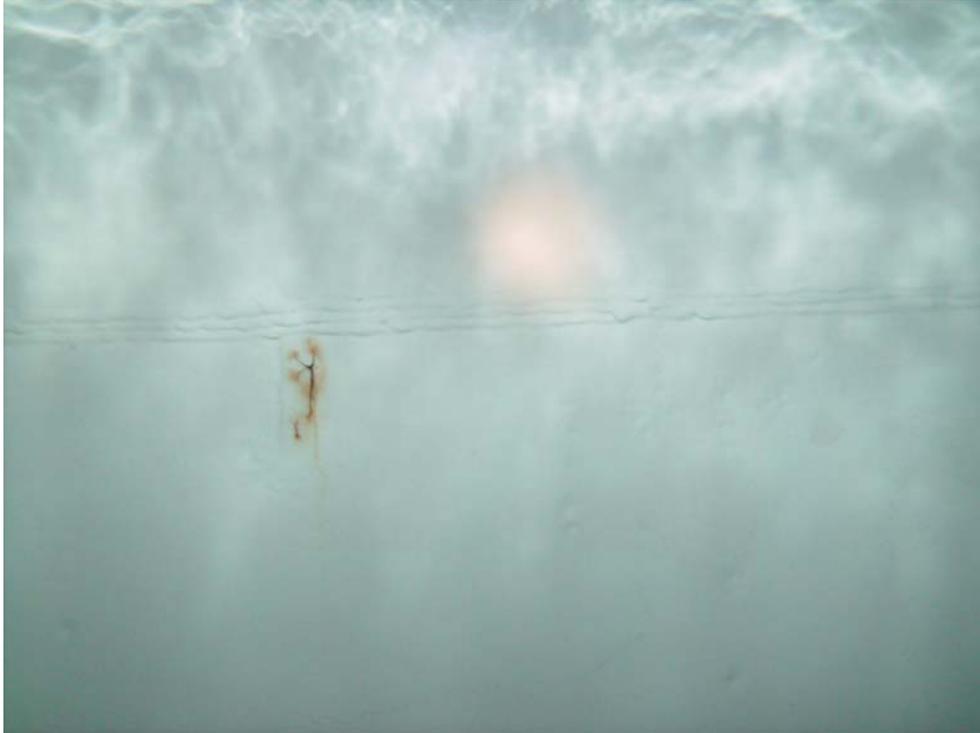
(56) Spot rusting near high water line.

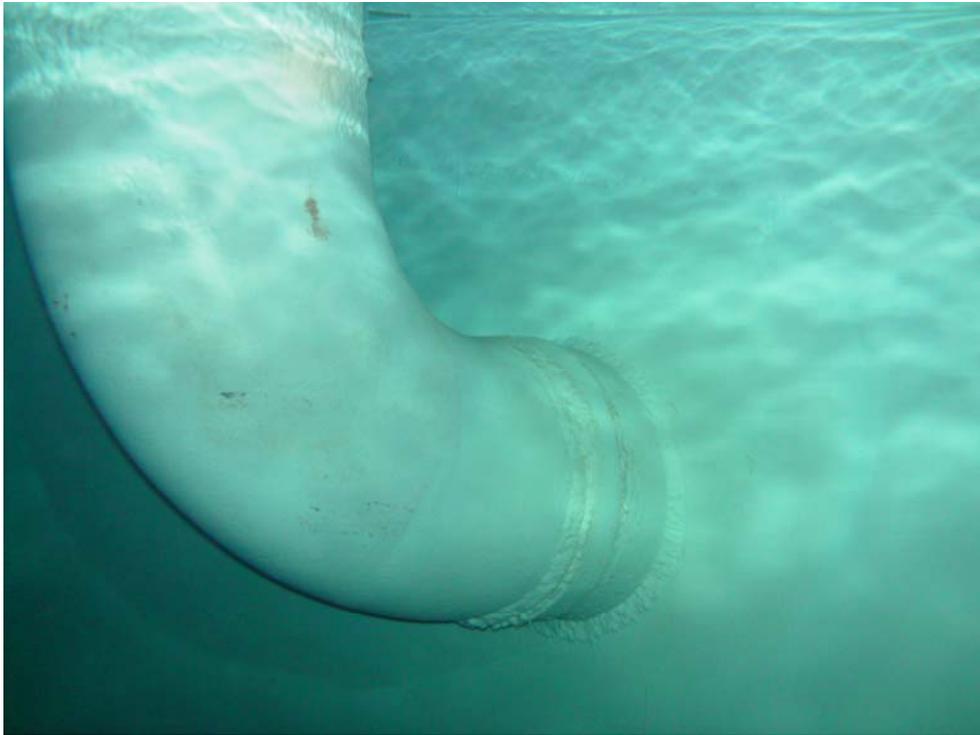
(57) Spot failures on overflow pipe.

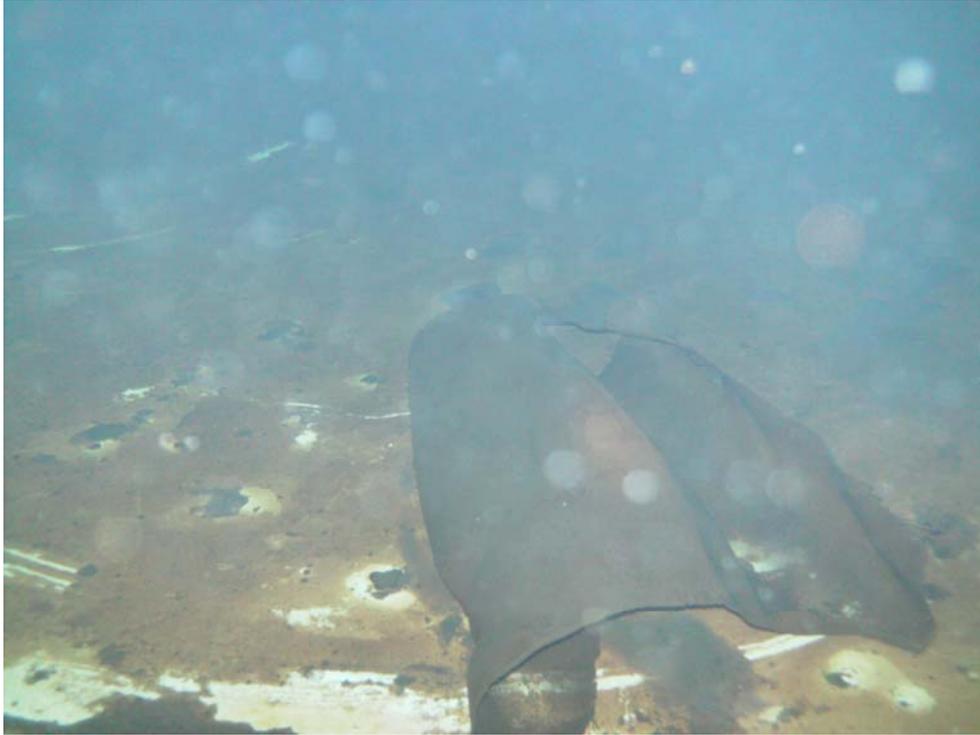
(58) Two pieces of screen were removed during dive.

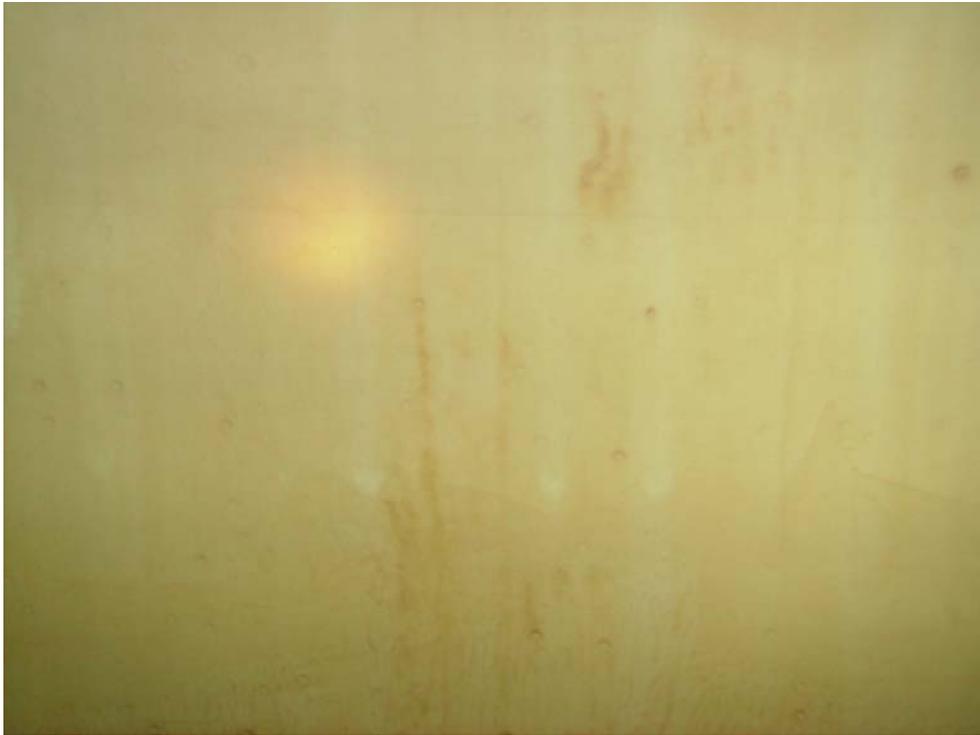
(59) Sidewall rust blooms.
