PHASING + COST PROJECTIONS

PROPOSED STADIUM PLAN
REDUCED SCOPE

CONSULTANT REPORTS

STURCTURAL REPORT ON EXISINTG CONDITIONS

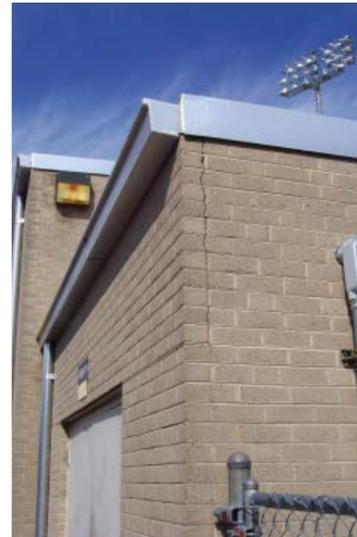
2.The exterior veneer has Control Joints (CJ's) but the concrete bricks still have shrinkage cracks. The exterior cracks at some of the corners are +1/8". (See Pictures)

Evidence of verical cracks at Building #1

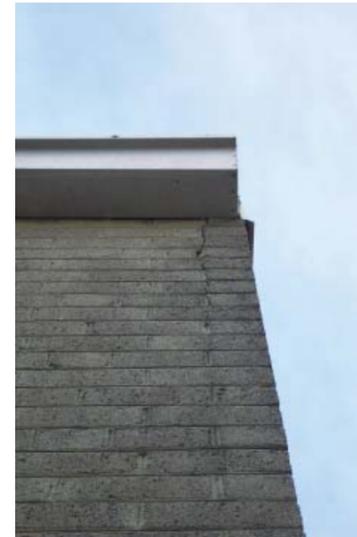
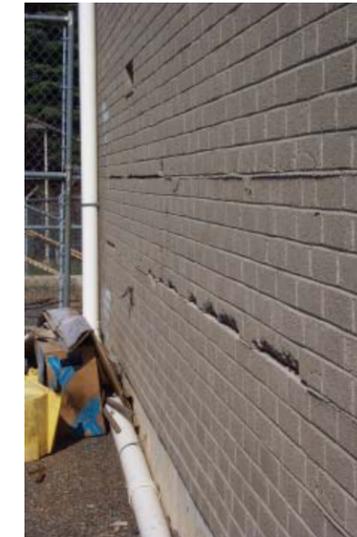
4.The joint reinforcing in the veneer is starting to corrode and expand. This is causing serious horizontal cracking and spalling of mortar joints. (See Picture)

Evidence of spalled concrete, protruding mortar caused from rusting joint reinforcement

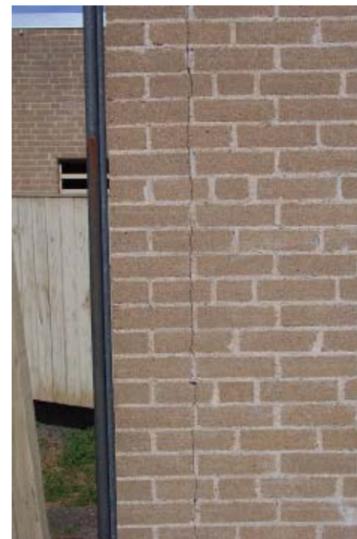
1.All exterior walls are double wythe concrete bricks without CJ's and most have shrinkage cracks. (See Pictures)

Evidence of verical cracks at Building #2

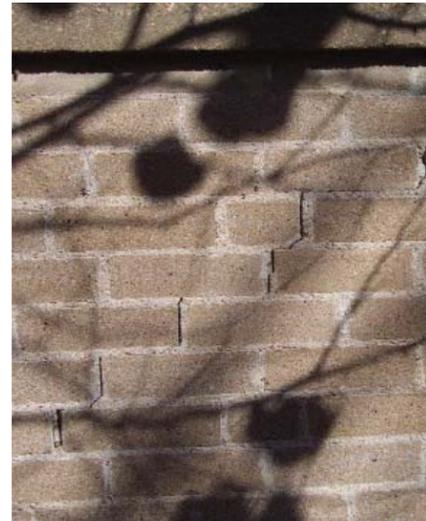
1.All exterior walls are double wythe concrete bricks without CJ's and all have shrinkage cracks. A few cracks go the full width of the wall. (See Pictures)

Evidence of diagonal cracks in masonry

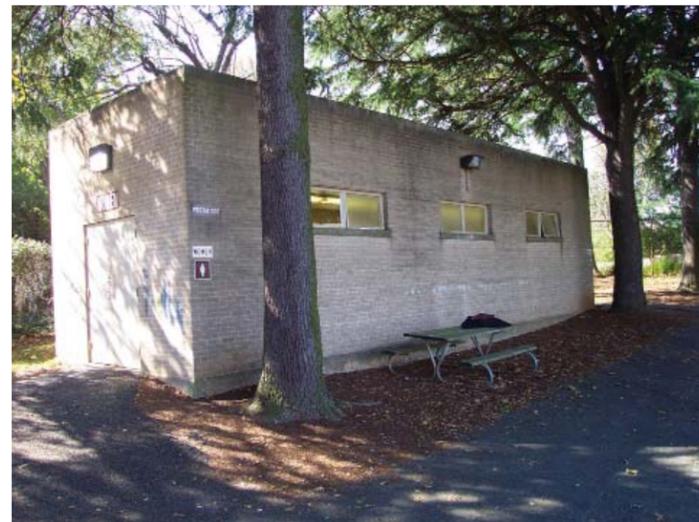
2.Foundation movement from two large tree is possible due to the size and proximity of the trees. (See Picture)

Large trees close to foundation

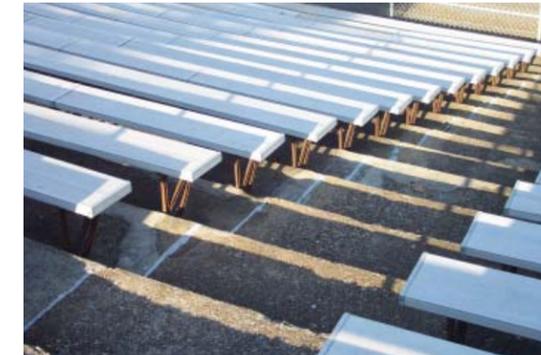
2.The sealant in all of the concrete slab-on-grade Expansion Joints (EJ's) is past its usefulness and should be replaced. (See Picture)

Sealant in EJ is cracked and brittle

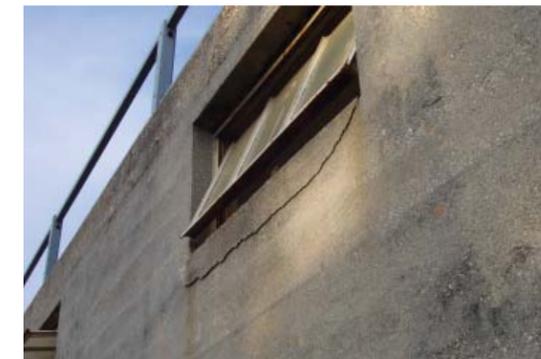
5.A few locations of Press Box window sills have spalled due to rusting rebar. These should be removed, prepared, coated, and repaired. (See Picture)

Window sill spalled from rebar's corrosive expansion

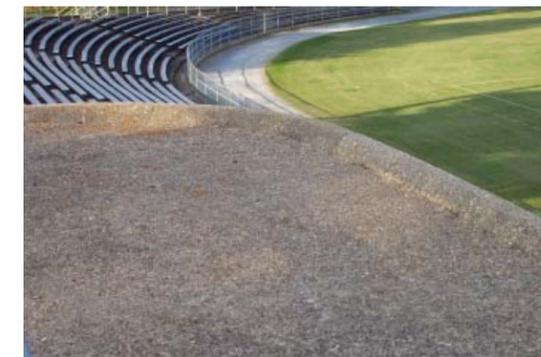
6.The concrete roof of the Press Box does not currently show signs of rebar deterioration. However, the remaining exposed life is limited. A roof membrane is recommended before deterioration sets in. (See Picture)

Exposed concrete roof

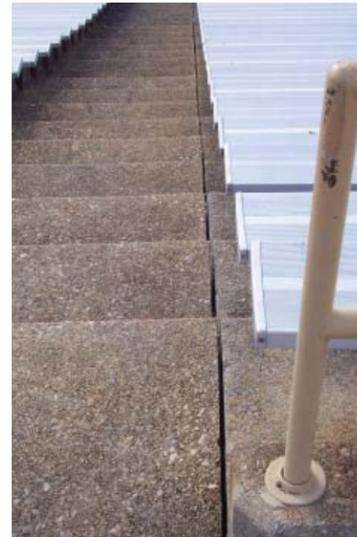
Open expansion joints need sealant

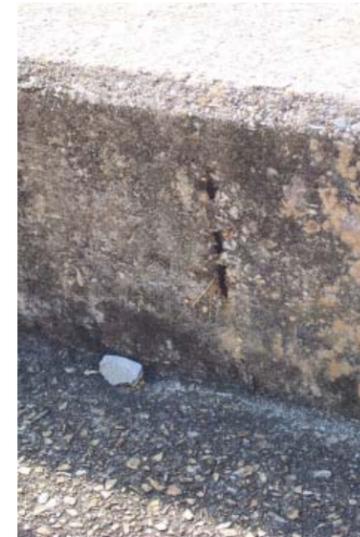
Exposed rebar

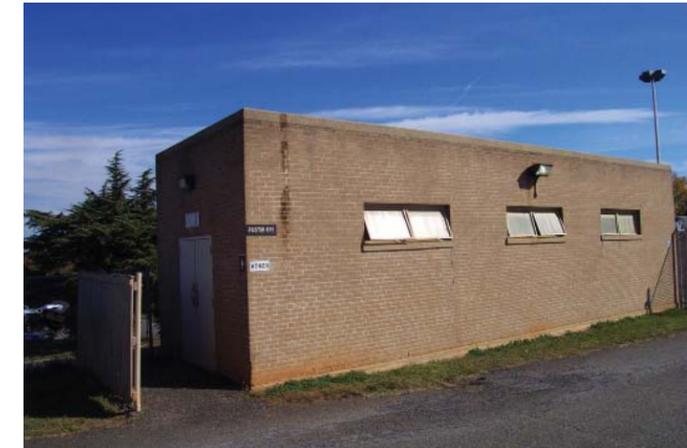
Large masonry and cap stone cracks

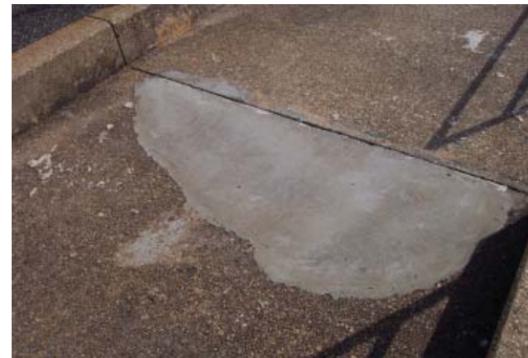
Concrete patch

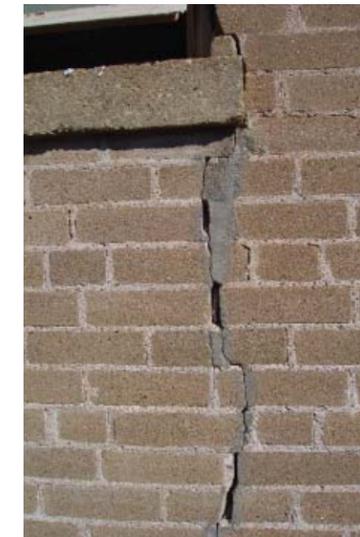
Large masonry and cracks

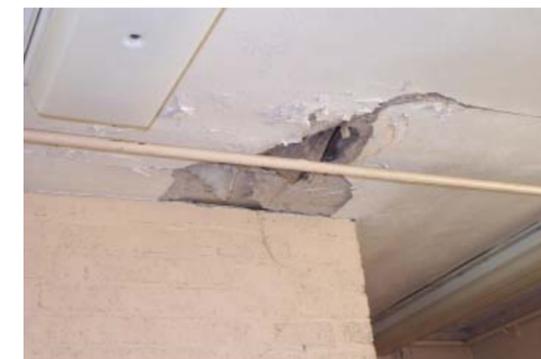
Water damaged ceiling

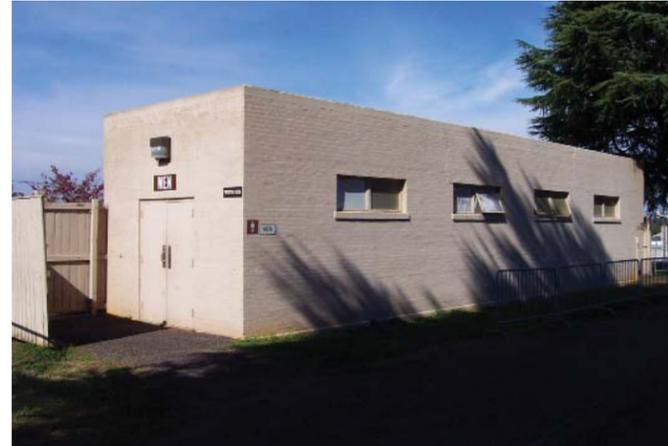
1.All exterior walls are double wythe concrete bricks without CJ's and all have movement/shrinkage cracks. Three cracks go the full width of the wall. (See Pictures)

Large masonry cracks

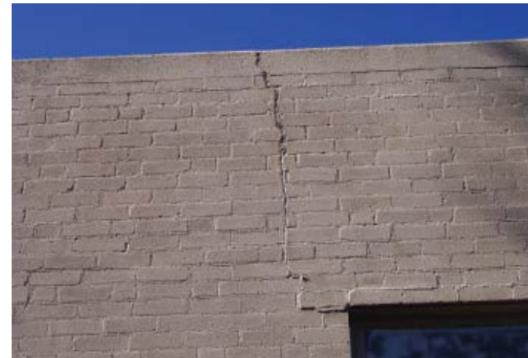
2.The worst wall cracks are around 5/16" wide. Some have been previously repaired and some are out of plane across the crack. (See Pictures)

Large masonry cracks

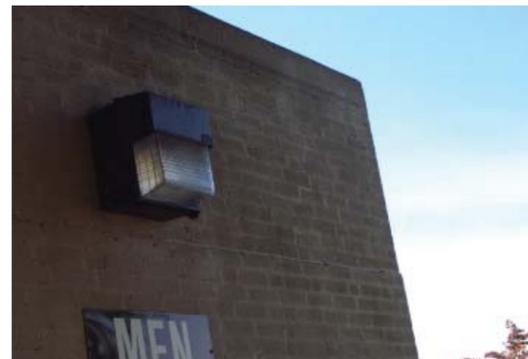
Out of plance crack
