JEFFERSON PARK RECREATION AREA
LANDFILL CAP PRELIMINARY EVALUATION

City of Lynchburg, Virginia
Department of Public Works
Waste Management Division

Draper Aden Associates
Consulting Engineers
4136 Innslake Drive
Glen Allen, Virginia 23060

April 11, 1997

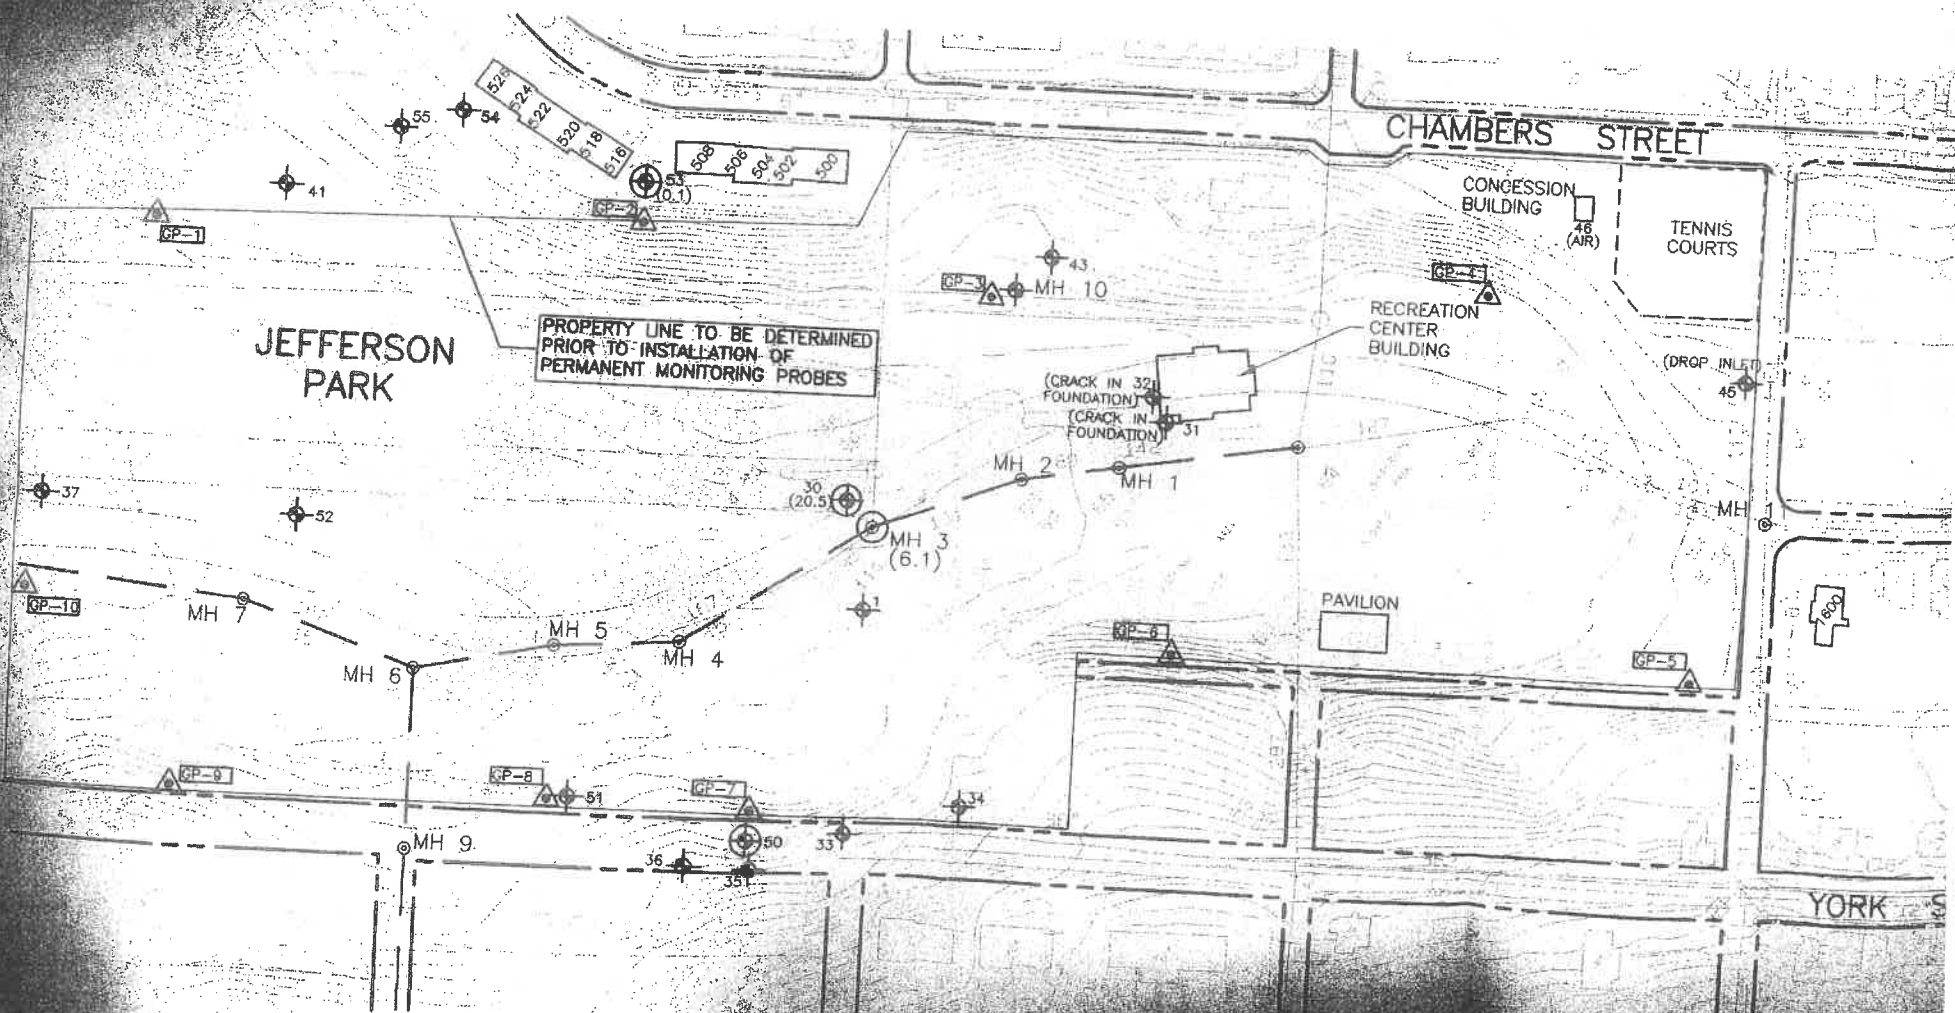
Methane was detected in two manholes, labeled as Manholes 3 and 8 on the drawing in Appendix A. The concentration of methane was 6.1 percent in Manhole 3 and 1.7 percent in Manhole 8. The lower explosive limit of methane in air is 5.0 percent. Thus, the methane concentration found in Manhole 3 is potentially dangerous.

The gas investigation in the landfill cap consisted of augering holes into the cap and measuring methane concentrations. The holes augered on July 2, 1996, were advanced with a hand auger bucket or punched with a bar. On July 3, 1996, a gasoline powered hand held auger was used to advance the boreholes. Bar holes were also punched on July 3, 1996. The approximate borehole locations are shown on the drawing in Appendix A. Methane was detected in Boreholes 30, 48, 50, 51, 52, 53, 56, 58, 67, 71, 72, 75, 76, 80, and 81. The concentration levels ranged from 0.1 percent methane to 54.7 percent methane. Concentration of methane above the lower explosive limits (5.0 percent) were found in Boreholes 30, 48, 56, 58, 72, and 81.

Borehole 48 was located on the western edge of the smaller park area. The methane level was recorded at 54.7 percent. A residence is located across York Street from Borehole 48. Borehole 47 was advanced on the edge of York Street, between Borehole 48 and the residence. Methane was non-detect at Borehole 47.

Boreholes were advanced around the smaller park area approximately 100 feet apart. Boreholes 56 and 58 indicated elevated readings (23.8 and 34.5 percent, respectively) of methane near the northeast corner of the site. A residence is located approximately 100 feet from the boreholes.

Methane was detected in Boreholes 67 and 71 below the lower explosive limits. Methane was detected in Borehole 72 above the lower explosive limit. Additional boreholes were advanced in the vicinity of Borehole 72 to attempt to determine the extent of migration. Boreholes 80 and 81 were advanced between the park and Chambers Street and on the east side of Chambers Street, respectively. A residence is located approximately 100 feet east of Chambers Street. Methane was detected in both Boreholes 80 and 81, with the concentration recorded in Borehole 81 at 6.1 percent.

1. Conduct methane monitoring within the house located to the east of Boreholes 80 and 81. This house is located at the intersection of Chambers Street and Second Street.
2. Conduct methane monitoring within the house located at the northeast corner of the smaller park area.

3. Install monitoring probes at the park property boundary in the vicinity of all boreholes near the property boundary in which methane was detected. At a minimum, probes will be installed in the vicinity of Boreholes 48, 50, 51, 53, 56, 58, 67, 71, 72, 75, and 76. Consideration should be given to constructing probes around the perimeter of each park area, spaced at a maximum of 400 feet apart.
