**Addendum for Invitation for Bids
College Hill WTP Interior Renovations
2016-075**

Date: 05/12/2016
From: Lisa Moss, Buyer VCA
RE: Addendum No. 1

**ASBESTOS MANAGEMENT PLAN
CITY OF LYNCHBURG
NEW FILTRATION PLANT**

UT-101

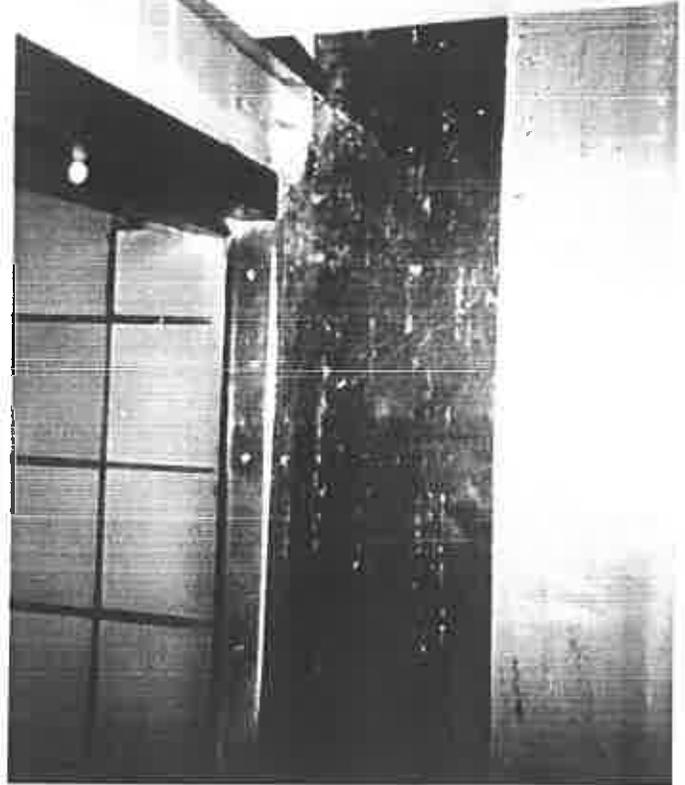
101.06 Hallway by Stairs, FT-9
