**Addendum for Request for Proposal  
Architectural/Engineering Services for the LRWWTP Operations Building Renovation**

**2016-007**

ASBESTOS MANAGEMENT PLAN  
CITY OF LYNCHBURG  
WASTEWATER TREATMENT COMPLEX

Project No. 6.89.1203.01  
January, 1989

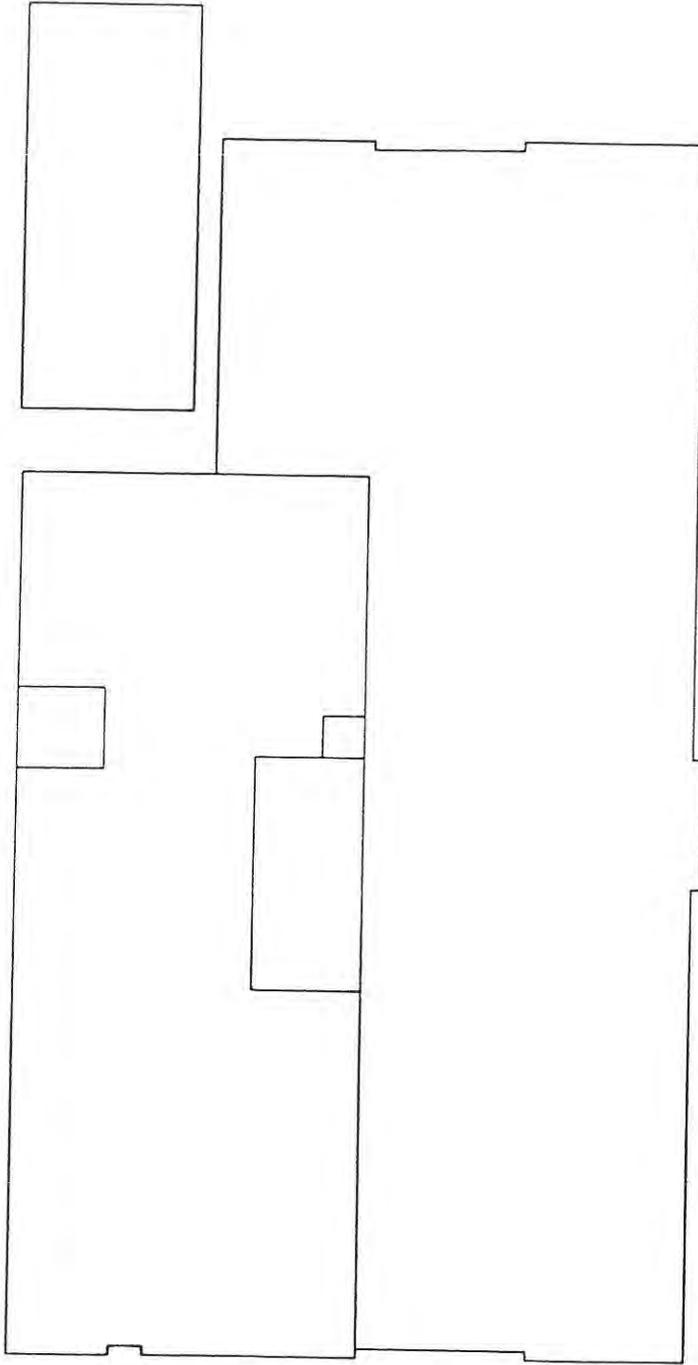
SECOND FLOOR  
SAMPLE POINT LOCATIONS

NOTE:  
 26 L.F. OF PIPE INSULATION WAS FOUND TO BE ACM, THEREFORE, ALL PIPE SHOULD BE ASSUMED ACM.
