**Addendum for Proposal**  
**Engineering Design Services for College Lake Dam**  
**13-848**

RE: Addendum No. 1

Name Of Dam: COLLEGE LAKE  
Location: CITY OF LYNCHBURG, VIRGINIA  
Inventory Number: VA 68002

## PHASE I INSPECTION REPORT NATIONAL DAM SAFETY PROGRAM

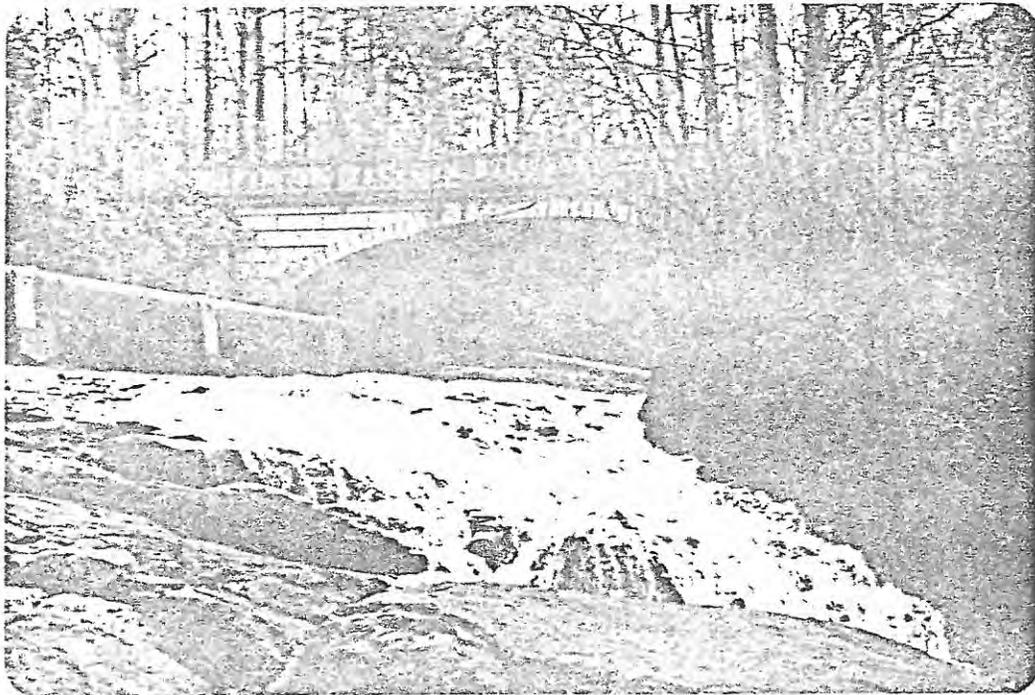
SPILLWAY

The spillway is a deteriorated masonry wier across a rock cut through the right abutment with a width of 60 feet. A concrete arch bridge carrying Rt. 221 spans the spillway outlet channel.

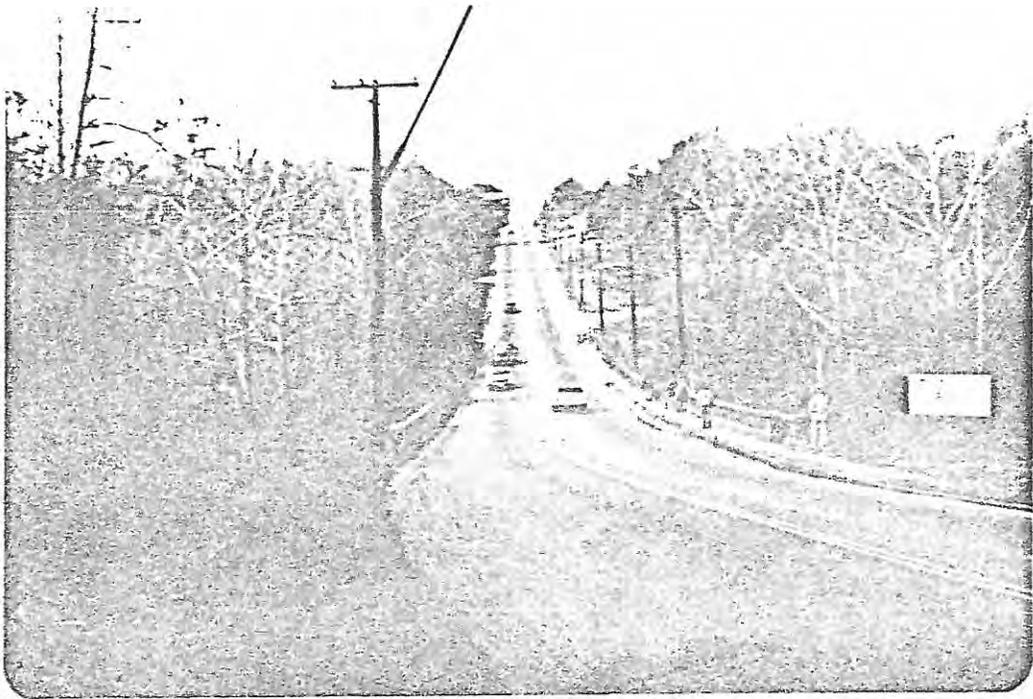
PHOTO #1 CREST OF DAM

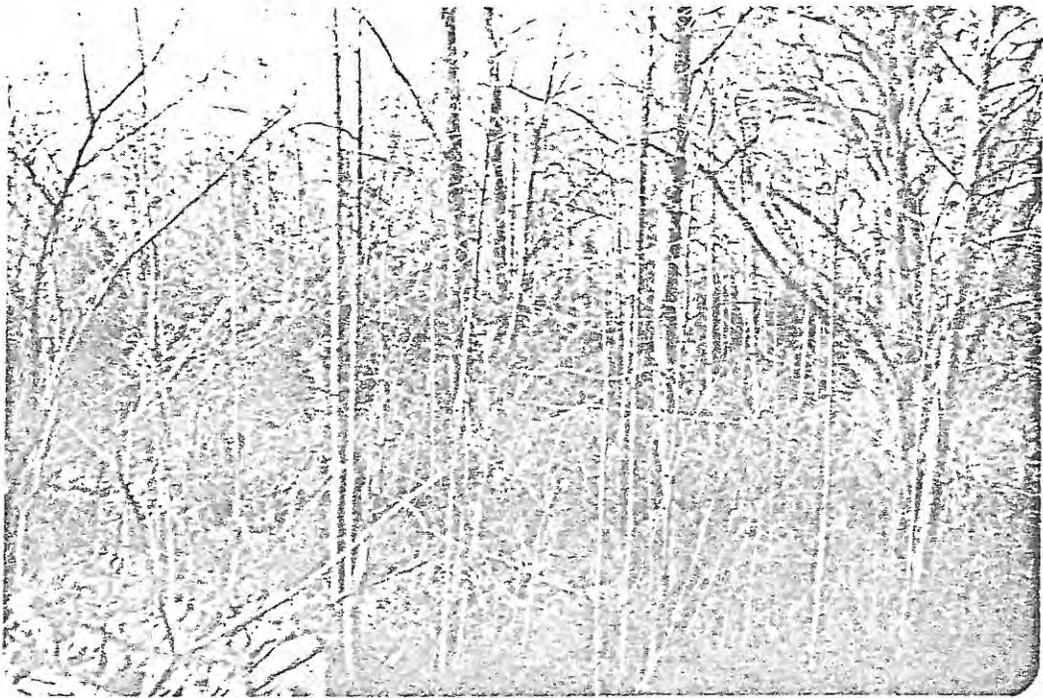
There are no signs of surface cracks, unusual movement, sloughing, or misalignment. However, there is a bench on the upstream face which is apparently the result of riprap failure and wave action. There are numerous animal burrows near the left abutment on the downstream face.

PHOTO #2 DOWNSTREAM FACE

- a. The animal burrows should be dressed with compacted fill and seeded.
- b. Place compacted fill in the area of the face eroded by wave action, reseed, and protect with riprap at the wave line area.
- c. Remove the brush and cut all trees. All trees greater than three inches in diameter should have their root structure and root ball removed. The subsequent holes should be filled with well compacted earth and seeded.
- d. Locate the wheel to the sluice gate stem and determine if the gate works. If it is not operable, make the necessary repairs to make it functional.

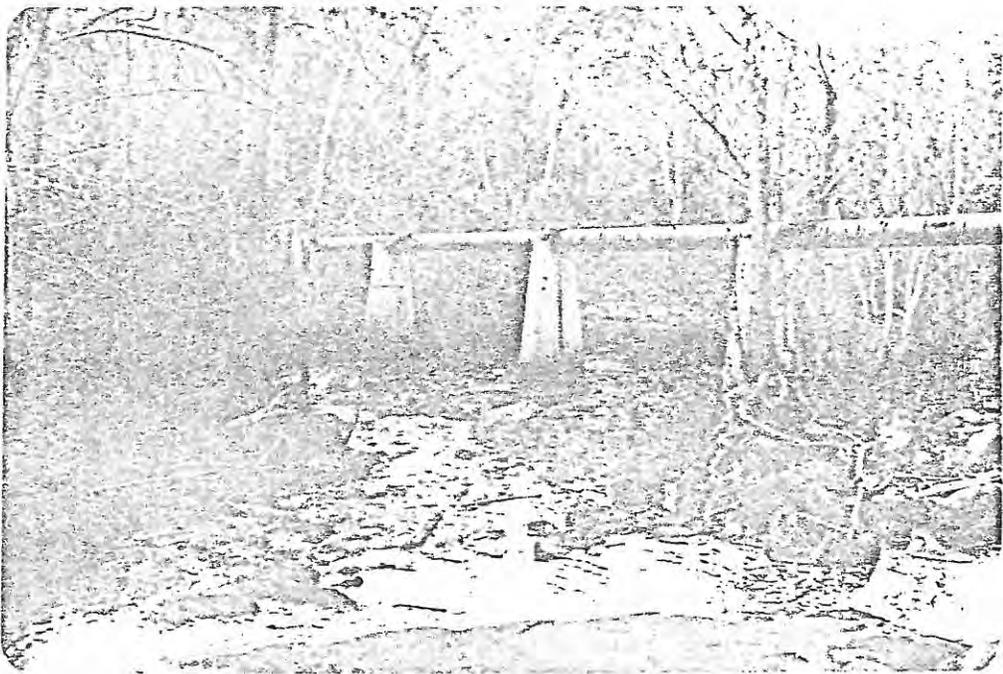
PHOTO # 6 AREA DOWNSTREAM OF SPILLWAY  
DISCHARGE CHANNEL
