PHASING + COST PROJECTIONS

PROPOSED STADIUM PLAN
REDUCED SCOPE

CONSULTANT REPORTS

STURCTURAL REPORT ON EXISINTG CONDITIONS

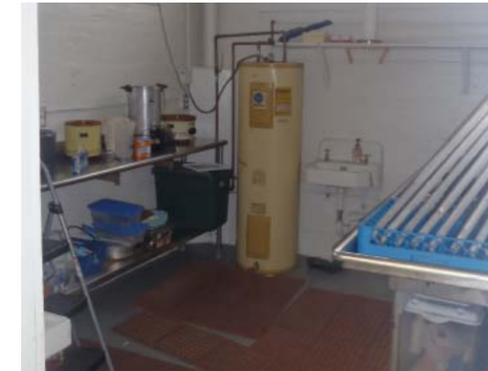
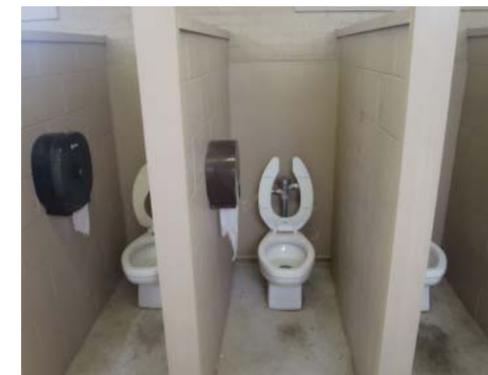
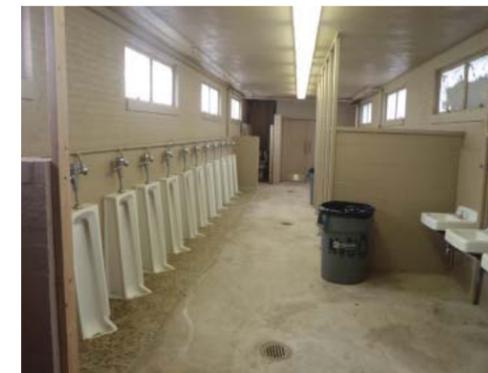
- Heating and cooling systems in most of the structures consist of simple terminal units – electric unit heaters, window air conditioners
- Ventilation for the Concessions preparation area is provided via a propeller wall exhaust fan – it is not known whether it provides sufficient ventilation or how effective it is.
- Groundskeeper's Office – electric unit heater
- No heating or cooling is provided for the restroom buildings. Ventilation is by natural means only through operable windows.
- Press Boxes – none
- Ticket Booth – none
- Team Locker Room – Packaged rooftop units provide heating and cooling (one for each locker room), multiple roof mounted exhaust fans

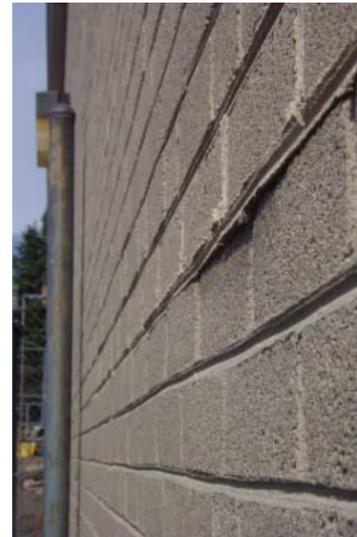
4.The joint reinforcing in the veneer is starting to corrode and expand. This is causing serious horizontal cracking and spalling of mortar joints. (See Picture)

Evidence of spalled concrete, protruding mortar caused from rusting joint reinforcement

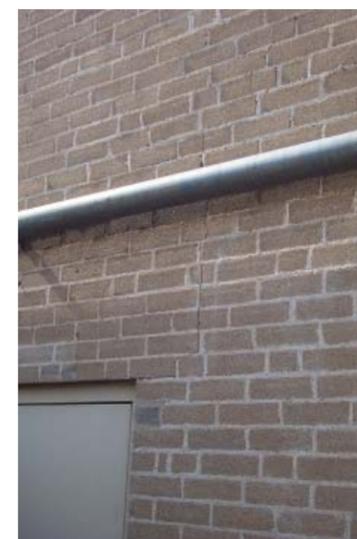
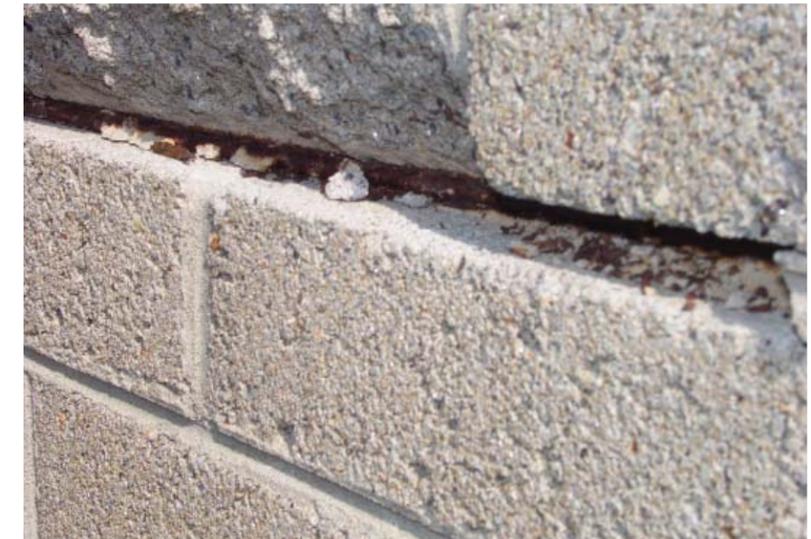
1.All exterior walls are double wythe concrete bricks without CJ's and most have shrinkage cracks. (See Pictures)

Evidence of verical cracks at Building #2
