**REISSUED:  
LCS STAGE UPGRADES E.C. GLASS H.S.**

**14-916**

Date: 02/04/2015  
From: Lisa Moss, Buyer VCA  
RE: Addendum No. 1

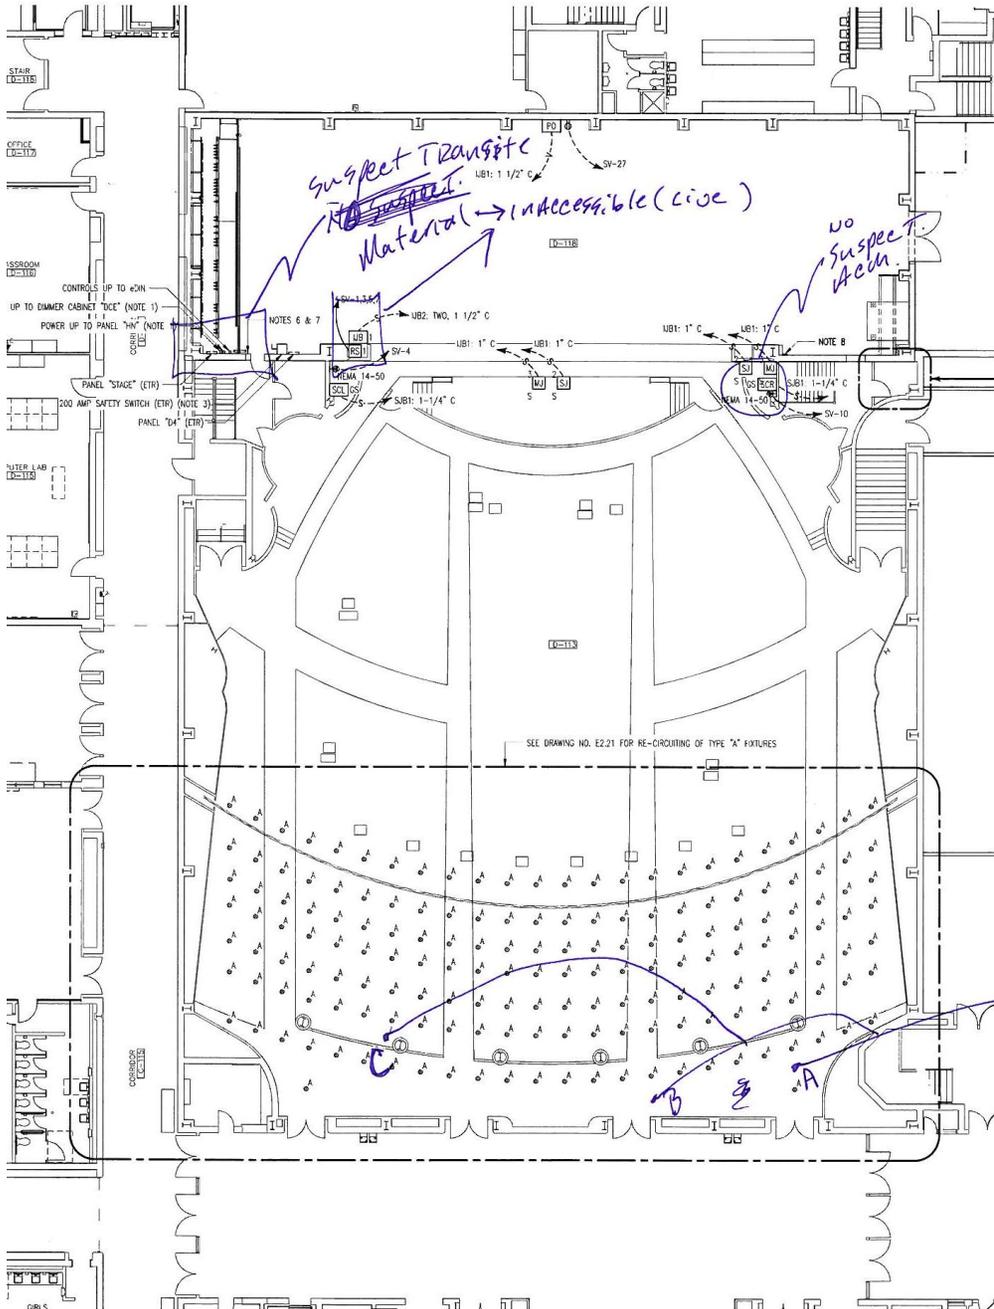
**FIRST FLOOR DRAWING**

**NOTES (DRAWING NO. E2.2)**

1. FOR CONDUIT TYPE, QUANTITY, SIZE AND FILL, SEE ONE LINE DIAGRAM - REWORKED CONDITIONS.
2. TYPE "A" FIXTURES ARE EXISTING, TO REMAIN. RE-CIRCUIT AS INDICATED.

6. INSTALL SIX GANGED SWITCHES TO CONTROL WALL-MOUNTED WORK LIGHTS PRESENTLY FED FROM PANEL "STAGE".
7. INSTALL EIGHT GANGED SWITCHES TO CONTROL WORK LIGHTS ON ELECTRICAL LIGHTING BATTENS. INSTALL EIGHT, 1P, 20 AT BREAKERS IN PANEL "STAGE" TO FEED WORK LIGHTS ON ELECTRICAL LIGHTING BATTENS. SEE PLAN ENTITLED "LIGHTING - THIRD FLOOR - REWORKED CONDITIONS" FOR BRANCH CIRCUIT DESTINATIONS.

8. CONNECT REPLACEMENT FIRE CURTAIN RELEASE MECHANISM TO EXISTING FIRE DETECTION AND ALARM SYSTEM FIRE CURTAIN RELEASE DEVICE.

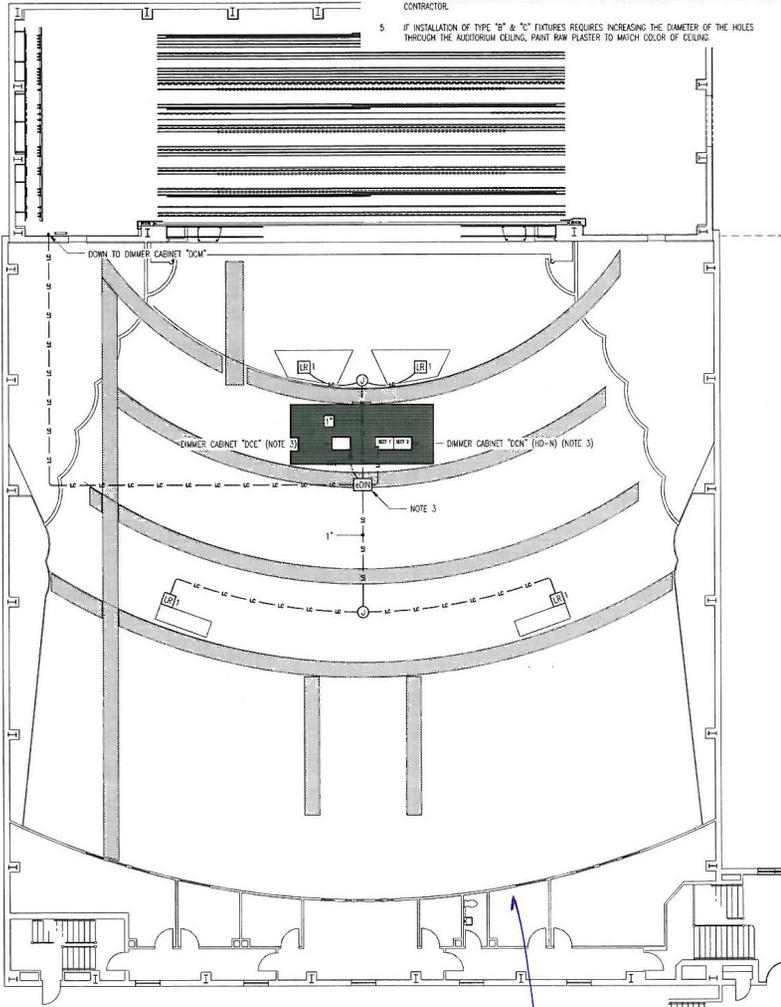
LIGHTING CONTROL WIRING

4. AT GRID IRON LEVEL, COORDINATE LOCATION WITH STAGE RIGGING CONTRACTOR. (CONNECT TO MULTI-CONDUCTOR CORD FROM ELECTRIC BATTERY. MULTI-CONDUCTOR CORD PROVIDED BY STAGE RIGGING CONTRACTOR.
5. IF INSTALLATION OF TYPE "B" & "C" FIXTURES REQUIRES INCREASING THE DIAMETER OF THE HOLES THROUGH THE AUDITORIUM CEILING, PAINT RAW PLASTER TO MATCH COLOR OF CEILING.
